# Manhole Inspection Report

Date:	05/13/2018	Weather:		Coding:	RZMACP
MH#:	M-604-075	Owner:	NA	Len. Surveyed:	11.5
P.O.#:		Surveyor:	Jen Costello	Rim to Invert:	11.3
Customer:		Cert. #:	U-907-5518	Wall Material:	Concrete (reinforced)

Street:	Washington St. 41' South of Old Rid	Project:	Hobart, IN
City:	Hobart, IN	GPS Northing:	2902117.066
Location:		GPS Easting:	2902117.066
Drain Area:	West	GPS Accuracy:	Sub-Meter
Cover Shape:	Circular	Evidence of Surcharge:	No
Cover Size:	22.5	Potential for Runoff:	None
Comments:

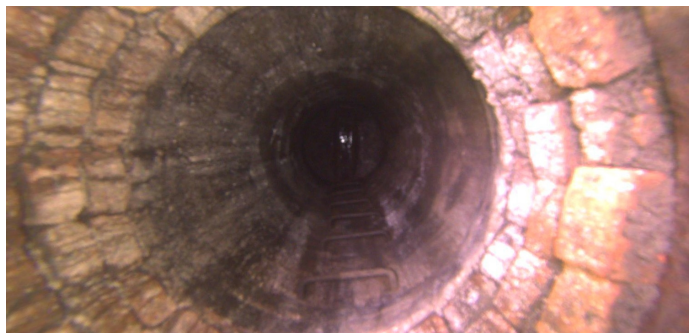
Code: **MGP**  
Description: **General Photo**

Distance (ft): **.0**  
Structural Grade: **0**  
O&M Grade: **0**  
Clock Start/From:  
Clock To:  
1st Value:  
2nd Value:  
Value Percent:  
Step: **NO**  
Remarks: **access MH**

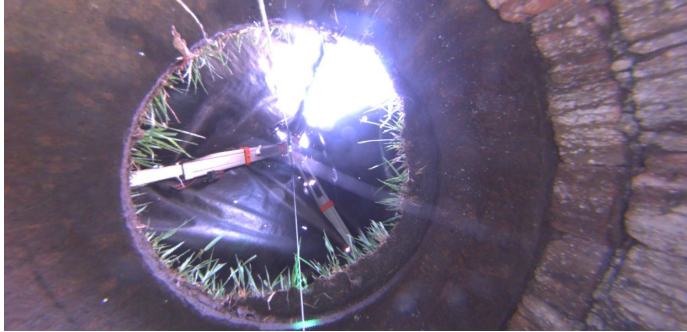
Code:	<b>MGO</b>
Description:	<b>General Observation</b>
Distance (ft):	<b>1.6</b>
Structural Grade:	<b>0</b>
O&M Grade:	<b>0</b>
Clock Start/From:	
Clock To:	
1st Value:	
2nd Value:	
Value Percent:	
Step:	<b>NO</b>
Remarks:	<b>UNDERSIDE OF FRAME</b>

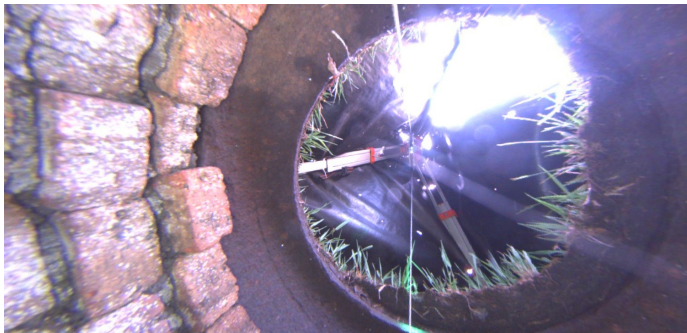
Code:	<b>DB</b>
Description:	<b>Displaced Brick</b>
Distance (ft):	<b>1.6</b>
Structural Grade:	<b>3</b>
O&M Grade:	<b>0</b>
Clock Start/From:	<b>3</b>
Clock To:	
1st Value:	
2nd Value:	
Value Percent:	
Step:	<b>NO</b>
Remarks:

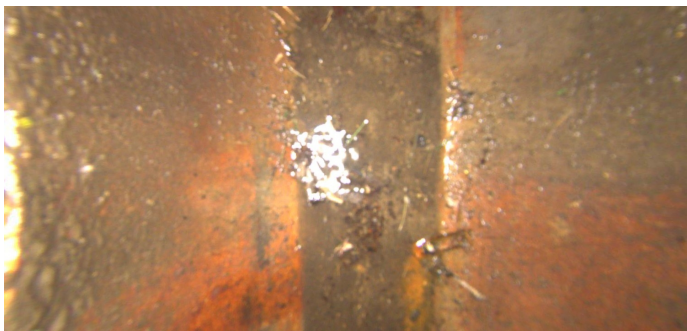
Code:	<b>MGO</b>
Description:	<b>General Observation</b>
Distance (ft):	<b>11.5</b>
Structural Grade:	<b>0</b>
O&M Grade:	<b>0</b>
Clock Start/From:	
Clock To:	
1st Value:	
2nd Value:	
Value Percent:	
Step:	<b>NO</b>
Remarks:	<b>END SURVEY</b>
