# Manhole Inspection Report

Date:	05/13/2018	Weather:		Coding:	RZMACP
MH#:	M-604-095	Owner:	NA	Len. Surveyed:	9.2
P.O.#:		Surveyor:	Jen Costello	Rim to Invert:	9.8
Customer:		Cert. #:	U-907-5518	Wall Material:	Brick

Street:	Pennsylvania St. 528' North of Ridge	Project:	Hobart, IN
City:	Hobart, IN	GPS Northing:	2902334.901
Location:		GPS Easting:	2902334.901
Drain Area:	Northwest	GPS Accuracy:	Sub-Meter
Cover Shape:	Circular	Evidence of Surcharge:	No
Cover Size:	22.5	Potential for Runoff:	None
Comments:

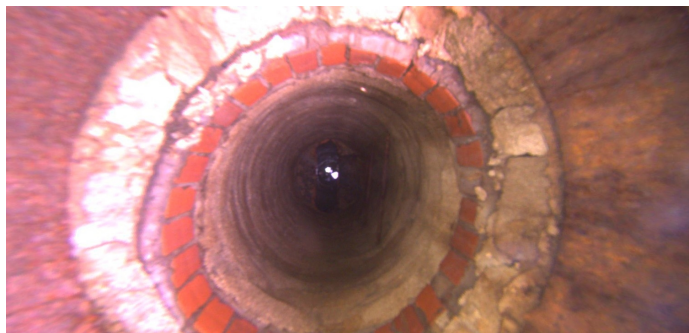
Code: **MGP**  
Description: **General Photo**

Distance (ft): **.0**  
Structural Grade: **0**  
O&M Grade: **0**  
Clock Start/From:  
Clock To:  
1st Value:  
2nd Value:  
Value Percent:  
Step: **NO**  
Remarks: **ACCESS MH**

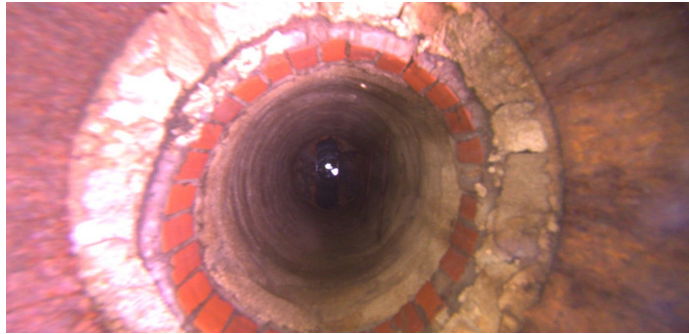
Code: **FM**  
Description: **Fracture Multiple**

Distance (ft): **.0**  
Structural Grade: **4**  
O&M Grade: **0**  
Clock Start/From: **12**  
Clock To: **12**  
1st Value:  
2nd Value:  
Value Percent:  
Step: **NO**  
Remarks:

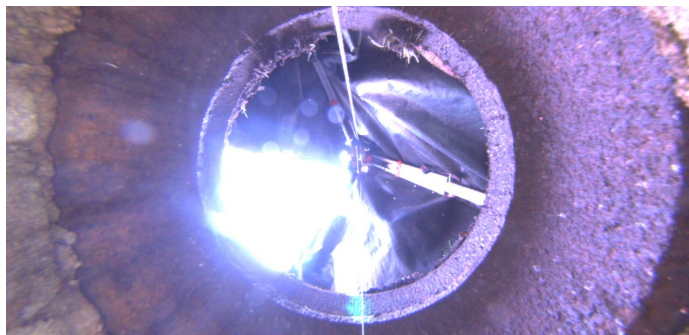
Code: **MGO**  
Description: **General Observation**

Distance (ft): **1.7**  
Structural Grade: **0**  
O&M Grade: **0**  
Clock Start/From:  
Clock To:  
1st Value:  
2nd Value:  
Value Percent:  
Step: **NO**  
Remarks: **UNDERSIDE OF FRAME**

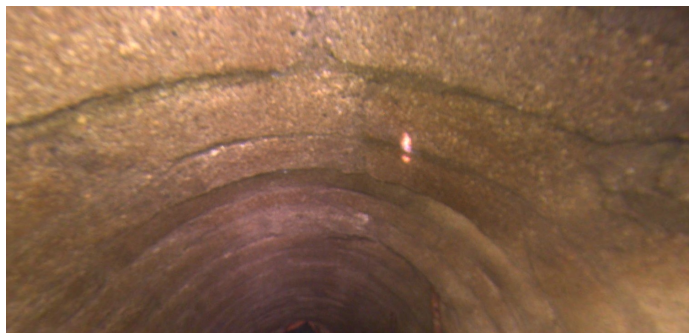
Code: **SAV**  
Description: **Surface Aggregate Visible**

Distance (ft): **1.7**  
Structural Grade: **3**  
O&M Grade: **0**  
Clock Start/From: **12**  
Clock To: **12**  
1st Value:  
2nd Value:  
Value Percent:  
Step: **NO**  
Remarks:

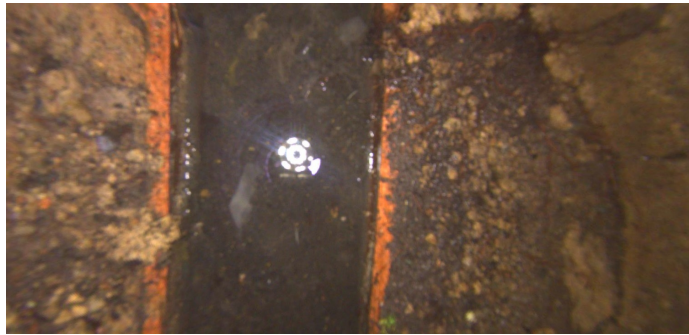
Code: **DSGV**  
Description: **Deposits Settled Gravel**

Distance (ft): **8.3**  
Structural Grade: **0**  
O&M Grade: **2**  
Clock Start/From: **12**  
Clock To: **12**  
1st Value:  
2nd Value:  
Value Percent: **5.000**  
Step: **NO**  
Remarks:

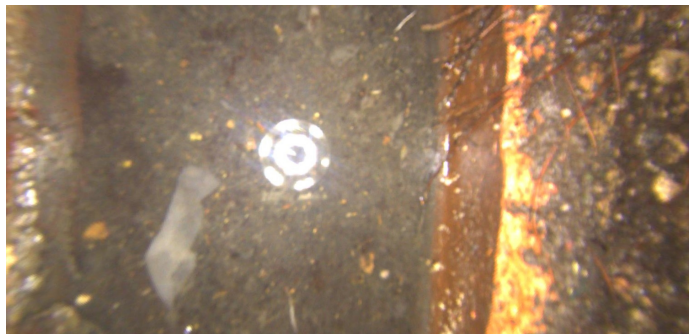
Code: **MGO**  
Description: **General Observation**

Distance (ft): **9.2**  
Structural Grade: **0**  
O&M Grade: **0**  
Clock Start/From:  
Clock To:  
1st Value:  
2nd Value:  
Value Percent:  
Step: **NO**  
Remarks: **END SURVEY**
