# Manhole Inspection Report

Date:	05/13/2018	Weather:		Coding:	RZMACP
MH#:	M-604-096	Owner:	NA	Len. Surveyed:	9.3
P.O.#:		Surveyor:	Jen Costello	Rim to Invert:	9.1
Customer:		Cert. #:	U-907-5518	Wall Material:	Concrete (reinforced)

Street:	Pennsylvania St. 690' North of Ridge	Project:	Hobart, IN
City:	Hobart, IN	GPS Northing:	2902334.724
Location:		GPS Easting:	2902334.724
Drain Area:	Northwest	GPS Accuracy:	Sub-Meter
Cover Shape:	Circular	Evidence of Surcharge:	No
Cover Size:	22.5	Potential for Runoff:	None
Comments:

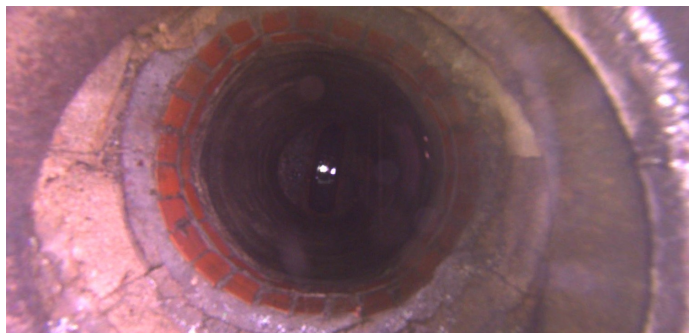
Code: **MGP**  
Description: **General Photo**

Distance (ft): **.0**  
Structural Grade: **0**  
O&M Grade: **0**  
Clock Start/From:  
Clock To:  
1st Value:  
2nd Value:  
Value Percent:  
Step: **NO**  
Remarks: **ACCESS MH**

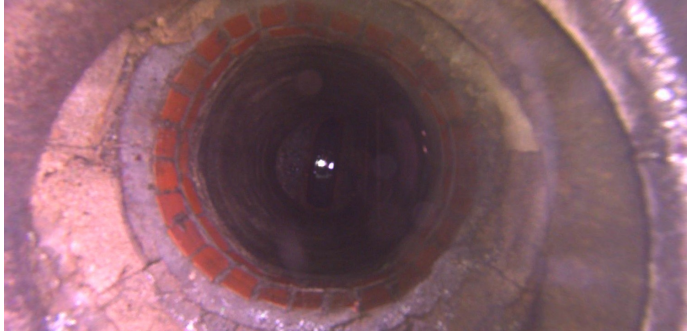
Code: **FM**  
Description: **Fracture Multiple**

Distance (ft): **.0**  
Structural Grade: **4**  
O&M Grade: **0**  
Clock Start/From: **4**  
Clock To: **11**  
1st Value:  
2nd Value:  
Value Percent:  
Step: **NO**  
Remarks:

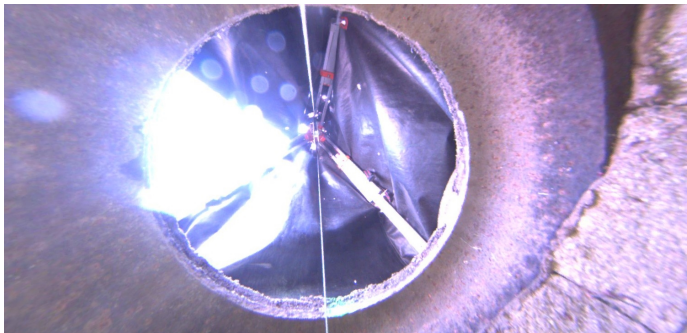
Code: **MGO**  
Description: **General Observation**

Distance (ft): **1.7**  
Structural Grade: **0**  
O&M Grade: **0**  
Clock Start/From:  
Clock To:  
1st Value:  
2nd Value:  
Value Percent:  
Step: **NO**  
Remarks: **UNDERSIDE OF FRAME**

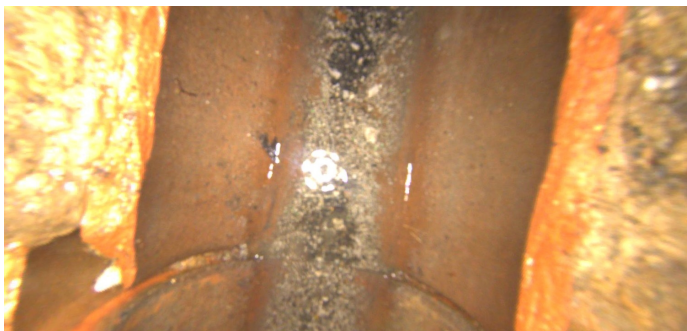
Code: **MGO**  
Description: **General Observation**

Distance (ft): **8.8**  
Structural Grade: **0**  
O&M Grade: **0**  
Clock Start/From:  
Clock To:  
1st Value:  
2nd Value:  
Value Percent:  
Step: **NO**  
Remarks: **END SURVEY**
