# Manhole Inspection Report

| MH#: | <b>M-604-097</b> | Owner: | <b>NA</b> | Len. Surveyed: | <b>3.3</b> |

| Street: | <b>Pennsylvania Ave. 932' North of Rid</b> | Project: | <b>Hobart, IN</b> |

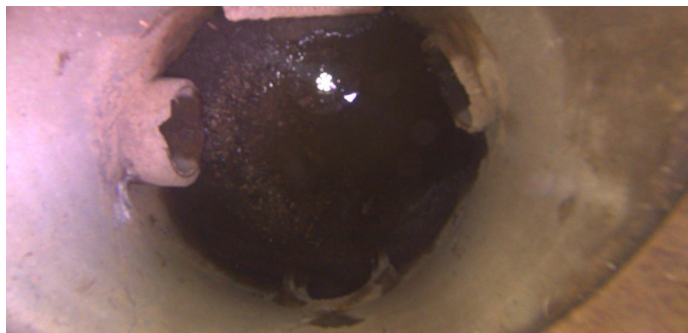
Code: **MGP**  
Description: **General Photo**

Distance (ft): **.0**  
Structural Grade: **0**  
O&M Grade: **0**  
Clock Start/From:  
Clock To:  
1st Value:  
2nd Value:  
Value Percent:  
Step: **NO**  
Remarks: **access mh**

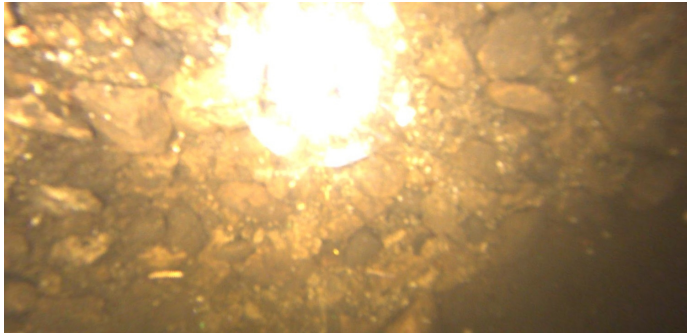
Code: **DSGV**  
Description: **Deposits Settled Gravel**

Distance (ft): **3.3**  
Structural Grade: **0**  
O&M Grade: **2**  
Clock Start/From: **12**  
Clock To: **12**  
1st Value:  
2nd Value:  
Value Percent: **10.000**  
Step: **NO**  
Remarks:

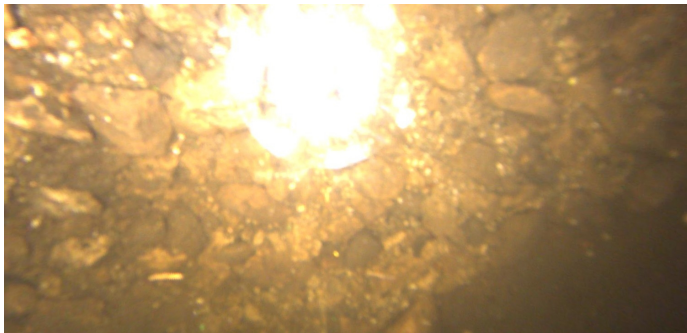
Code: **MGO**  
Description: **General Observation**

Distance (ft): **3.3**  
Structural Grade: **0**  
O&M Grade: **0**  
Clock Start/From:  
Clock To:  
1st Value:  
2nd Value:  
Value Percent:  
Step: **NO**  
Remarks: **end survey**
