Manhole Inspection Report

Date:	05/13/2018	Weather:		Coding:	RZMACP
MH#:	M-604-098	Owner:	NA	Len. Surveyed:	8.5
P.O.#:		Surveyor:	Jen Costello	Rim to Invert:	8.9
Customer:		Cert. #:	U-907-5518	Wall Material:	Concrete (reinforced)

Street:	Pennsylvania St. to the North. East o	Project:	Hobart, IN
City:	Hobart, IN	GPS Northing:	2902333.986
Location:		GPS Easting:	2902333.986
Drain Area:	Northwest	GPS Accuracy:	Sub-Meter
Cover Shape:	Circular	Evidence of Surcharge:	No
Cover Size:	22.5	Potential for Runoff:	None
Comments:

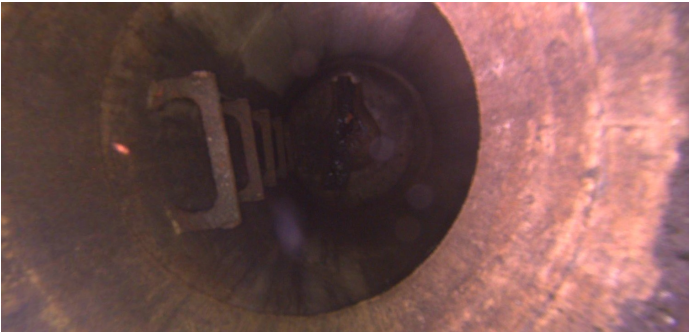
Code:

MGP

Description:

General Photo

Remarks:

ACCESS MH

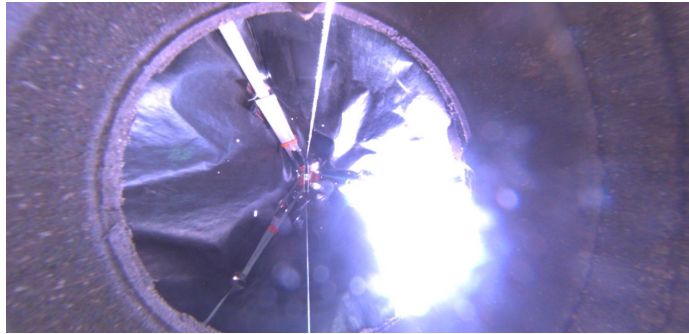
Code: **MGO**
Description: **General Observation**

Distance (ft): **1.2**
Structural Grade: **0**
O&M Grade: **0**
Clock Start/From:
Clock To:
1st Value:
2nd Value:
Value Percent:
Step: **NO**
Remarks: **UNDERSIDE OF FRAME**

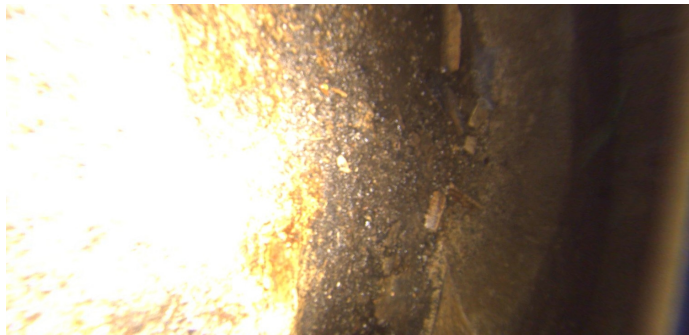
Code: **DSF**
Description: **Deposits Settled Fine**

Distance (ft): **8.5**
Structural Grade: **0**
O&M Grade: **3**
Clock Start/From: **4**
Clock To: **8**
1st Value:
2nd Value:
Value Percent: **20.000**
Step: **NO**
Remarks:

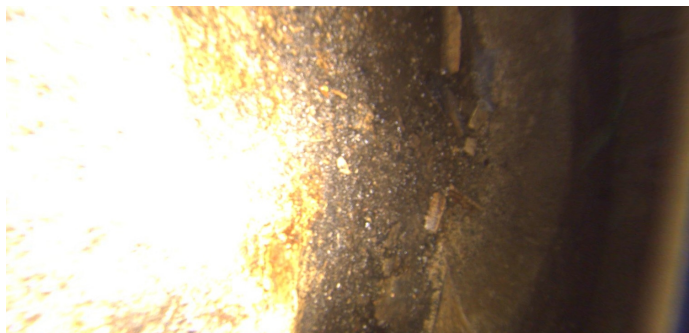
Code: **MGO**
Description: **General Observation**

Distance (ft): **8.5**
Structural Grade: **0**
O&M Grade: **0**
Clock Start/From:
Clock To:
1st Value:
2nd Value:
Value Percent:
Step: **NO**
Remarks: **END SURVEY**
