# Manhole Inspection Report

Date:	05/14/2018	Weather:		Coding:	RZMACP
MH#:	M-604-100	Owner:	NA	Len. Surveyed:	8.0
P.O.#:		Surveyor:	Jen Costello	Rim to Invert:	8.2
Customer:		Cert. #:	U-907-5518	Wall Material:	Brick

Street:	163' East of Wisconsin St. 627' North	Project:	Hobart, IN
City:	Hobart, IN	GPS Northing:	2901964.478
Location:		GPS Easting:	2901964.478
Drain Area:	Northwest	GPS Accuracy:	Sub-Meter
Cover Shape:	Circular	Evidence of Surcharge:	No
Cover Size:	22.5	Potential for Runoff:	None
Comments:

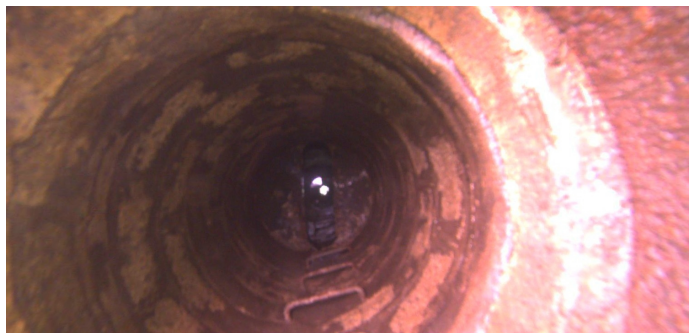
Code: **MGP**  
Description: **General Photo**

Distance (ft): **.0**  
Structural Grade: **0**  
O&M Grade: **0**  
Clock Start/From:  
Clock To:  
1st Value:  
2nd Value:  
Value Percent:  
Step: **NO**  
Remarks: **ACCESS MH**

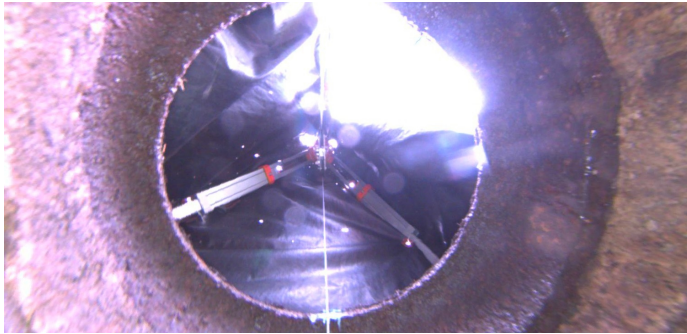
Code: **MGO**  
Description: **General Observation**

Distance (ft): **1.9**  
Structural Grade: **0**  
O&M Grade: **0**  
Clock Start/From:  
Clock To:  
1st Value:  
2nd Value:  
Value Percent:  
Step: **NO**  
Remarks: **END SURVEY**

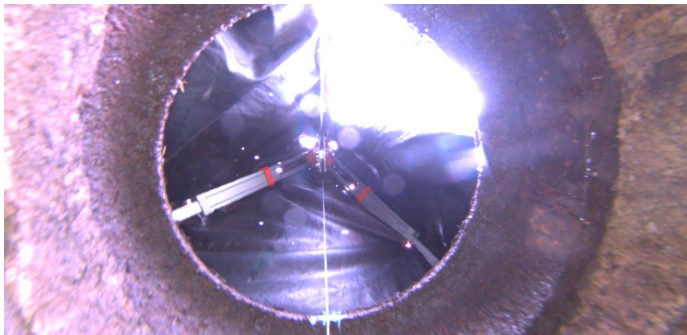
Code: **SAV**  
Description: **Surface Aggregate Visible**

Distance (ft): **1.9**  
Structural Grade: **3**  
O&M Grade: **0**  
Clock Start/From: **12**  
Clock To: **12**  
1st Value:  
2nd Value:  
Value Percent:  
Step: **NO**  
Remarks:

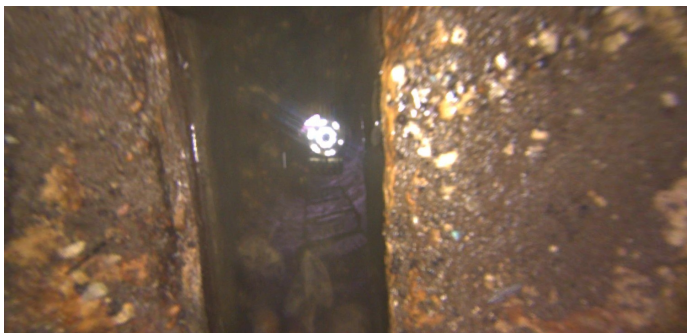
Code: **DSF**  
Description: **Deposits Settled Fine**

Distance (ft): **7.3**  
Structural Grade: **0**  
O&M Grade: **2**  
Clock Start/From: **12**  
Clock To: **12**  
1st Value:  
2nd Value:  
Value Percent: **5.000**  
Step: **NO**  
Remarks:

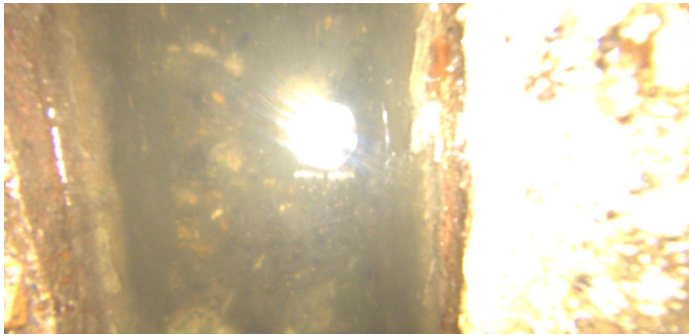
Code: **MGO**  
Description: **General Observation**

Distance (ft): **8.0**

Structural Grade: **0**

O&M Grade: **0**

Remarks: **END SURVEY**
