Manhole Inspection Report

Date:	05/14/2018	Weather:		Coding:	RZMACP
MH#:	M-604-101	Owner:	NA	Len. Surveyed:	8.0
P.O.#:		Surveyor:	Jen Costello	Rim to Invert:	8.8
Customer:		Cert. #:	U-907-5518	Wall Material:	Brick

Street:	375' South of Pennsylvania St. 164'	Project:	Hobart, IN
City:	Hobart, IN	GPS Northing:	2901959.537
Location:		GPS Easting:	2901959.537
Drain Area:	Northwest	GPS Accuracy:	Sub-Meter
Cover Shape:	Circular	Evidence of Surcharge:	No
Cover Size:	22.5	Potential for Runoff:	None
Comments:

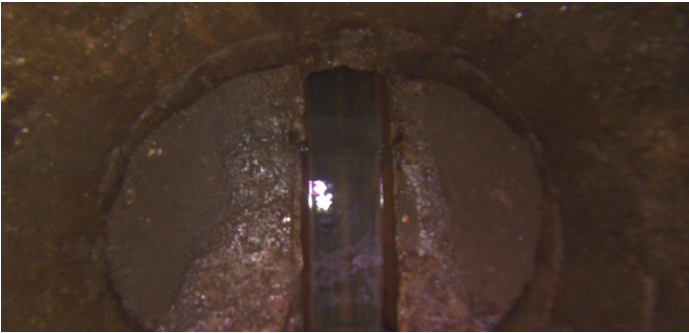
Code: **MGP**
Description: **General Photo**

Distance (ft): **.0**
Structural Grade: **0**
O&M Grade: **0**
Clock Start/From:
Clock To:
1st Value:
2nd Value:
Value Percent:
Step: **NO**
Remarks: **ACCESS MH**

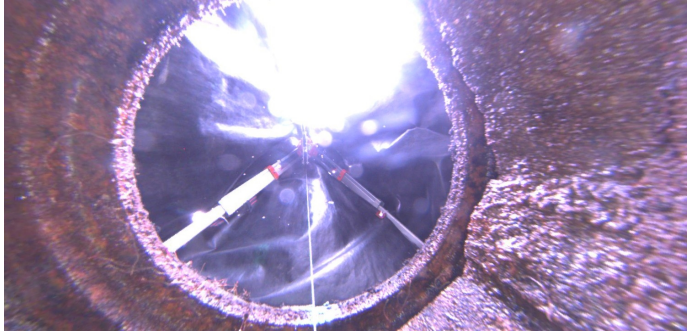
Code:	MGO
Description:	General Observation
Distance (ft):	1.4
Structural Grade:	0
O&M Grade:	0
Clock Start/From:	
Clock To:	
1st Value:	
2nd Value:	
Value Percent:	
Step:	NO
Remarks:	UNDERSIDE OF FRAME

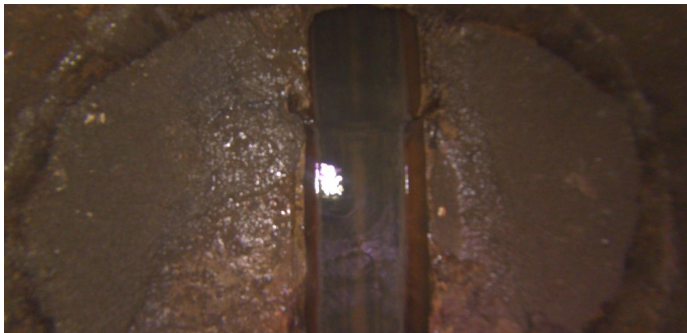
Code:	DSF
Description:	Deposits Settled Fine
Distance (ft):	6.3
Structural Grade:	0
O&M Grade:	2
Clock Start/From:	12
Clock To:	12
1st Value:	
2nd Value:	
Value Percent:	5.000
Step:	NO
Remarks:

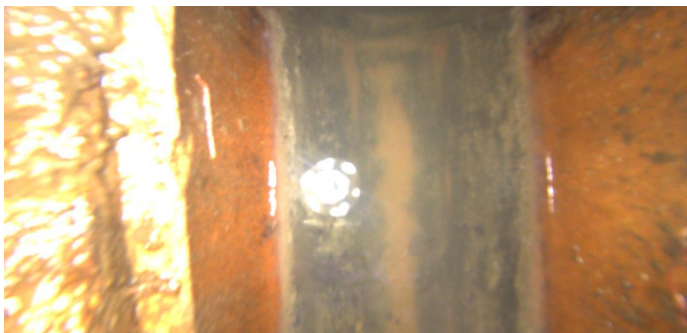
Code:	MGO
Description:	General Observation
Distance (ft):	7.9
Structural Grade:	0
O&M Grade:	0
Clock Start/From:	
Clock To:	
1st Value:	
2nd Value:	
Value Percent:	
Step:	NO
Remarks:	END SURVEY
