Manhole Inspection Report

Date:	05/14/2018	Weather:		Coding:	RZMACP
MH#:	M-604-103	Owner:	NA	Len. Surveyed:	8.9
P.O.#:		Surveyor:	Jen Costello	Rim to Invert:	9.3
Customer:		Cert. #:	U-907-5518	Wall Material:	Brick

Street:	162' East of Wisconsin St. 158' South	Project:	Hobart, IN
City:	Hobart, IN	GPS Northing:	2901964.5
Location:		GPS Easting:	2901964.5
Drain Area:	Northwest	GPS Accuracy:	Sub-Meter
Cover Shape:	Circular	Evidence of Surcharge:	No
Cover Size:	22.5	Potential for Runoff:	None
Comments:

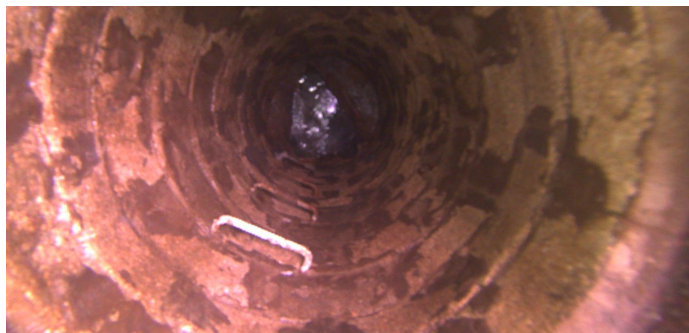
Code: **MGP**
Description: **General Photo**

Distance (ft): **.0**
Structural Grade: **0**
O&M Grade: **0**
Clock Start/From:
Clock To:
1st Value:
2nd Value:
Value Percent:
Step: **NO**
Remarks: **ACCESS MH**

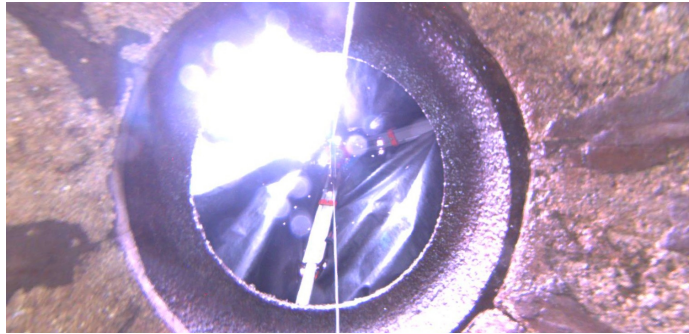
Code: **MGO**
Description: **General Observation**

Distance (ft): **2.3**
Structural Grade: **0**
O&M Grade: **0**
Clock Start/From:
Clock To:
1st Value:
2nd Value:
Value Percent:
Step: **NO**
Remarks: **UNDERSIDE OF FRAME**

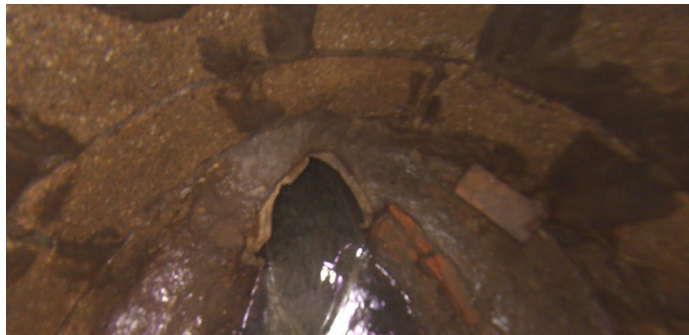
Code: **OBR**
Description: **Obstacle Rocks**

Distance (ft): **6.8**
Structural Grade: **0**
O&M Grade: **2**
Clock Start/From: **1**
Clock To:
1st Value:
2nd Value:
Value Percent: **5.000**
Step: **NO**
Remarks:

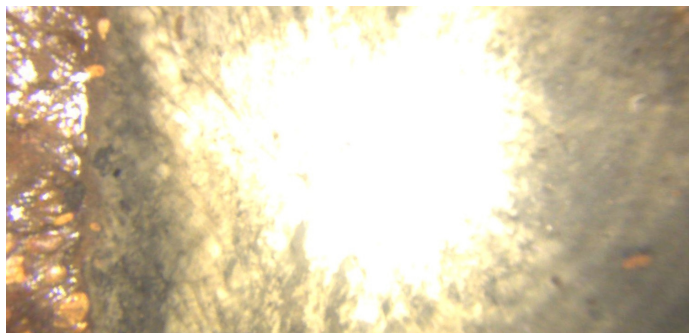
Code: **MGO**
Description: **General Observation**

Distance (ft): **8.9**
Structural Grade: **0**
O&M Grade: **0**
Clock Start/From:
Clock To:
1st Value:
2nd Value:
Value Percent:
Step: **NO**
Remarks: **END SURVEY**
