Manhole Inspection Report

Date:	04/29/2018	Weather:		Coding:	RZMACP
MH#:	M-604-107	Owner:	NA	Len. Surveyed:	5.9
P.O.#:		Surveyor:	Jen Costello	Rim to Invert:	5.7
Customer:		Cert. #:	U-907-5518	Wall Material:	Brick

Street:	Intersection of Home Ave and Ash S	Project:	Hobart, IN
City:	Hobart, IN	GPS Northing:	2903130.646
Location:		GPS Easting:	2903130.646
Drain Area:	West	GPS Accuracy:	Sub-Meter
Cover Shape:	Circular	Evidence of Surcharge:	No
Cover Size:	22.5	Potential for Runoff:	None
Comments:

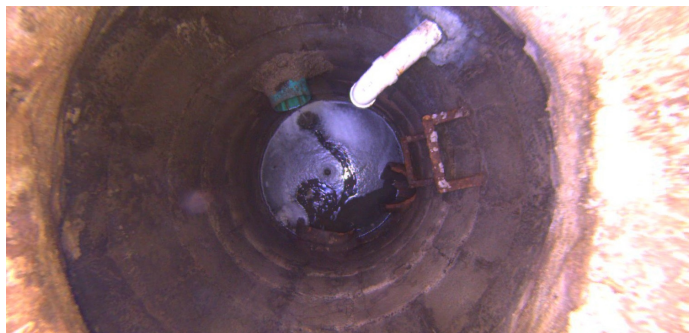
Code: **MGO**
Description: **General Observation**

Distance (ft): **.0**
Structural Grade: **0**
O&M Grade: **0**
Clock Start/From:
Clock To:
1st Value:
2nd Value:
Value Percent:
Step: **NO**
Remarks: **ACCESS MH**

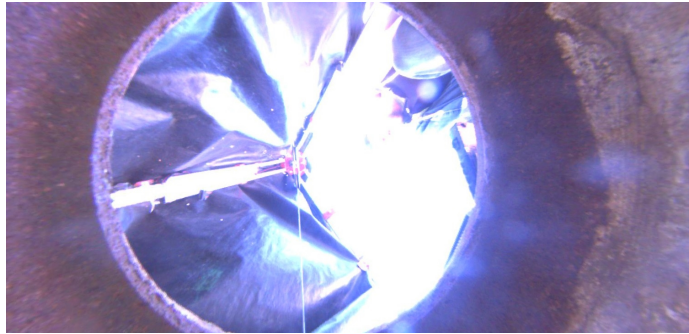
Code:	MGP
Description:	General Photo
Distance (ft):	1.3
Structural Grade:	0
O&M Grade:	0
Clock Start/From:	
Clock To:	
1st Value:	
2nd Value:	
Value Percent:	
Step:	NO
Remarks:	UNDERSIDE OF FRAME

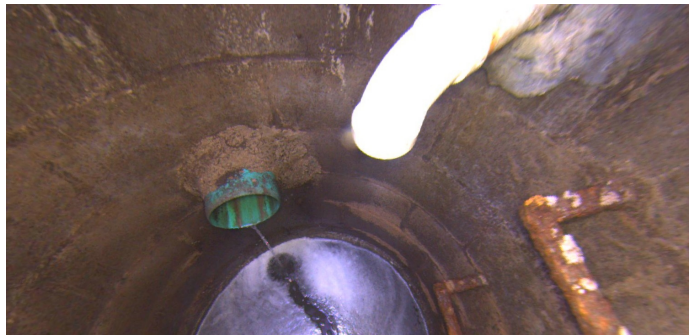
Code:	OBP
Description:	Obstacle External Pipe or Cable
Distance (ft):	1.7
Structural Grade:	0
O&M Grade:	2
Clock Start/From:	1
Clock To:	
1st Value:	
2nd Value:	
Value Percent:	10.000
Step:	NO
Remarks:

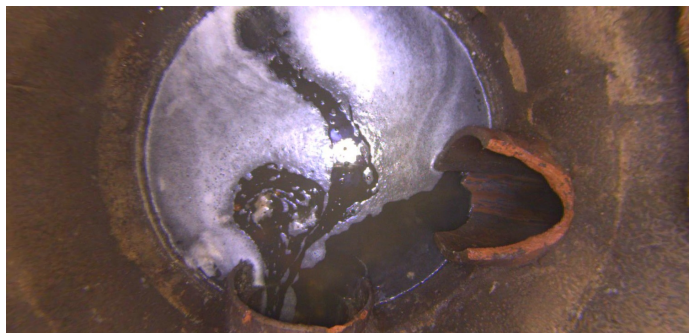
Code:	SRI
Description:	Surface Roughness Increased
Distance (ft):	3.5
Structural Grade:	1
O&M Grade:	0
Clock Start/From:	12
Clock To:	12
1st Value:	
2nd Value:	
Value Percent:	
Step:	NO
Remarks:

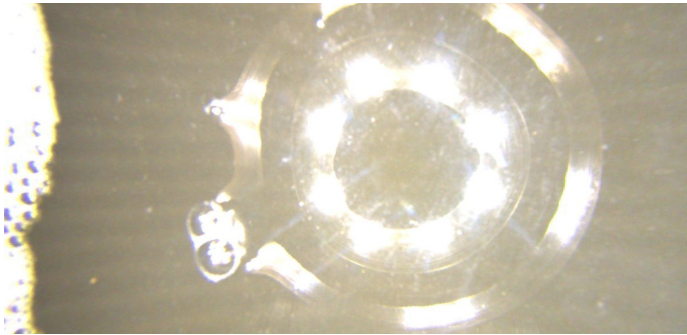
Code:	MGO
Description:	General Observation
Distance (ft):	5.9
Structural Grade:	0
O&M Grade:	0
Clock Start/From:	
Clock To:	
1st Value:	
2nd Value:	
Value Percent:	
Step:	NO
Remarks:	BENCH IS SUBMERGED END SURVEY
