# Manhole Inspection Report

Date:	<b>04/28/2018</b>	Weather:		Coding:	<b>RZMACP</b>
MH#:	<b>M-604-123</b>	Owner:	<b>NA</b>	Len. Surveyed:	<b>7.6</b>
P.O.#:		Surveyor:	<b>Jen Costello</b>	Rim to Invert:	<b>8.5</b>
Customer:		Cert. #:	<b>U-907-5518</b>	Wall Material:	<b>Brick</b>

Street:	<b>Old Ridge Road, and Beverly Blvd. T</b>	Project:	<b>Hobart, IN</b>
City:	<b>Hobart, IN</b>	GPS Northing:	<b>2904174.75</b>
Location:		GPS Easting:	<b>2904174.75</b>
Drain Area:	<b>Northwest</b>	GPS Accuracy:	<b>Sub-Meter</b>
Cover Shape:	<b>Circular</b>	Evidence of Surcharge:	<b>No</b>
Cover Size:	<b>22.5</b>	Potential for Runoff:	<b>None</b>
Comments:

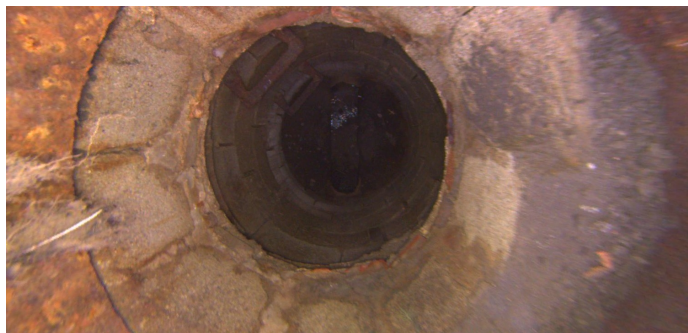
Code: **FM**  
Description: **Fracture Multiple**

Distance (ft): **.0**  
Structural Grade: **4**  
O&M Grade: **0**  
Clock Start/From: **12**  
Clock To: **12**  
1st Value:  
2nd Value:  
Value Percent:  
Step: **NO**  
Remarks:

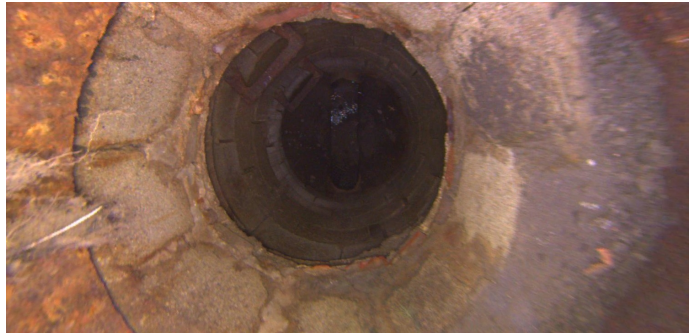
Code: **MGO**  
Description: **General Observation**

Distance (ft): **.0**  
Structural Grade: **0**  
O&M Grade: **0**  
Clock Start/From:  
Clock To:  
1st Value:  
2nd Value:  
Value Percent:  
Step: **NO**  
Remarks: **ACCESS MH**

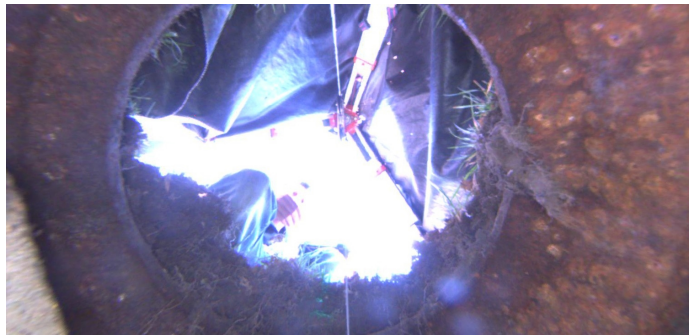
Code: **MGP**  
Description: **General Photo**

Distance (ft): **1.8**  
Structural Grade: **0**  
O&M Grade: **0**  
Clock Start/From:  
Clock To:  
1st Value:  
2nd Value:  
Value Percent:  
Step: **NO**  
Remarks: **UNDERSIDE OF FRAME**

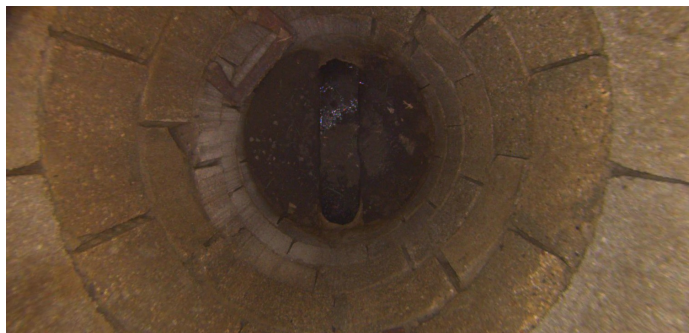
Code: **SAV**  
Description: **Surface Aggregate Visible**

Distance (ft): **2.6**  
Structural Grade: **3**  
O&M Grade: **0**  
Clock Start/From: **12**  
Clock To: **12**  
1st Value:  
2nd Value:  
Value Percent:  
Step: **NO**  
Remarks:

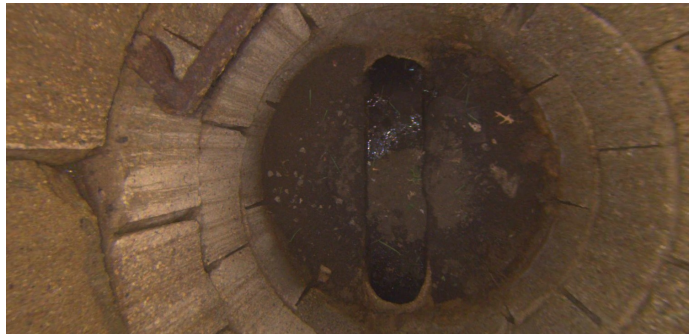
Code: **SSS**  
Description: **Surface Spalling**

Distance (ft): **4.4**  
Structural Grade: **2**  
O&M Grade: **0**  
Clock Start/From: **8**  
Clock To: **9**  
1st Value:  
2nd Value:  
Value Percent:  
Step: **NO**  
Remarks:

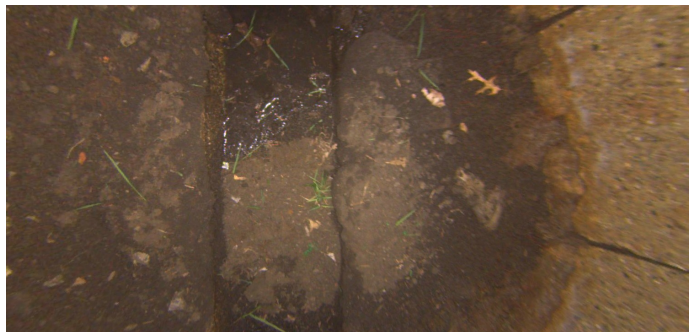
Code: **DSF**  
Description: **Deposits Settled Fine**

Distance (ft): **6.2**  
Structural Grade: **0**  
O&M Grade: **2**  
Clock Start/From: **12**  
Clock To: **12**  
1st Value:  
2nd Value:  
Value Percent: **5.000**  
Step: **NO**  
Remarks:

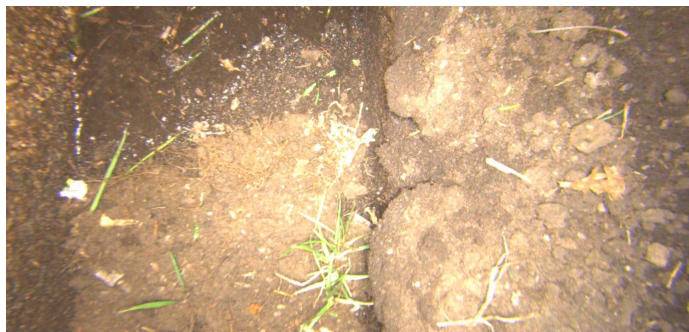
Code: **DSF**  
Description: **Deposits Settled Fine**

Distance (ft): **7.6**  
Structural Grade: **0**  
O&M Grade: **5**  
Clock Start/From: **3**  
Clock To: **9**  
1st Value:  
2nd Value:  
Value Percent: **40.000**  
Step: **NO**  
Remarks:

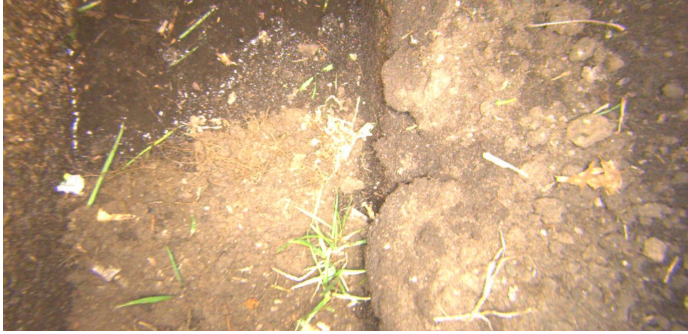
Code:	<b>MGO</b>
Description:	<b>General Observation</b>
Distance (ft):	<b>7.6</b>
Structural Grade:	<b>0</b>
O&M Grade:	<b>0</b>
Clock Start/From:	
Clock To:	
1st Value:	
2nd Value:	
Value Percent:	
Step:	<b>NO</b>
Remarks:	<b>END SURVEY</b>
