Manhole Inspection Report

Date:	04/28/2018	Weather:		Coding:	RZMACP
MH#:	M-604-124	Owner:	NA	Len. Surveyed:	6.1
P.O.#:		Surveyor:	Jen Costello	Rim to Invert:	6.0
Customer:		Cert. #:	U-907-5518	Wall Material:	Concrete (reinforced)

Street:	Old Ridge Rd. and Beverly Blvd. The	Project:	Hobart, IN
City:	Hobart, IN	GPS Northing:	2903996.569
Location:		GPS Easting:	2903996.569
Drain Area:	Northwest	GPS Accuracy:	Sub-Meter
Cover Shape:	Circular	Evidence of Surcharge:	No
Cover Size:	22.5	Potential for Runoff:	None
Comments:

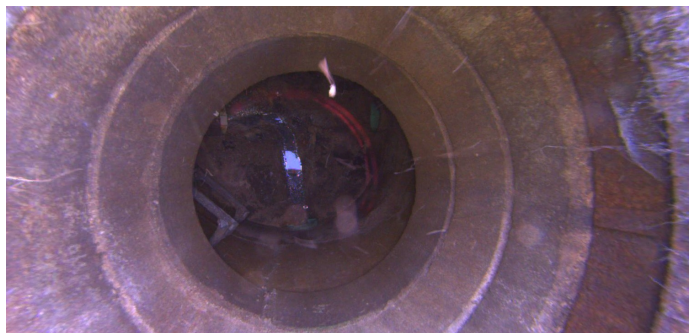
Code: **MGO**
Description: **General Observation**

Distance (ft): **.0**
Structural Grade: **0**
O&M Grade: **0**
Clock Start/From:
Clock To:
1st Value:
2nd Value:
Value Percent:
Step: **NO**
Remarks: **ACCESS MH**

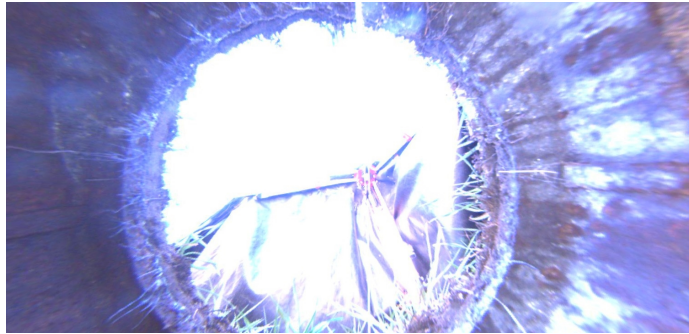
Code:	MGP
Description:	General Photo
Distance (ft):	1.4
Structural Grade:	0
O&M Grade:	0
Clock Start/From:	
Clock To:	
1st Value:	
2nd Value:	
Value Percent:	
Step:	NO
Remarks:	UNDERSIDE OF FRAME

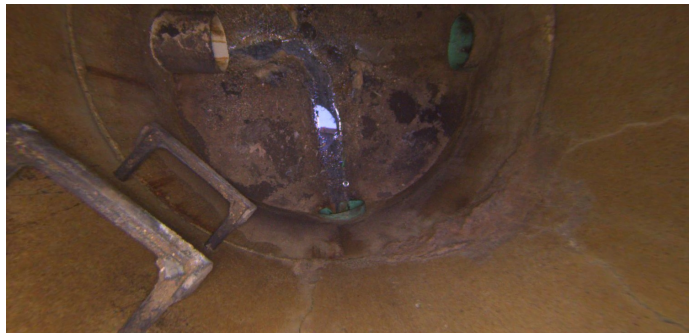
Code:	FM
Description:	Fracture Multiple
Distance (ft):	2.1
Structural Grade:	4
O&M Grade:	0
Clock Start/From:	3
Clock To:	9
1st Value:	
2nd Value:	
Value Percent:	
Step:	NO
Remarks:

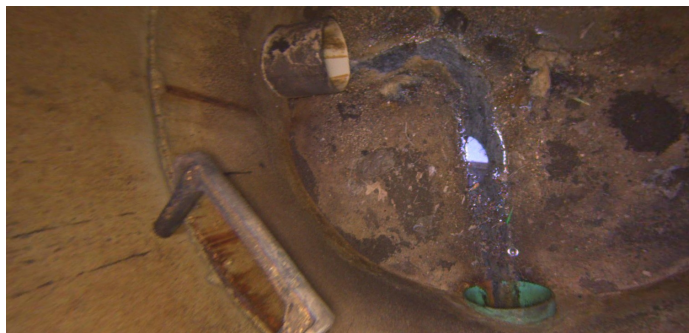
Code:	IW
Description:	Infil Weeper
Distance (ft):	3.4
Structural Grade:	0
O&M Grade:	2
Clock Start/From:	7
Clock To:	9
1st Value:	
2nd Value:	
Value Percent:	
Step:	NO
Remarks:

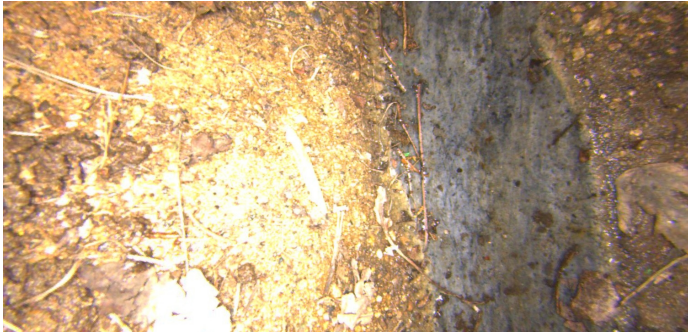
Code:	MGO
Description:	General Observation
Distance (ft):	6.1
Structural Grade:	0
O&M Grade:	0
Clock Start/From:	
Clock To:	
1st Value:	
2nd Value:	
Value Percent:	
Step:	NO
Remarks:	END SURVEY
