# Manhole Inspection Report

Date:	<b>04/28/2018</b>	Weather:		Coding:	<b>RZMACP</b>
MH#:	<b>M-604-125</b>	Owner:	<b>NA</b>	Len. Surveyed:	<b>1.4</b>
P.O.#:		Surveyor:	<b>Jen Costello</b>	Rim to Invert:	<b>1.4</b>
Customer:		Cert. #:	<b>U-907-5518</b>	Wall Material:	<b>Concrete (reinforced)</b>

Street:	<b>Old Ridge Rd. and Beverly Blvd.</b>	Project:	<b>Hobart, IN</b>
City:	<b>Hobart, IN</b>	GPS Northing:	<b>2903967.807</b>
Location:		GPS Easting:	<b>2903967.807</b>
Drain Area:	<b>Northwest</b>	GPS Accuracy:	<b>Sub-Meter</b>
Cover Shape:	<b>Circular</b>	Evidence of Surcharge:	<b>No</b>
Cover Size:	<b>22.5</b>	Potential for Runoff:	<b>None</b>
Comments:

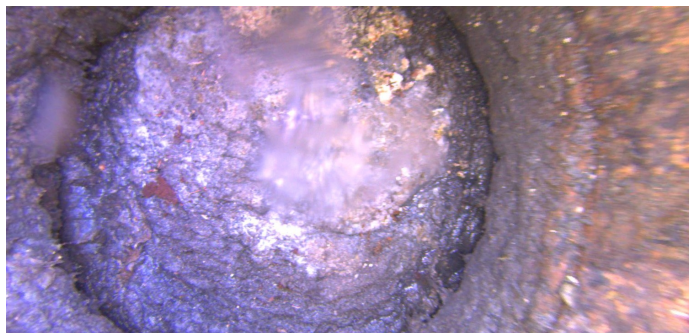
Code: **MGO**  
Description: **General Observation**

Distance (ft): **.0**  
Structural Grade: **0**  
O&M Grade: **0**  
Clock Start/From:  
Clock To:  
1st Value:  
2nd Value:  
Value Percent:  
Step: **NO**  
Remarks: **ACCESS MH**

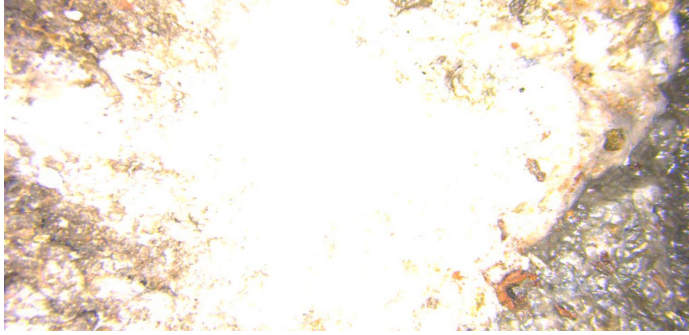
Code:	<b>MSA</b>
Description:	<b>Abandoned Survey</b>
Distance (ft):	<b>1.4</b>
Structural Grade:	<b>0</b>
O&M Grade:	<b>0</b>
Clock Start/From:	
Clock To:	
1st Value:	
2nd Value:	
Value Percent:	
Step:	<b>NO</b>
Remarks:	<b>DEBRIS</b>
