Manhole Inspection Report

Date:	05/02/2018	Weather:		Coding:	RZMACP
MH#:	M-605-002	Owner:	NA	Len. Surveyed:	8.7
P.O.#:		Surveyor:	Jen Costello	Rim to Invert:	8.9
Customer:		Cert. #:	U-907-5518	Wall Material:	Brick

Street:	Lake Park Ave. 270' North of 3rd St.	Project:	Hobart, IN
City:	Hobart, IN	GPS Northing:	41.53223801
Location:		GPS Easting:	-87.25966644
Drain Area:	West	GPS Accuracy:	Nearest Meter
Cover Shape:	Circular	Evidence of Surcharge:	No
Cover Size:	22.5	Potential for Runoff:	None
Comments:

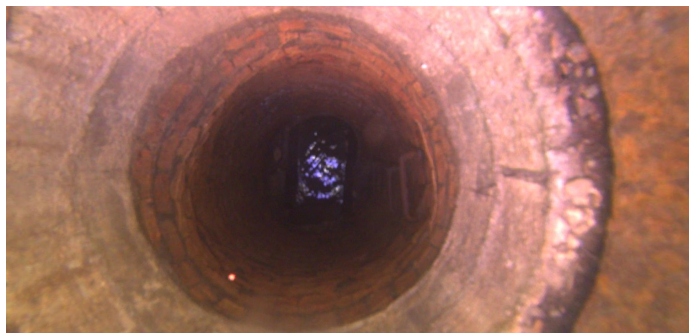
Code: **MGP**
 Description: **General Photo**

Distance (ft): **.0**
 Structural Grade: **0**
 O&M Grade: **0**
 Clock Start/From:
 Clock To:
 1st Value:
 2nd Value:
 Value Percent:
 Step: **NO**
 Remarks: **access MH**

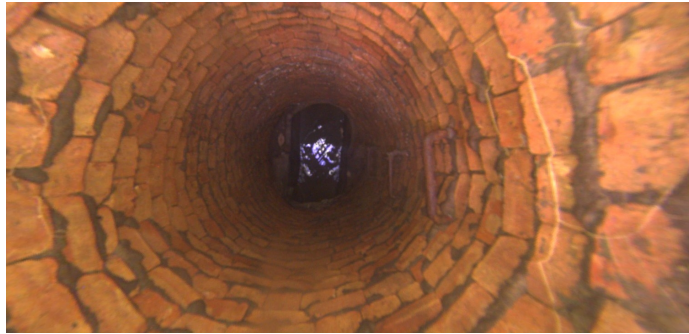
Code: **RFB**
Description: **Roots Fine Barrel**

Distance (ft): **1.8**
Structural Grade: **0**
O&M Grade: **2**
Clock Start/From: **12**
Clock To: **12**
1st Value:
2nd Value:
Value Percent:
Step: **NO**
Remarks:

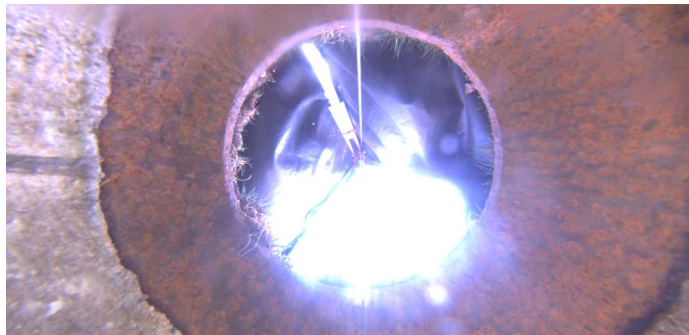
Code: **MGO**
Description: **General Observation**

Distance (ft): **1.8**
Structural Grade: **0**
O&M Grade: **0**
Clock Start/From:
Clock To:
1st Value:
2nd Value:
Value Percent:
Step: **NO**
Remarks: **UNDERSIDE OF FRAME**

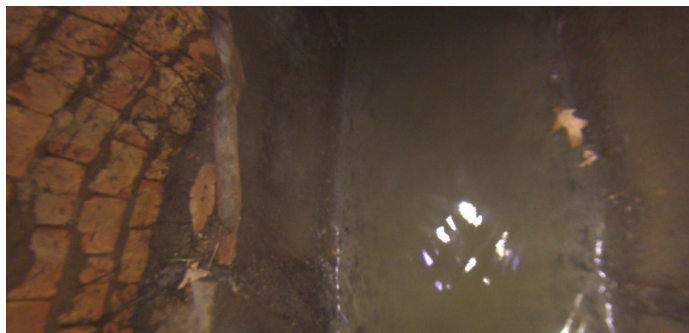
Code: **RFB**
Description: **Roots Fine Barrel**

Distance (ft): **7.4**
Structural Grade: **0**
O&M Grade: **2**
Clock Start/From: **9**
Clock To: **10**
1st Value:
2nd Value:
Value Percent:
Step: **NO**
Remarks:
