# Manhole Inspection Report

Date:	<b>05/02/2018</b>	Weather:		Coding:	<b>RZMACP</b>
MH#:	<b>M-605-003</b>	Owner:	<b>NA</b>	Len. Surveyed:	<b>9.2</b>
P.O.#:		Surveyor:	<b>Jen Costello</b>	Rim to Invert:	<b>9.1</b>
Customer:		Cert. #:	<b>U-907-5518</b>	Wall Material:	<b>Brick</b>

Street:	<b>Lake Park Ave. 580' North of 3rd St.</b>	Project:	<b>Hobart, IN</b>
City:	<b>Hobart, IN</b>	GPS Northing:	<b>41.5330658</b>
Location:		GPS Easting:	<b>-87.25965881</b>
Drain Area:	<b>West</b>	GPS Accuracy:	<b>Nearest Meter</b>
Cover Shape:	<b>Circular</b>	Evidence of Surcharge:	<b>No</b>
Cover Size:	<b>22.5</b>	Potential for Runoff:	<b>None</b>
Comments:

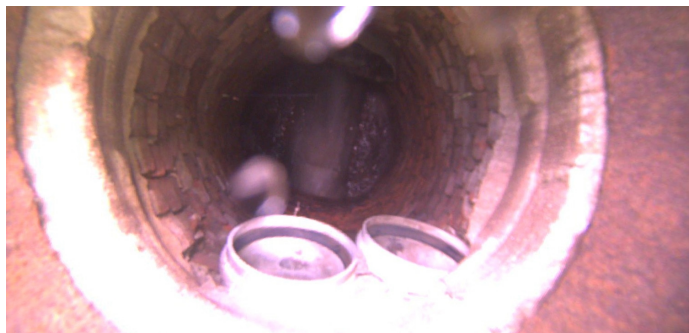
Code: **MGP**  
 Description: **General Photo**

Distance (ft): **.0**  
 Structural Grade: **0**  
 O&M Grade: **0**  
 Clock Start/From:  
 Clock To:  
 1st Value:  
 2nd Value:  
 Value Percent:  
 Step: **NO**  
 Remarks: **ACCESS MH**

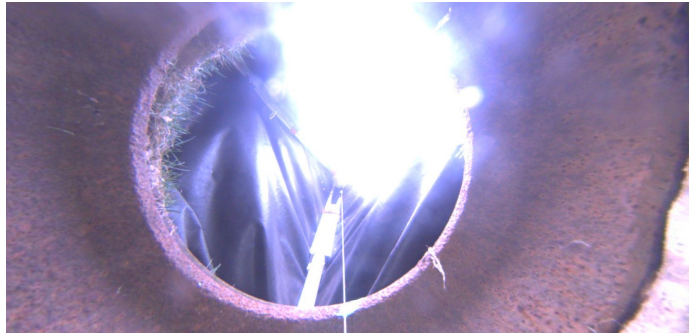
Code:	<b>MGO</b>
Description:	<b>General Observation</b>
Distance (ft):	<b>1.5</b>
Structural Grade:	<b>0</b>
O&M Grade:	<b>0</b>
Clock Start/From:	
Clock To:	
1st Value:	
2nd Value:	
Value Percent:	
Step:	<b>NO</b>
Remarks:	<b>UNDERSIDE OF FRAME</b>

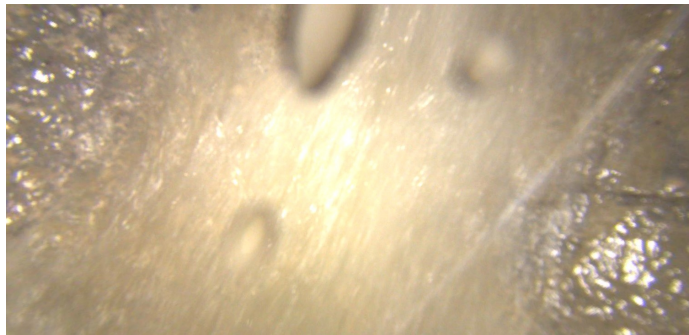
Code:	<b>MGO</b>
Description:	<b>General Observation</b>
Distance (ft):	<b>9.2</b>
Structural Grade:	<b>0</b>
O&M Grade:	<b>0</b>
Clock Start/From:	
Clock To:	
1st Value:	
2nd Value:	
Value Percent:	
Step:	<b>NO</b>
Remarks:	<b>END SURVEY</b>
