Manhole Inspection Report

Date:	05/01/2018	Weather:		Coding:	RZMACP
MH#:	M-605-004	Owner:	NA	Len. Surveyed:	11.5
P.O.#:		Surveyor:	Jen Costello	Rim to Invert:	11.9
Customer:		Cert. #:	U-907-5518	Wall Material:	Brick

Street:	3rd St. 309' East of Ellendale St.	Project:	Hobart, IN
City:	Hobart, IN	GPS Northing:	41.53173828
Location:		GPS Easting:	-87.26091766
Drain Area:	West	GPS Accuracy:	Nearest Meter
Cover Shape:	Circular	Evidence of Surcharge:	No
Cover Size:	22.5	Potential for Runoff:	None
Comments:

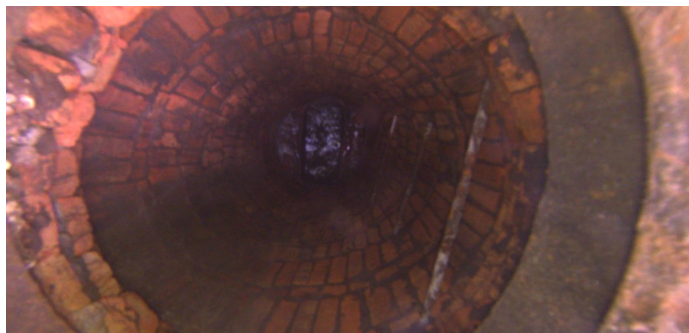
Code: **MGP**
Description: **General Photo**

Distance (ft): **.0**
Structural Grade: **0**
O&M Grade: **0**
Clock Start/From:
Clock To:
1st Value:
2nd Value:
Value Percent:
Step: **NO**
Remarks: **access MH**

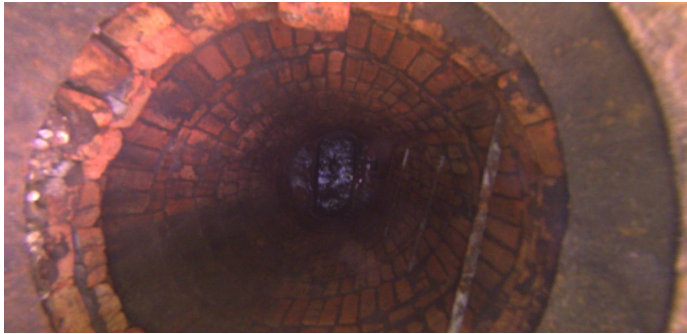
Code: **DB**
Description: **Displaced Brick**

Distance (ft): **.0**
Structural Grade: **3**
O&M Grade: **0**
Clock Start/From: **6**
Clock To: **12**
1st Value:
2nd Value:
Value Percent:
Step: **NO**
Remarks:

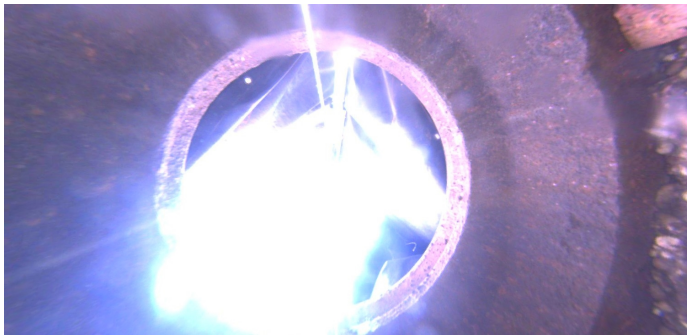
Code: **MGO**
Description: **General Observation**

Distance (ft): **1.9**
Structural Grade: **0**
O&M Grade: **0**
Clock Start/From:
Clock To:
1st Value:
2nd Value:
Value Percent:
Step: **NO**
Remarks: **UNDERSIDE OF FRAME**

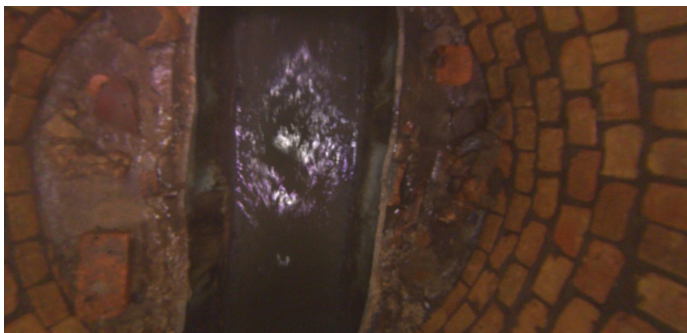
Code: **OBR**
Description: **Obstacle Rocks**

Distance (ft): **9.4**
Structural Grade: **0**
O&M Grade: **2**
Clock Start/From: **12**
Clock To: **12**
1st Value:
2nd Value:
Value Percent: **5.000**
Step: **NO**
Remarks:

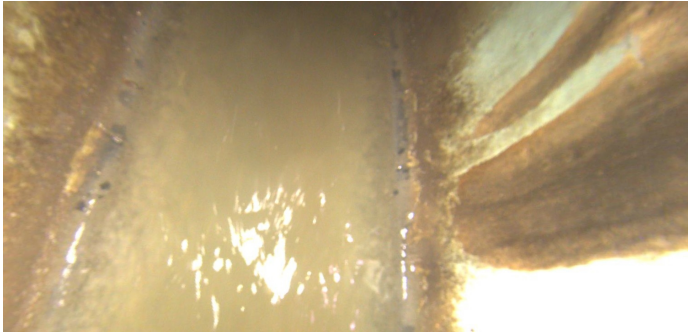
Code:	MGP
Description:	General Photo
Distance (ft):	11.5
Structural Grade:	0
O&M Grade:	0
Clock Start/From:	
Clock To:	
1st Value:	
2nd Value:	
Value Percent:	
Step:	NO
Remarks:	ACCESS MH
