Manhole Inspection Report

Date:	05/01/2018	Weather:		Coding:	RZMACP
MH#:	M-605-006	Owner:	NA	Len. Surveyed:	6.5
P.O.#:		Surveyor:	Jen Costello	Rim to Invert:	6.4
Customer:		Cert. #:	U-907-5518	Wall Material:	Brick

Street:	Ellendale St. and 3rd St.	Project:	Hobart, IN
City:	Hobart, IN	GPS Northing:	41.53201675
Location:		GPS Easting:	-87.26200104
Drain Area:	West	GPS Accuracy:	Nearest Meter
Cover Shape:	Circular	Evidence of Surcharge:	No
Cover Size:	22.5	Potential for Runoff:	None
Comments:

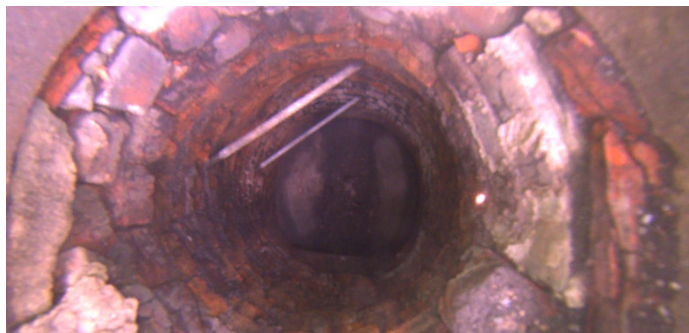
Code: **MGP**
Description: **General Photo**

Distance (ft): **.0**
Structural Grade: **0**
O&M Grade: **0**
Clock Start/From:
Clock To:
1st Value:
2nd Value:
Value Percent:
Step: **NO**
Remarks: **ACCESS MH**

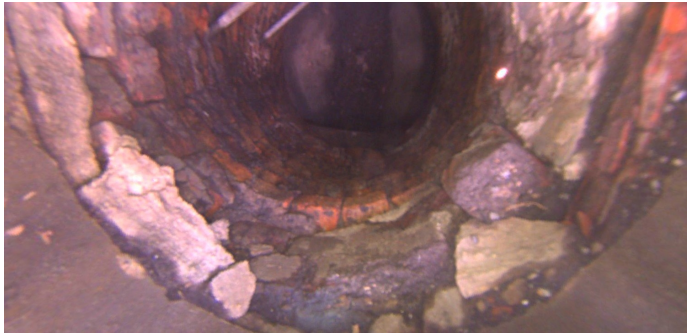
Code: **B**
Description: **Broken**

Distance (ft): **.0**
Structural Grade: **5**
O&M Grade: **0**
Clock Start/From: **4**
Clock To: **8**
1st Value:
2nd Value:
Value Percent:
Step: **NO**
Remarks:

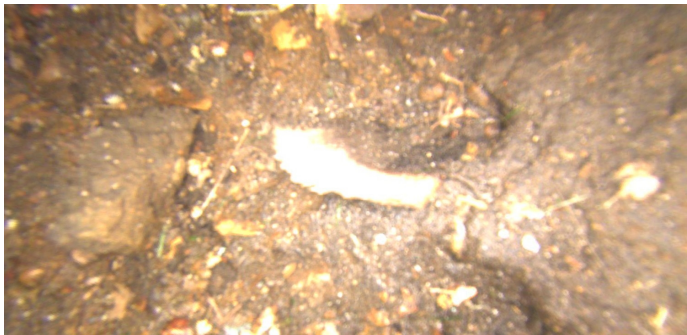
Code: **DSF**
Description: **Deposits Settled Fine**

Distance (ft): **6.5**
Structural Grade: **0**
O&M Grade: **3**
Clock Start/From: **4**
Clock To: **8**
1st Value:
2nd Value:
Value Percent: **20.000**
Step: **NO**
Remarks:

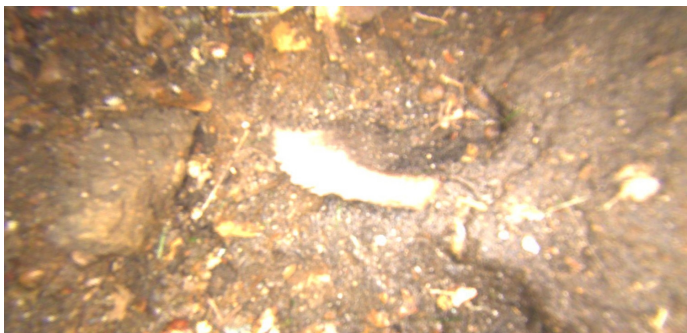
Code: **MGO**
Description: **General Observation**

Distance (ft): **6.5**
Structural Grade: **0**
O&M Grade: **0**
Clock Start/From:
Clock To:
1st Value:
2nd Value:
Value Percent:
Step: **NO**
Remarks: **END SURVEY**
