# Manhole Inspection Report

Date:	<b>05/01/2018</b>	Weather:		Coding:	<b>RZMACP</b>
MH#:	<b>M-605-008</b>	Owner:	<b>NA</b>	Len. Surveyed:	<b>8.3</b>
P.O.#:		Surveyor:	<b>Jen Costello</b>	Rim to Invert:	<b>8.9</b>
Customer:		Cert. #:	<b>U-907-5518</b>	Wall Material:	<b>Brick</b>

Street:	<b>Intersection of 3rd St. and Ash St.</b>	Project:	<b>Hobart, IN</b>
City:	<b>Hobart, IN</b>	GPS Northing:	<b>41.53244781</b>
Location:		GPS Easting:	<b>-87.26452637</b>
Drain Area:	<b>West</b>	GPS Accuracy:	<b>Nearest Meter</b>
Cover Shape:	<b>Circular</b>	Evidence of Surcharge:	<b>No</b>
Cover Size:	<b>22.5</b>	Potential for Runoff:	<b>None</b>
Comments:

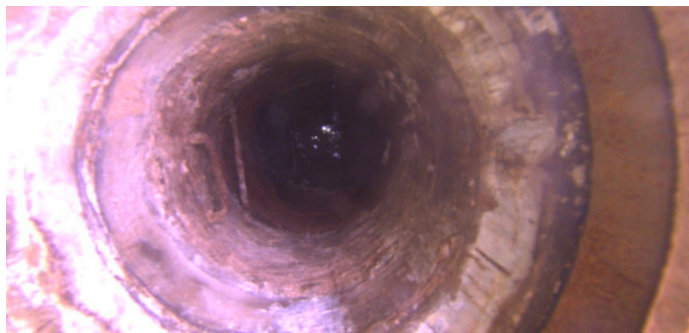
Code: **MGP**  
Description: **General Photo**

Distance (ft): **.0**  
Structural Grade: **0**  
O&M Grade: **0**  
Clock Start/From:  
Clock To:  
1st Value:  
2nd Value:  
Value Percent:  
Step: **NO**  
Remarks: **ACCESS MH**

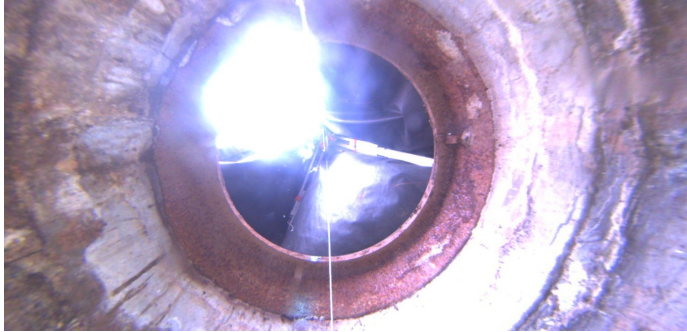
Code: **MGO**  
Description: **General Observation**

Distance (ft): **2.3**  
Structural Grade: **0**  
O&M Grade: **0**  
Clock Start/From:  
Clock To:  
1st Value:  
2nd Value:  
Value Percent:  
Step: **NO**  
Remarks: **UNDERSIDE OF FRAME**

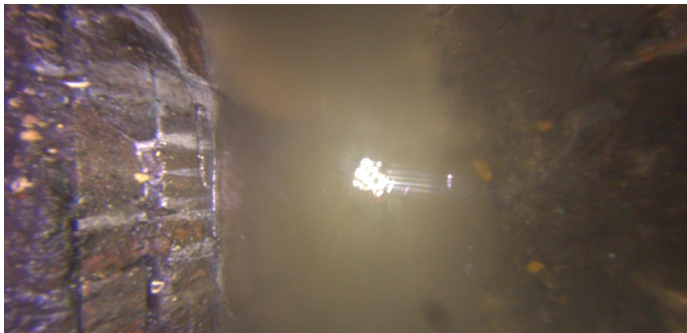
Code: **MGO**  
Description: **General Observation**

Distance (ft): **8.3**  
Structural Grade: **0**  
O&M Grade: **0**  
Clock Start/From:  
Clock To:  
1st Value:  
2nd Value:  
Value Percent:  
Step: **NO**  
Remarks: **END SURVEY**
