Manhole Inspection Report

Date:	05/01/2018	Weather:		Coding:	RZMACP
MH#:	M-605-009	Owner:	NA	Len. Surveyed:	8.1
P.O.#:		Surveyor:	Jen Costello	Rim to Invert:	8.7
Customer:		Cert. #:	U-907-5518	Wall Material:	Brick

Street:	Intersection of Connecticut St. and 3	Project:	Hobart, IN
City:	Hobart, IN	GPS Northing:	41.53247452
Location:		GPS Easting:	-87.26571655
Drain Area:	West	GPS Accuracy:	Nearest Meter
Cover Shape:	Circular	Evidence of Surcharge:	No
Cover Size:	22.5	Potential for Runoff:	None
Comments:

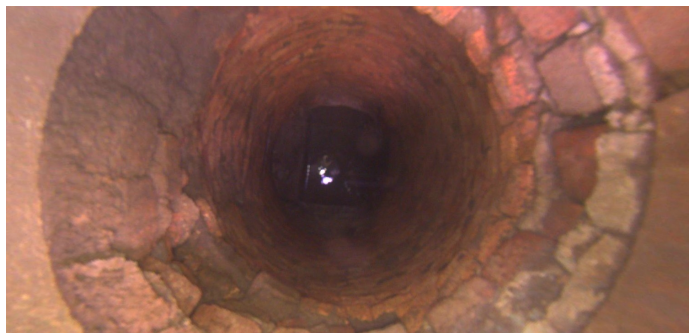
Code: **MGP**
Description: **General Photo**

Distance (ft): **.0**
Structural Grade: **0**
O&M Grade: **0**
Clock Start/From:
Clock To:
1st Value:
2nd Value:
Value Percent:
Step: **NO**
Remarks: **access mh**

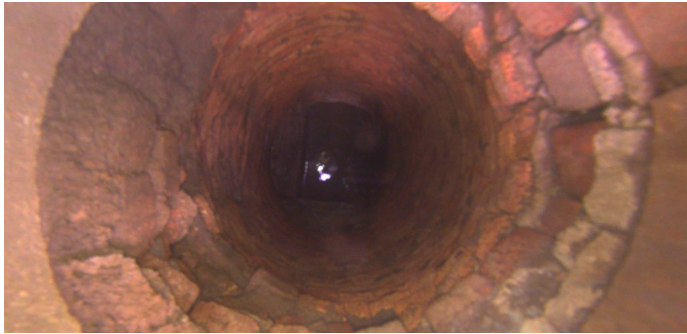
Code: **DB**
Description: **Displaced Brick**

Distance (ft): **.0**
Structural Grade: **3**
O&M Grade: **0**
Clock Start/From: **12**
Clock To: **12**
1st Value:
2nd Value:
Value Percent:
Step: **NO**
Remarks:

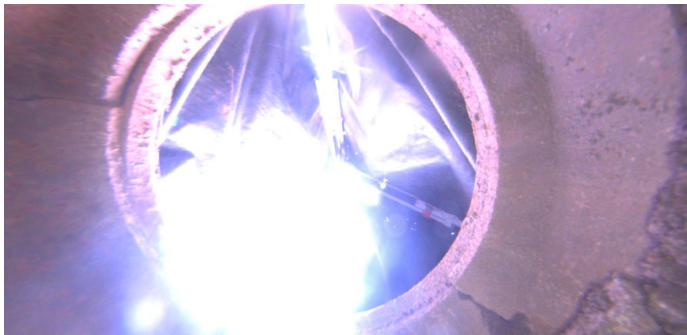
Code: **MGO**
Description: **General Observation**

Distance (ft): **1.7**
Structural Grade: **0**
O&M Grade: **0**
Clock Start/From:
Clock To:
1st Value:
2nd Value:
Value Percent:
Step: **NO**
Remarks: **underside of frame**

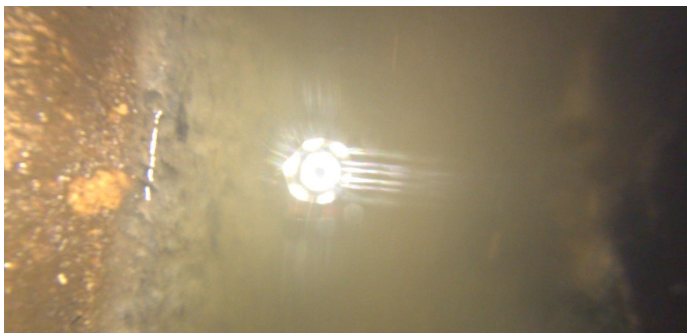
Code: **MGO**
Description: **General Observation**

Distance (ft): **8.1**
Structural Grade: **0**
O&M Grade: **0**
Clock Start/From:
Clock To:
1st Value:
2nd Value:
Value Percent:
Step: **NO**
Remarks: **end survey**
