Manhole Inspection Report

Date:	05/01/2018	Weather:		Coding:	RZMACP
MH#:	M-605-010	Owner:	NA	Len. Surveyed:	7.8
P.O.#:		Surveyor:	Jen Costello	Rim to Invert:	8.5
Customer:		Cert. #:	U-907-5518	Wall Material:	Brick

Street:	Intersection of Pennsylvania St. and	Project:	Hobart, IN
City:	Hobart, IN	GPS Northing:	41.53255081
Location:		GPS Easting:	-87.266922
Drain Area:	West	GPS Accuracy:	Nearest Meter
Cover Shape:	Circular	Evidence of Surcharge:	No
Cover Size:	22.5	Potential for Runoff:	None
Comments:

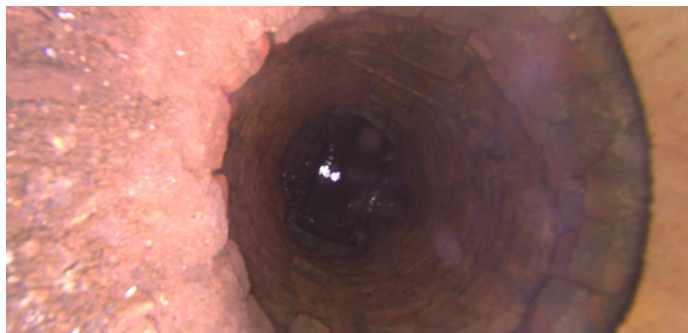
Code: **MGP**
Description: **General Photo**

Distance (ft): **.0**
Structural Grade: **0**
O&M Grade: **0**
Clock Start/From:
Clock To:
1st Value:
2nd Value:
Value Percent:
Step: **NO**
Remarks: **ACCESS MH**

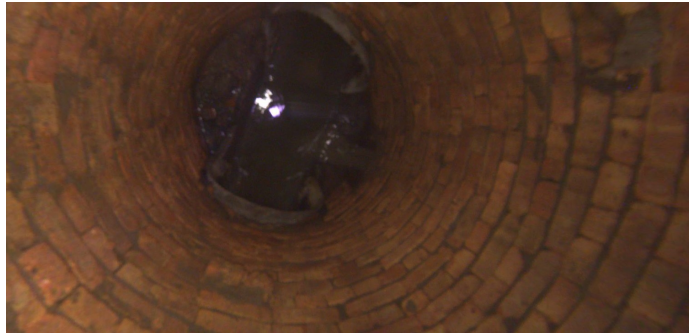
Code: **DB**
Description: **Displaced Brick**

Distance (ft): **2.1**
Structural Grade: **3**
O&M Grade: **0**
Clock Start/From: **6**
Clock To:
1st Value:
2nd Value:
Value Percent:
Step: **NO**
Remarks:

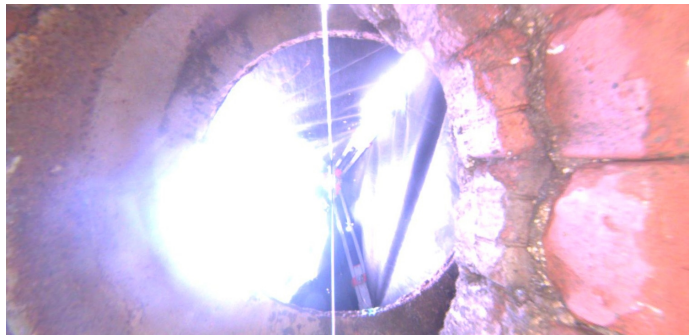
Code: **MGO**
Description: **General Observation**

Distance (ft): **2.1**
Structural Grade: **0**
O&M Grade: **0**
Clock Start/From:
Clock To:
1st Value:
2nd Value:
Value Percent:
Step: **NO**
Remarks: **UNDERSIDE OF FRAME**

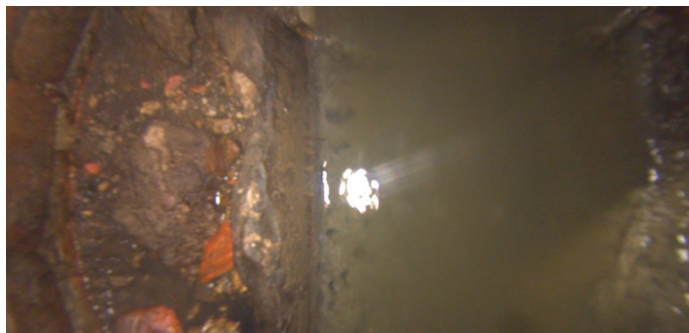
Code: **OBR**
Description: **Obstacle Rocks**

Distance (ft): **7.3**
Structural Grade: **0**
O&M Grade: **2**
Clock Start/From: **8**
Clock To: **10**
1st Value:
2nd Value:
Value Percent: **5.000**
Step: **NO**
Remarks:

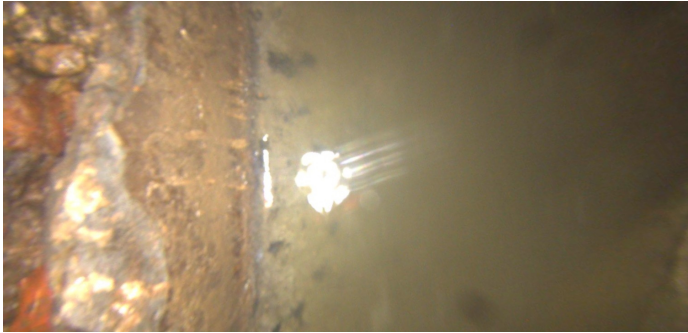
Code:	MGO
Description:	General Observation
Distance (ft):	7.8
Structural Grade:	0
O&M Grade:	0
Clock Start/From:	
Clock To:	
1st Value:	
2nd Value:	
Value Percent:	
Step:	NO
Remarks:	END SURVEY
