Manhole Inspection Report

Date:	05/01/2018	Weather:		Coding:	RZMACP
MH#:	M-605-013	Owner:	NA	Len. Surveyed:	10.2
P.O.#:		Surveyor:	Jen Costello	Rim to Invert:	10.6
Customer:		Cert. #:	U-907-5518	Wall Material:	Brick

Street:	Intersection of Ellendale St. and Cou	Project:	Hobart, IN
City:	Hobart, IN	GPS Northing:	41.53304672
Location:		GPS Easting:	-87.26202393
Drain Area:	West	GPS Accuracy:	Nearest Meter
Cover Shape:	Circular	Evidence of Surcharge:	No
Cover Size:	22.5	Potential for Runoff:	None
Comments:

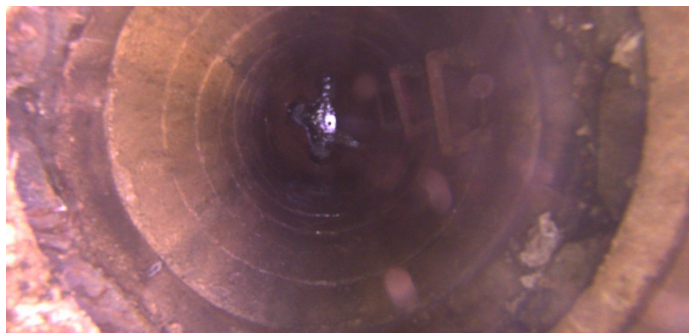
Code: **MGP**
Description: **General Photo**

Distance (ft): **.0**
Structural Grade: **0**
O&M Grade: **0**
Clock Start/From:
Clock To:
1st Value:
2nd Value:
Value Percent:
Step: **NO**
Remarks: **ACCESS MH**

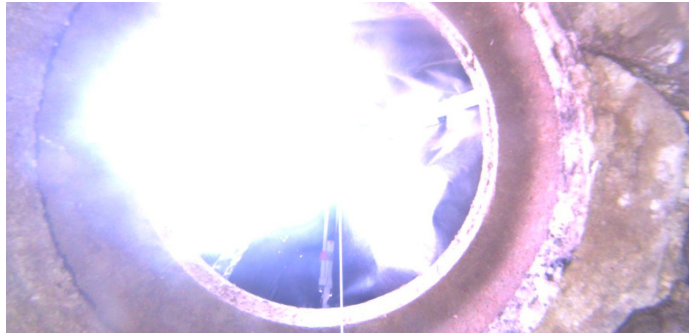
Code: **MGO**
Description: **General Observation**

Distance (ft): **2.0**
Structural Grade: **0**
O&M Grade: **0**
Clock Start/From:
Clock To:
1st Value:
2nd Value:
Value Percent:
Step: **NO**
Remarks: **UNDERSIDE OF FRAME**

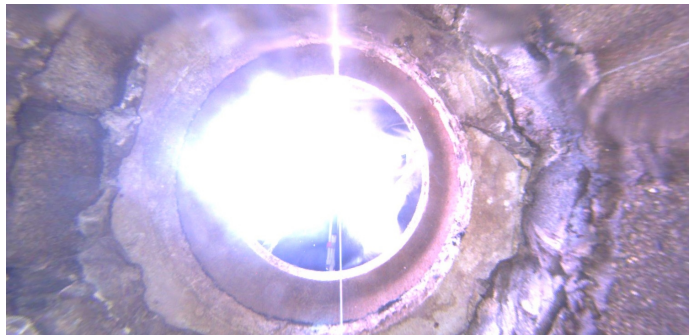
Code: **FM**
Description: **Fracture Multiple**

Distance (ft): **2.3**
Structural Grade: **4**
O&M Grade: **0**
Clock Start/From: **12**
Clock To: **12**
1st Value:
2nd Value:
Value Percent:
Step: **NO**
Remarks:

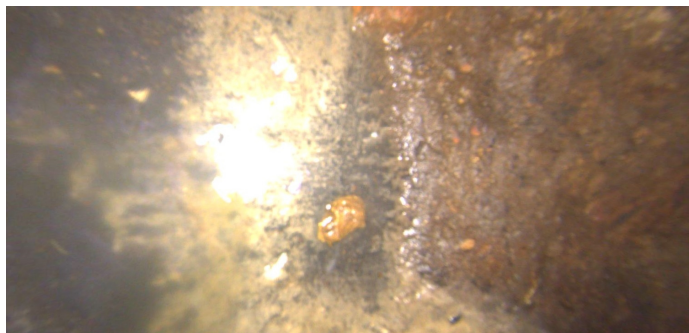
Code: **MGO**
Description: **General Observation**

Distance (ft): **9.9**
Structural Grade: **0**
O&M Grade: **0**
Clock Start/From:
Clock To:
1st Value:
2nd Value:
Value Percent:
Step: **NO**
Remarks: **END SURVEY**
