Manhole Inspection Report

Date:	05/01/2018	Weather:		Coding:	RZMACP
MH#:	M-605-014	Owner:	NA	Len. Surveyed:	9.4
P.O.#:		Surveyor:	Jen Costello	Rim to Invert:	9.5
Customer:		Cert. #:	U-907-5518	Wall Material:	Brick

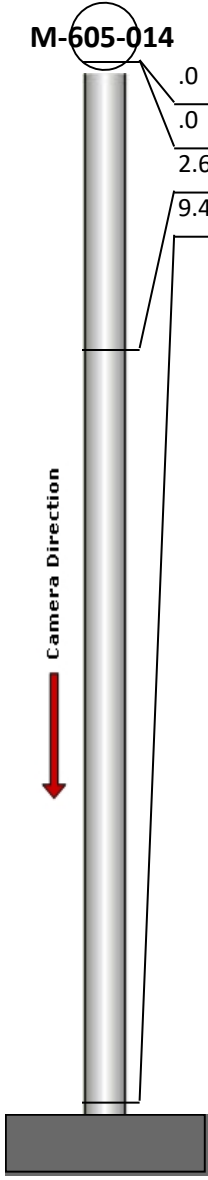
.0	MGP	General Photo	10	NA
	.0	FM	Fracture Multiple	21	S 4
	2.6	MGO	General Observation	40	NA
	9.4	MGO	General Observation	67	NA

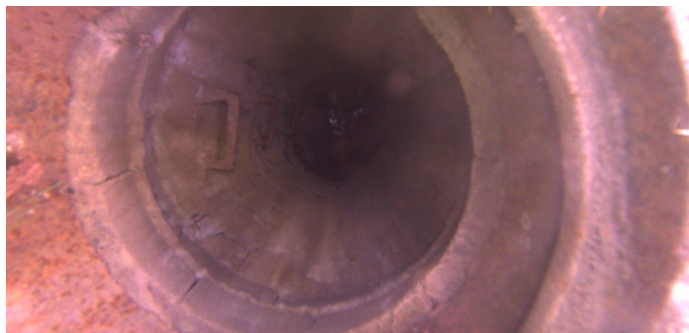
Code: **MGP**
Description: **General Photo**

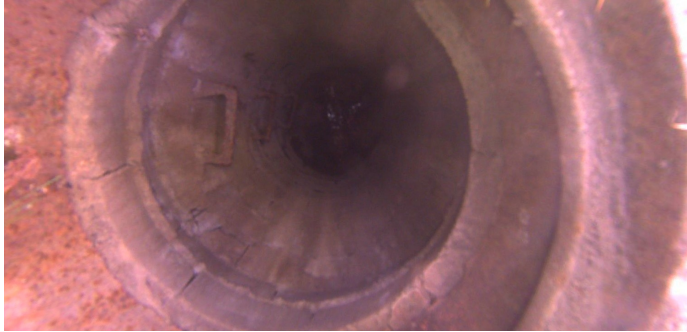
Code: **FM**
Description: **Fracture Multiple**

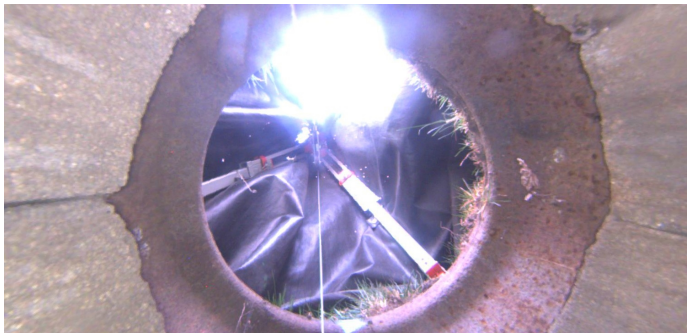
Code: **MGO**
Description: **General Observation**
