Manhole Inspection Report

Date:	04/29/2018	Weather:		Coding:	RZMACP
MH#:	M-605-024	Owner:	NA	Len. Surveyed:	6.7
P.O.#:		Surveyor:	Jen Costello	Rim to Invert:	7.5
Customer:		Cert. #:	U-907-5518	Wall Material:	Concrete (reinforced)

Street:	2nd St. 135' West of Henry St.	Project:	Hobart, IN
City:	Hobart, IN	GPS Northing:	2903339.441
Location:		GPS Easting:	2903339.441
Drain Area:	West	GPS Accuracy:	Sub-Meter
Cover Shape:	Circular	Evidence of Surcharge:	No
Cover Size:	22.5	Potential for Runoff:	None
Comments:

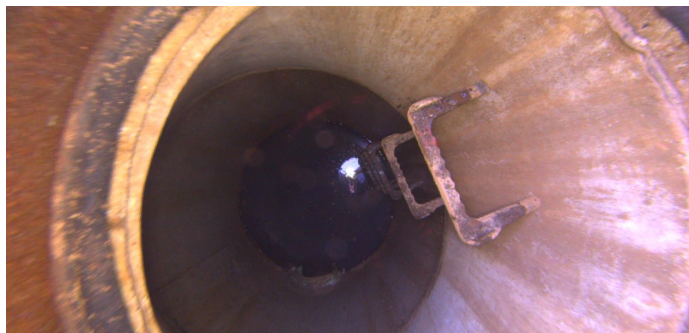
Code: **MGO**
Description: **General Observation**

Distance (ft): **.0**
Structural Grade: **0**
O&M Grade: **0**
Clock Start/From:
Clock To:
1st Value:
2nd Value:
Value Percent:
Step: **NO**
Remarks: **ACCESS MH**

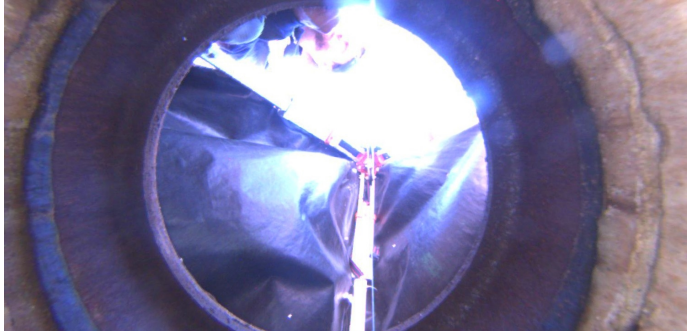
Code:	MGP
Description:	General Photo
Distance (ft):	1.8
Structural Grade:	0
O&M Grade:	0
Clock Start/From:	
Clock To:	
1st Value:	
2nd Value:	
Value Percent:	
Step:	NO
Remarks:	UNDERSIDE OF FRAME

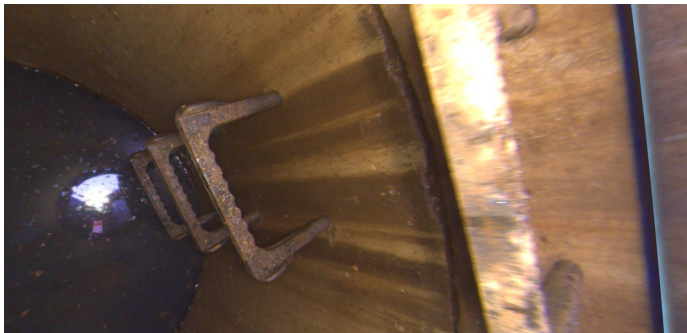
Code:	IW
Description:	Infil Weeper
Distance (ft):	3.1
Structural Grade:	0
O&M Grade:	2
Clock Start/From:	2
Clock To:	3
1st Value:	
2nd Value:	
Value Percent:	
Step:	NO
Remarks:

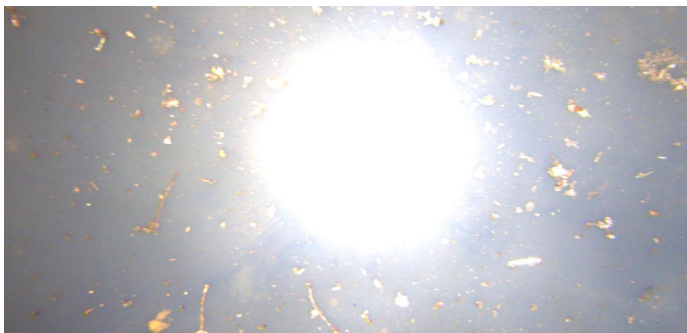
Code:	MGO
Description:	General Observation
Distance (ft):	6.7
Structural Grade:	0
O&M Grade:	0
Clock Start/From:	
Clock To:	
1st Value:	
2nd Value:	
Value Percent:	
Step:	NO
Remarks:	END SURVEY BENCH IS SUBMERGED
