Manhole Inspection Report

Date:	05/02/2018	Weather:		Coding:	RZMACP
MH#:	M-605-025	Owner:	NA	Len. Surveyed:	9.9
P.O.#:		Surveyor:	Jen Costello	Rim to Invert:	9.8
Customer:		Cert. #:	U-907-5518	Wall Material:	Brick

Street:	Intersection of Ash St. and Court St.	Project:	Hobart, IN
City:	Hobart, IN	GPS Northing:	41.53326416
Location:		GPS Easting:	-87.26446533
Drain Area:	West	GPS Accuracy:	Nearest Meter
Cover Shape:	Circular	Evidence of Surcharge:	No
Cover Size:	22.5	Potential for Runoff:	None
Comments:

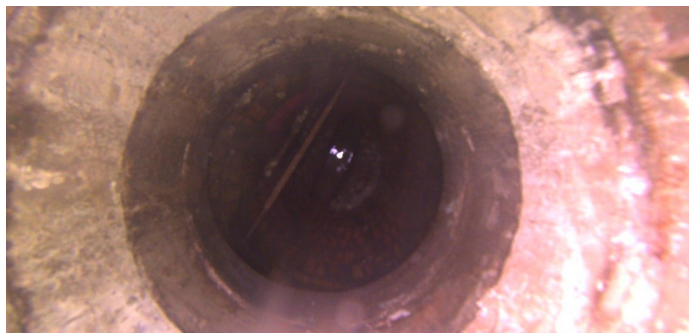
Code: **MGP**
Description: **General Photo**

Distance (ft): **.0**
Structural Grade: **0**
O&M Grade: **0**
Clock Start/From:
Clock To:
1st Value:
2nd Value:
Value Percent:
Step: **NO**
Remarks: **access mh**

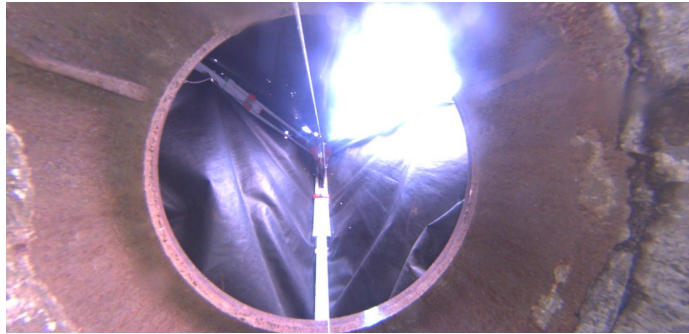
Code: **MGO**
Description: **General Observation**

Distance (ft): **1.4**
Structural Grade: **0**
O&M Grade: **0**
Clock Start/From:
Clock To:
1st Value:
2nd Value:
Value Percent:
Step: **NO**
Remarks: **underside of frame**

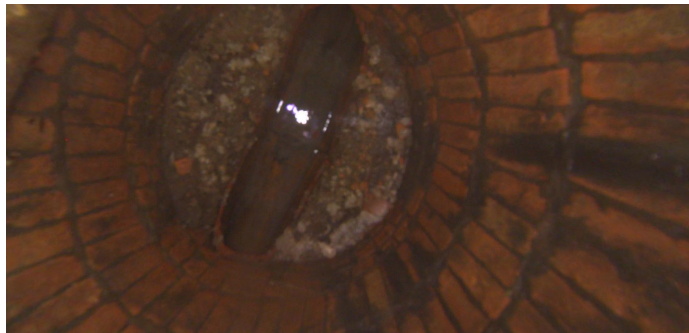
Code: **IS**
Description: **Infil Stain**

Distance (ft): **6.1**
Structural Grade: **0**
O&M Grade: **0**
Clock Start/From: **3**
Clock To: **6**
1st Value:
2nd Value:
Value Percent:
Step: **NO**
Remarks:

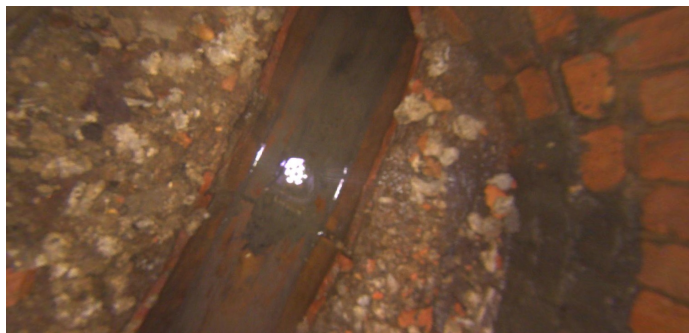
Code: **DSZ**
Description: **Deposits Settled Other**

Distance (ft): **7.9**
Structural Grade: **0**
O&M Grade: **2**
Clock Start/From: **12**
Clock To: **12**
1st Value:
2nd Value:
Value Percent: **5.000**
Step: **NO**
Remarks: **misc**

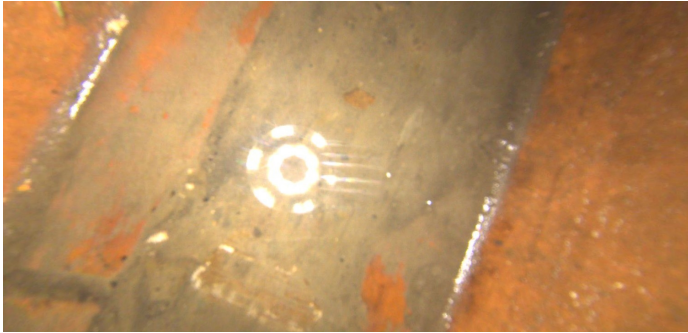
Code:	MGO
Description:	General Observation
Distance (ft):	9.9
Structural Grade:	0
O&M Grade:	0
Clock Start/From:	
Clock To:	
1st Value:	
2nd Value:	
Value Percent:	
Step:	NO
Remarks:	end survey
