Manhole Inspection Report

Date:	04/29/2018	Weather:		Coding:	RZMACP
MH#:	M-605-032	Owner:	NA	Len. Surveyed:	7.4
P.O.#:		Surveyor:	Jen Costello	Rim to Invert:	7.8
Customer:		Cert. #:	U-907-5518	Wall Material:	Brick

Street:	Connecticut St. 2nd St.	Project:	Hobart, IN
City:	Hobart, IN	GPS Northing:	2902820.644
Location:		GPS Easting:	2902820.644
Drain Area:	West	GPS Accuracy:	Sub-Meter
Cover Shape:	Circular	Evidence of Surcharge:	No
Cover Size:	22.5	Potential for Runoff:	None
Comments:

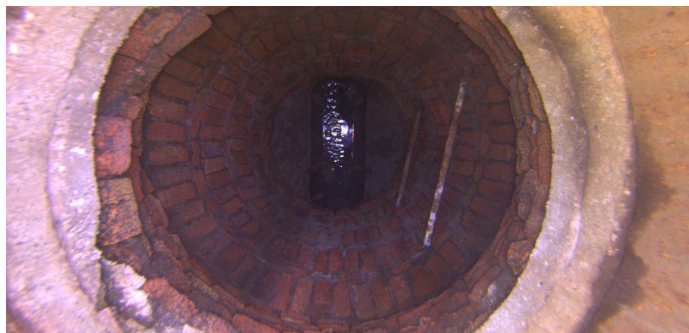
Code: **MGO**
Description: **General Observation**

Distance (ft): **.0**
Structural Grade: **0**
O&M Grade: **0**
Clock Start/From:
Clock To:
1st Value:
2nd Value:
Value Percent:
Step: **NO**
Remarks: **ACCESS MH**

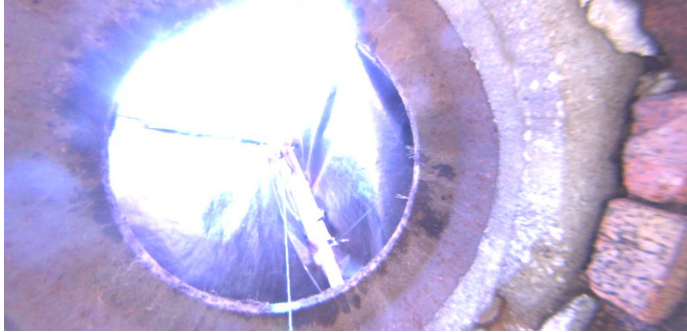
Code: **MGO**
Description: **General Observation**

Distance (ft): **2.1**
Structural Grade: **0**
O&M Grade: **0**
Clock Start/From:
Clock To:
1st Value:
2nd Value:
Value Percent:
Step: **NO**
Remarks: **UNDERSIDE OF FRAME**

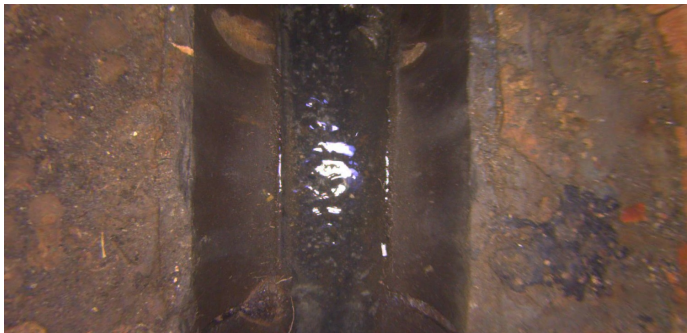
Code: **DSF**
Description: **Deposits Settled Fine**

Distance (ft): **5.7**
Structural Grade: **0**
O&M Grade: **2**
Clock Start/From: **12**
Clock To: **12**
1st Value:
2nd Value:
Value Percent: **5.000**
Step: **NO**
Remarks:

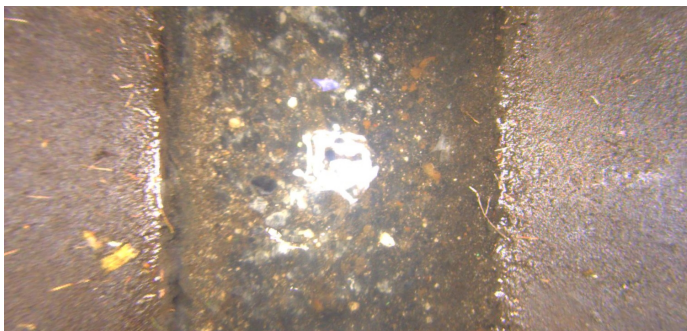
Code: **MGO**
Description: **General Observation**

Distance (ft): **7.4**
Structural Grade: **0**
O&M Grade: **0**
Clock Start/From:
Clock To:
1st Value:
2nd Value:
Value Percent:
Step: **NO**
Remarks: **END SURVEY**
