Manhole Inspection Report

Date:	04/29/2018	Weather:		Coding:	RZMACP
MH#:	M-605-033	Owner:	NA	Len. Surveyed:	6.8
P.O.#:		Surveyor:	Jen Costello	Rim to Invert:	7.2
Customer:		Cert. #:	U-907-5518	Wall Material:	Brick

Street:	Connecticut St. 243' North of 2nd St.	Project:	Hobart, IN
City:	Hobart, IN	GPS Northing:	2902822.561
Location:		GPS Easting:	2902822.561
Drain Area:	West	GPS Accuracy:	Sub-Meter
Cover Shape:	Circular	Evidence of Surcharge:	No
Cover Size:	22.5	Potential for Runoff:	None
Comments:

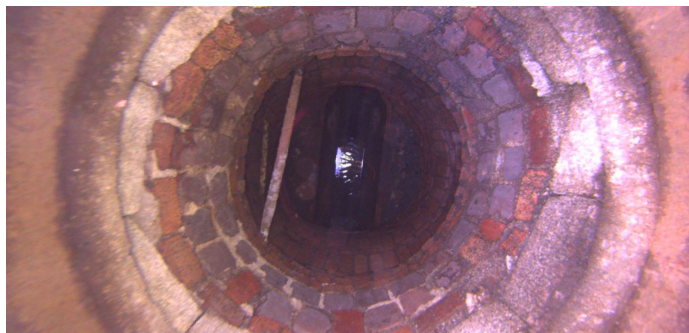
Code: **MGP**
Description: **General Photo**

Distance (ft): **.0**
Structural Grade: **0**
O&M Grade: **0**
Clock Start/From:
Clock To:
1st Value:
2nd Value:
Value Percent:
Step: **NO**
Remarks: **ACCESS MH**

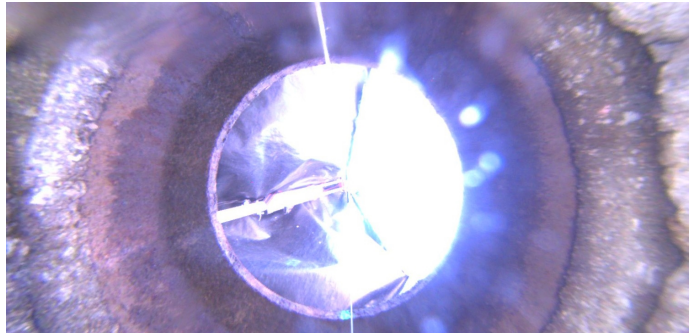
Code:	MGO
Description:	General Observation
Distance (ft):	1.9
Structural Grade:	0
O&M Grade:	0
Clock Start/From:	
Clock To:	
1st Value:	
2nd Value:	
Value Percent:	
Step:	NO
Remarks:	UNDERSIDE OF FRAME

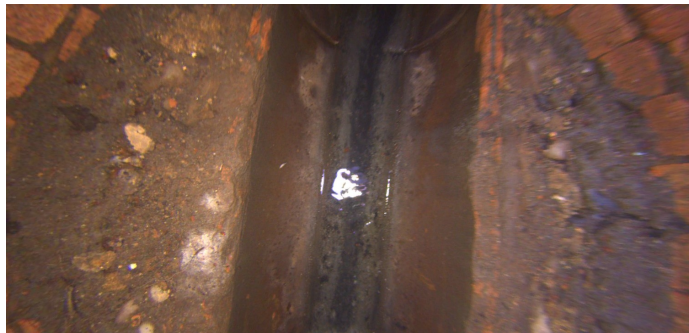
Code:	DSF
Description:	Deposits Settled Fine
Distance (ft):	5.4
Structural Grade:	0
O&M Grade:	2
Clock Start/From:	12
Clock To:	12
1st Value:	
2nd Value:	
Value Percent:	5.000
Step:	NO
Remarks:

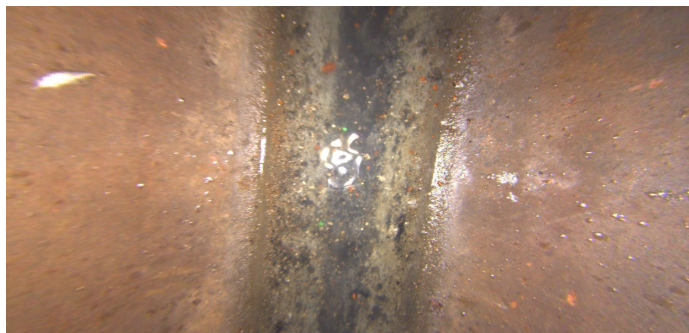
Code:	MGO
Description:	General Observation
Distance (ft):	6.8
Structural Grade:	0
O&M Grade:	0
Clock Start/From:	
Clock To:	
1st Value:	
2nd Value:	
Value Percent:	
Step:	NO
Remarks:	END SURVEY
