Manhole Inspection Report

Date:	04/29/2018	Weather:		Coding:	RZMACP
MH#:	M-605-034	Owner:	NA	Len. Surveyed:	5.7
P.O.#:		Surveyor:	Jen Costello	Rim to Invert:	5.7
Customer:		Cert. #:	U-907-5518	Wall Material:	Concrete (reinforced)

Street:	Connecticut St. 191' South of Clevel	Project:	Hobart, IN
City:	Hobart, IN	GPS Northing:	2902813.431
Location:		GPS Easting:	2902813.431
Drain Area:	West	GPS Accuracy:	Sub-Meter
Cover Shape:	Circular	Evidence of Surcharge:	No
Cover Size:	22.5	Potential for Runoff:	None
Comments:

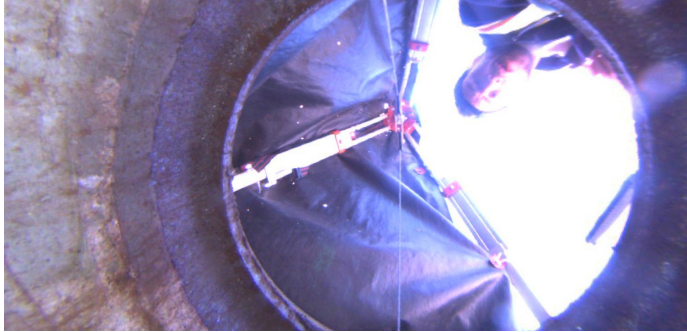
Code:	MGO
Description:	General Observation
Distance (ft):	1.6
Structural Grade:	0
O&M Grade:	0
Clock Start/From:	
Clock To:	
1st Value:	
2nd Value:	
Value Percent:	
Step:	NO
Remarks:	UNDERSIDE OF FRAME

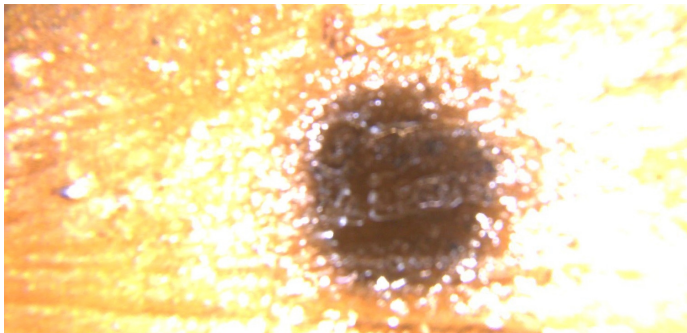
Code:	MGO
Description:	General Observation
Distance (ft):	5.7
Structural Grade:	0
O&M Grade:	0
Clock Start/From:	
Clock To:	
1st Value:	
2nd Value:	
Value Percent:	
Step:	NO
Remarks:	END SURVEY
