Manhole Inspection Report

Date:	04/29/2018	Weather:		Coding:	RZMACP
MH#:	M-605-038	Owner:	NA	Len. Surveyed:	
P.O.#:		Surveyor:	Jen Costello	Rim to Invert:	7.4
Customer:		Cert. #:	U-907-5518	Wall Material:	Brick
Street:	Intersection of Per	insylvania St. and	Project:	Hobart, IN	
City:	Hobart, IN		GPS Northing:	2902484.374	
Location:			GPS Easting:	2902484.374	
Drain Area:	West		GPS Accuracy:	Sub-Meter	
Cover Shape:	Circular		Evidence of Surcharge:	Νο	
Cover Size:	22.5		Potential for Runoff:	None	
Comments:					
O&M Index:	2.00	O&M Quick:	2100	O&M Rating:	2.00
Structural Index:	5.00	Structural Qu	ick: 5100	Structural Rating:	5.00
Overall Index:	3.50	Overall Quick	· 5121	Overall Rating:	7.00

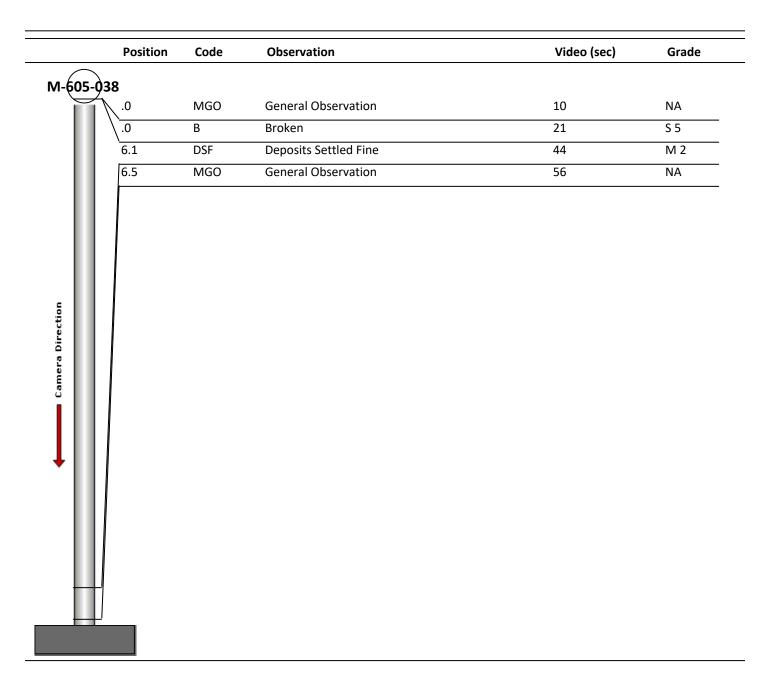
Code:	В
Description:	Broken
	•
Distance (ft):	.0
Structural Grade:	5
O&M Grade:	0
Clock Start/From:	12
Clock To:	12
1st Value:	
2nd Value:	
Value Percent:	
Step:	NO
Remarks:
