Manhole Inspection Report

Date:	04/29/2018	Weather:		Coding:	RZMACP
MH#:	M-605-039	Owner:	NA	Len. Surveyed:	4.6
P.O.#:		Surveyor:	Jen Costello	Rim to Invert:	4.6
Customer:		Cert. #:	U-907-5518	Wall Material:	Brick

Street:	Pennsylvania St. 220' North of 2nd S	Project:	Hobart, IN
City:	Hobart, IN	GPS Northing:	2902487.339
Location:		GPS Easting:	2902487.339
Drain Area:	West	GPS Accuracy:	Sub-Meter
Cover Shape:	Circular	Evidence of Surcharge:	No
Cover Size:	24.0	Potential for Runoff:	None
Comments:

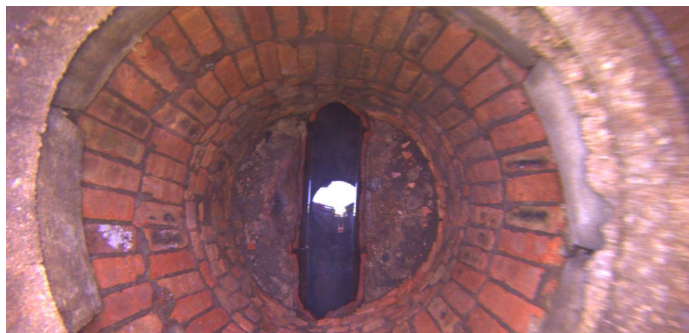
Code: **MGP**
Description: **General Photo**

Distance (ft): **.0**
Structural Grade: **0**
O&M Grade: **0**
Clock Start/From:
Clock To:
1st Value:
2nd Value:
Value Percent:
Step: **NO**
Remarks: **ACCESS MH**

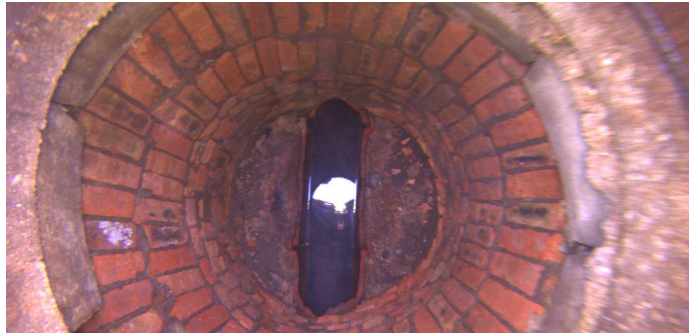
Code:	SAV
Description:	Surface Aggregate Visible
Distance (ft):	.0
Structural Grade:	3
O&M Grade:	0
Clock Start/From:	12
Clock To:	12
1st Value:	
2nd Value:	
Value Percent:	
Step:	NO
Remarks:

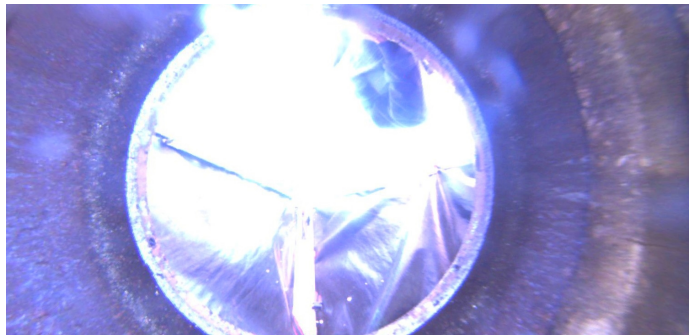
Code:	MGP
Description:	General Photo
Distance (ft):	1.7
Structural Grade:	0
O&M Grade:	0
Clock Start/From:	
Clock To:	
1st Value:	
2nd Value:	
Value Percent:	
Step:	NO
Remarks:	UNDERSIDE OF FRAME

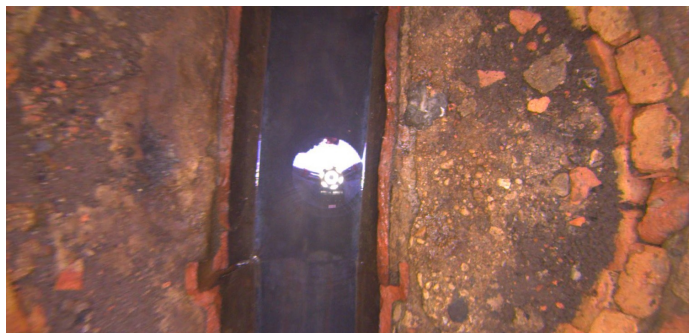
Code:	DSGV
Description:	Deposits Settled Gravel
Distance (ft):	2.9
Structural Grade:	0
O&M Grade:	2
Clock Start/From:	12
Clock To:	12
1st Value:	
2nd Value:	
Value Percent:	5.000
Step:	NO
Remarks:

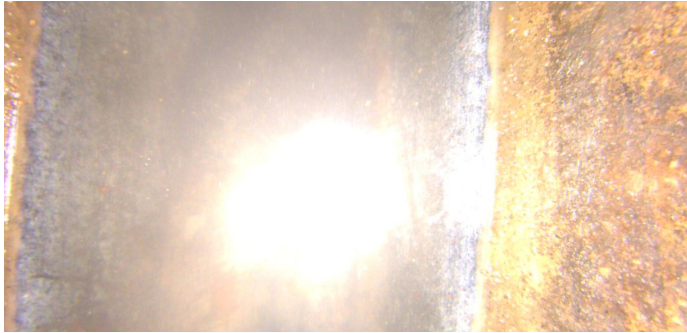
Code:	MGO
Description:	General Observation
Distance (ft):	4.6
Structural Grade:	0
O&M Grade:	0
Clock Start/From:	
Clock To:	
1st Value:	
2nd Value:	
Value Percent:	
Step:	NO
Remarks:	END SURVEY
