Manhole Inspection Report

Date:	04/29/2018	Weather:		Coding:	RZMACP
MH#:	M-605-040	Owner:	NA	Len. Surveyed:	3.3
P.O.#:		Surveyor:	Jen Costello	Rim to Invert:	4.1
Customer:		Cert. #:	U-907-5518	Wall Material:	Brick

Street:	Pennsylvania St. 226' South of 1st St	Project:	Hobart, IN
City:	Hobart, IN	GPS Northing:	2902483.017
Location:		GPS Easting:	2902483.017
Drain Area:	West	GPS Accuracy:	Sub-Meter
Cover Shape:	Circular	Evidence of Surcharge:	No
Cover Size:	24.0	Potential for Runoff:	None
Comments:

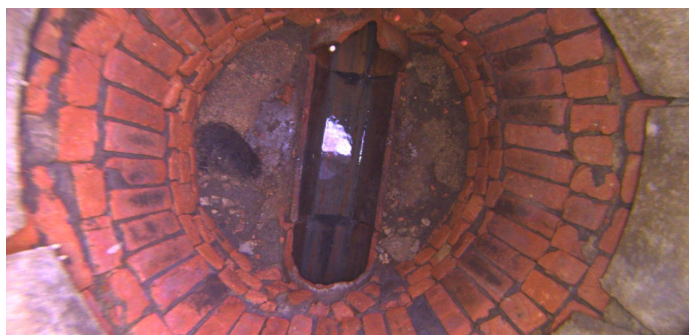
Code: **MGO**
Description: **General Observation**

Distance (ft): **.0**
Structural Grade: **0**
O&M Grade: **0**
Clock Start/From:
Clock To:
1st Value:
2nd Value:
Value Percent:
Step: **NO**
Remarks: **ACCESS MH**

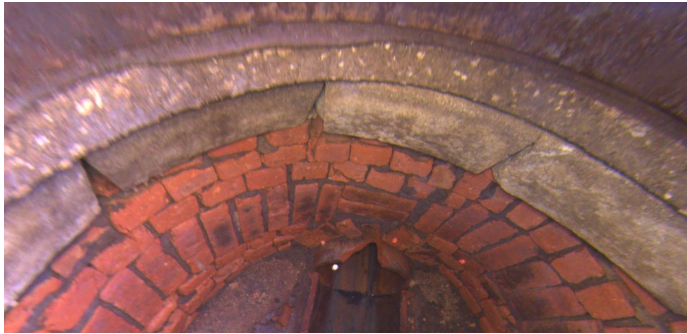
Code:	SAV
Description:	Surface Aggregate Visible
Distance (ft):	.0
Structural Grade:	3
O&M Grade:	0
Clock Start/From:	12
Clock To:	12
1st Value:	
2nd Value:	
Value Percent:	
Step:	NO
Remarks:

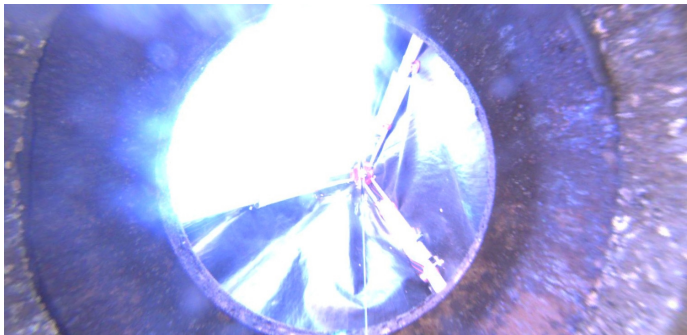
Code:	MGO
Description:	General Observation
Distance (ft):	1.3
Structural Grade:	0
O&M Grade:	0
Clock Start/From:	
Clock To:	
1st Value:	
2nd Value:	
Value Percent:	
Step:	NO
Remarks:	UNDERSIDE OF FRAME

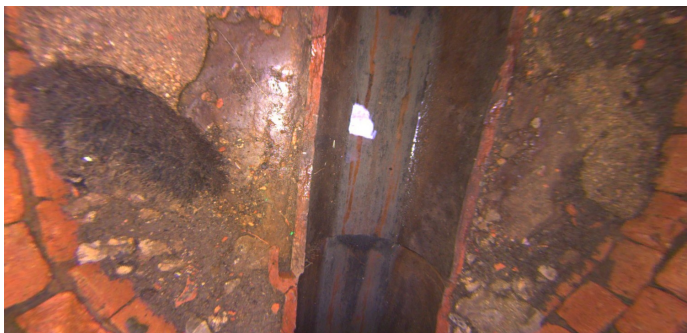
Code:	DSF
Description:	Deposits Settled Fine
Distance (ft):	2.2
Structural Grade:	0
O&M Grade:	2
Clock Start/From:	12
Clock To:	12
1st Value:	
2nd Value:	
Value Percent:	5.000
Step:	NO
Remarks:

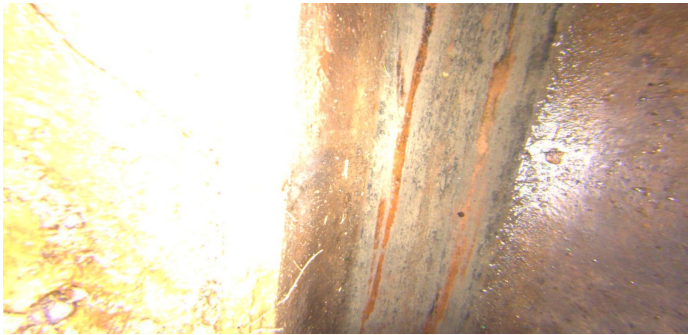
Code: **MGO**
Description: **General Observation**

Distance (ft): **3.3**
Structural Grade: **0**
O&M Grade: **0**
Clock Start/From:
Clock To:
1st Value:
2nd Value:
Value Percent:
Step: **NO**
Remarks: **END SURVEY**
