Manhole Inspection Report

Date:	04/29/2018	Weather:		Coding:	RZMACP
MH#:	M-605-043	Owner:	NA	Len. Surveyed:	7.3
P.O.#:		Surveyor:	Jen Costello	Rim to Invert:	7.8
Customer:		Cert. #:	U-907-5518	Wall Material:	Brick

Street:	Washington St. 261' South of 2nd St.	Project:	Hobart, IN
City:	Hobart, IN	GPS Northing:	2902163.327
Location:		GPS Easting:	2902163.327
Drain Area:	West	GPS Accuracy:	Sub-Meter
Cover Shape:	Circular	Evidence of Surcharge:	No
Cover Size:	22.5	Potential for Runoff:	None
Comments:

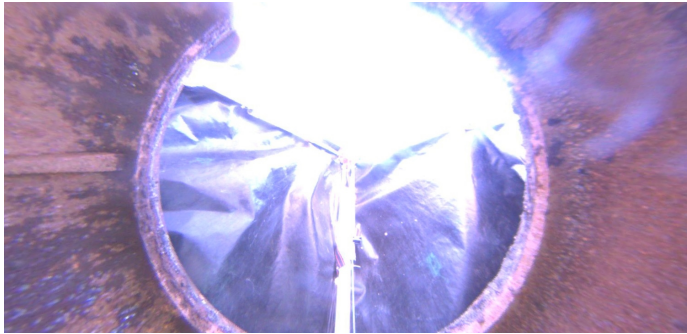
Code: **MGO**
Description: **General Observation**

Distance (ft): **1.2**
Structural Grade: **0**
O&M Grade: **0**
Clock Start/From:
Clock To:
1st Value:
2nd Value:
Value Percent:
Step: **NO**
Remarks: **UNDERSIDE OF FRAME**

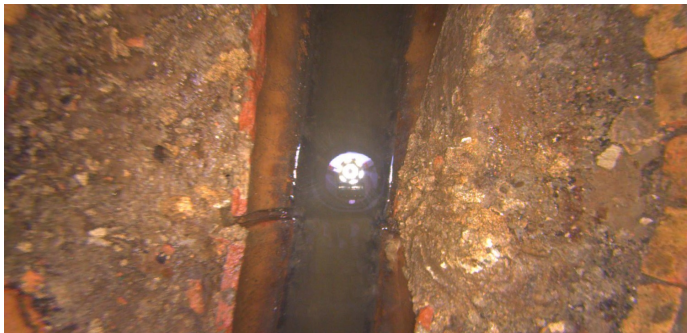
Code: **DSF**
Description: **Deposits Settled Fine**

Distance (ft): **5.9**
Structural Grade: **0**
O&M Grade: **2**
Clock Start/From: **12**
Clock To: **12**
1st Value:
2nd Value:
Value Percent: **5.000**
Step: **NO**
Remarks:

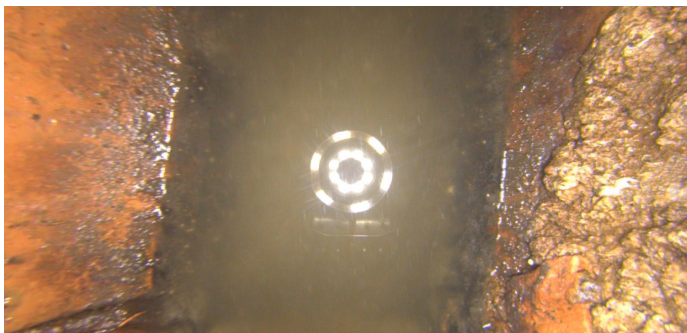
Code: **MGO**
Description: **General Observation**

Distance (ft): **7.3**
Structural Grade: **0**
O&M Grade: **0**
Clock Start/From:
Clock To:
1st Value:
2nd Value:
Value Percent:
Step: **NO**
Remarks: **END SURVEY**
