Manhole Inspection Report

Date:	04/29/2018	Weather:		Coding:	RZMACP
MH#:	M-605-044	Owner:	NA	Len. Surveyed:	7.0
P.O.#:		Surveyor:	Jen Costello	Rim to Invert:	7.6
Customer:		Cert. #:	U-907-5518	Wall Material:	Brick

Street:	Intersection of 2nd St. and Washingt	Project:	Hobart, IN
City:	Hobart, IN	GPS Northing:	2902168.003
Location:		GPS Easting:	2902168.003
Drain Area:	West	GPS Accuracy:	Sub-Meter
Cover Shape:	Circular	Evidence of Surcharge:	No
Cover Size:	22.5	Potential for Runoff:	None
Comments:

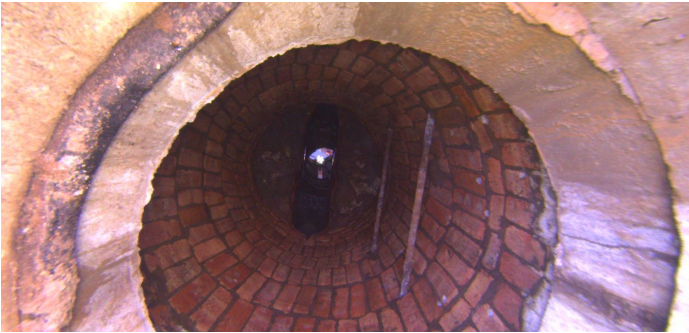
MGP

General Photo

ACCESS MH

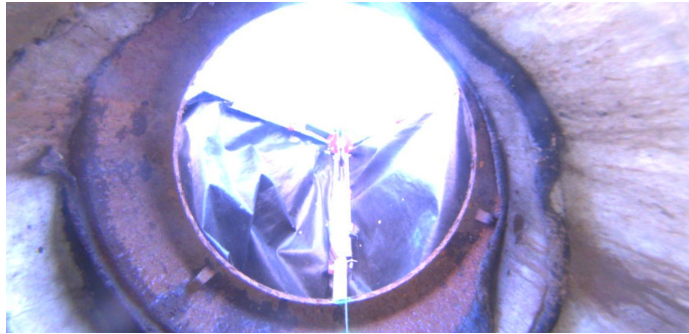
Code: **MGO**
Description: **General Observation**

Distance (ft): **1.9**
Structural Grade: **0**
O&M Grade: **0**
Clock Start/From:
Clock To:
1st Value:
2nd Value:
Value Percent:
Step: **NO**
Remarks: **UNDERSIDE OF FRAME**

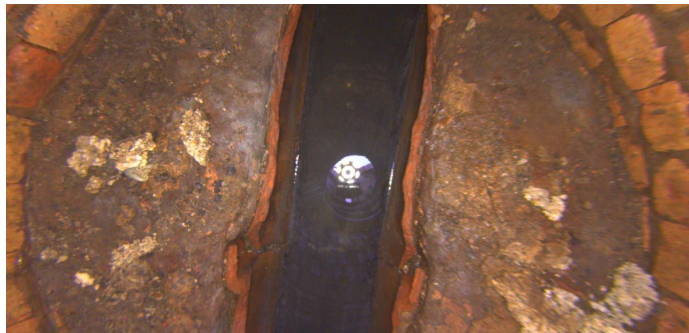
Code: **DSF**
Description: **Deposits Settled Fine**

Distance (ft): **5.6**
Structural Grade: **0**
O&M Grade: **2**
Clock Start/From: **12**
Clock To: **12**
1st Value:
2nd Value:
Value Percent: **5.000**
Step: **NO**
Remarks:

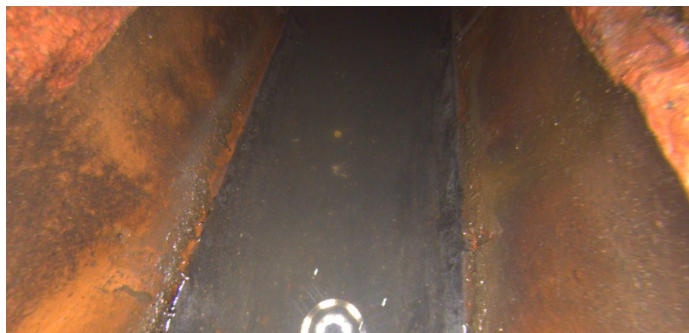
Code: **MGO**
Description: **General Observation**

Distance (ft): **7.0**
Structural Grade: **0**
O&M Grade: **0**
Clock Start/From:
Clock To:
1st Value:
2nd Value:
Value Percent:
Step: **NO**
Remarks: **END SURVEYE**
