Manhole Inspection Report

Date:	04/29/2018	Weather:		Coding:	RZMACP
MH#:	M-605-046	Owner:	NA	Len. Surveyed:	7.6
P.O.#:		Surveyor:	Jen Costello	Rim to Invert:	8.1
Customer:		Cert. #:	U-907-5518	Wall Material:	Brick

Street:	Washington St. 227' South of 1st St.	Project:	Hobart, IN
City:	Hobart, IN	GPS Northing:	2902145.769
Location:		GPS Easting:	2902145.769
Drain Area:	West	GPS Accuracy:	Sub-Meter
Cover Shape:	Circular	Evidence of Surcharge:	No
Cover Size:	22.5	Potential for Runoff:	None
Comments:

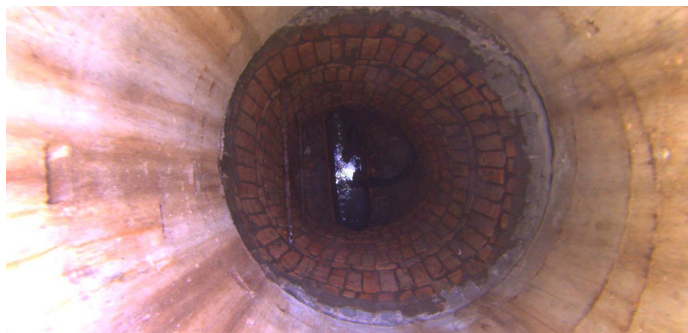
Code: **MGP**
Description: **General Photo**

Distance (ft): **.0**
Structural Grade: **0**
O&M Grade: **0**
Clock Start/From:
Clock To:
1st Value:
2nd Value:
Value Percent:
Step: **NO**
Remarks: **ACCESS MH**

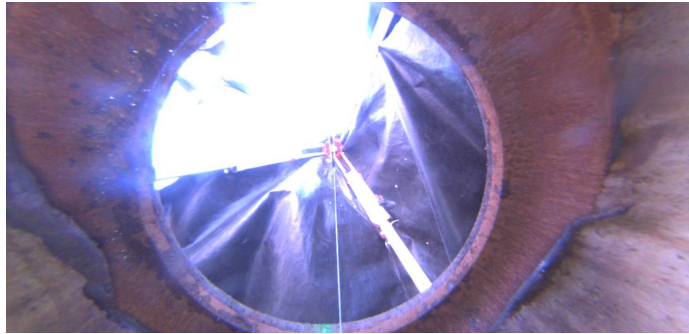
Code:	MGO
Description:	General Observation
Distance (ft):	1.3
Structural Grade:	0
O&M Grade:	0
Clock Start/From:	
Clock To:	
1st Value:	
2nd Value:	
Value Percent:	
Step:	NO
Remarks:	UNDERSIDE OF FRAME

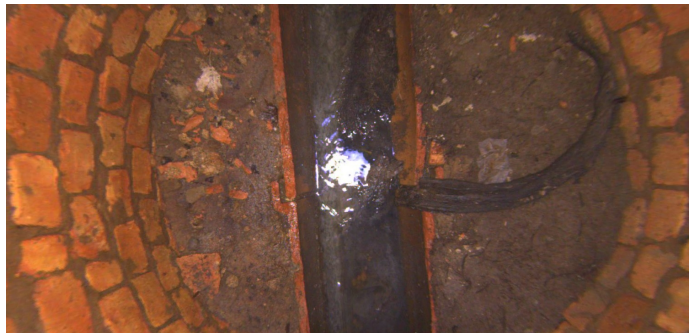
Code:	DSZ
Description:	Deposits Settled Other
Distance (ft):	5.5
Structural Grade:	0
O&M Grade:	2
Clock Start/From:	12
Clock To:	12
1st Value:	
2nd Value:	
Value Percent:	5.000
Step:	NO
Remarks:	MISC

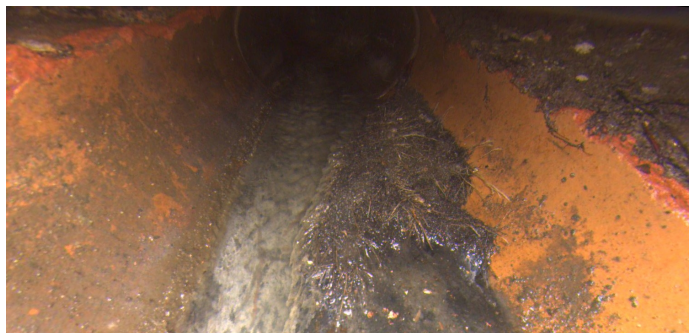
Code:	RMJ
Description:	Roots Medium Joint
Distance (ft):	7.6
Structural Grade:	0
O&M Grade:	3
Clock Start/From:	4
Clock To:	6
1st Value:	
2nd Value:	
Value Percent:	10.000
Step:	NO
Remarks:

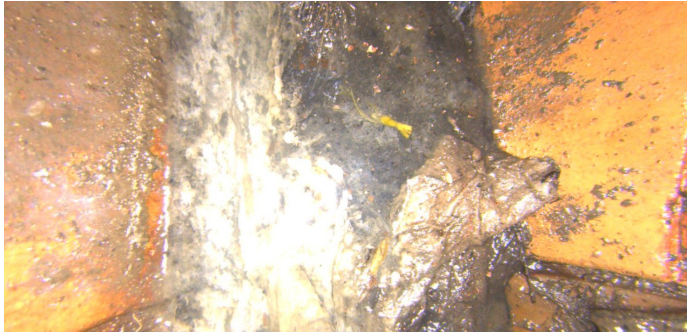
Code: **MGO**
Description: **General Observation**

Remarks: **END SURVEY**
