Manhole Inspection Report

Date:	05/02/2018	Weather:		Coding:	RZMACP
MH#:	M-605-048	Owner:	NA	Len. Surveyed:	9.3
P.O.#:		Surveyor:	Jen Costello	Rim to Invert:	10.2
Customer:		Cert. #:	U-907-5518	Wall Material:	Brick

Street:	Wisconsin St. 245' North of 3rd St.	Project:	Hobart, IN
City:	Hobart, IN	GPS Northing:	41.53331375
Location:		GPS Easting:	-87.26930237
Drain Area:	West	GPS Accuracy:	Nearest Meter
Cover Shape:	Circular	Evidence of Surcharge:	No
Cover Size:	22.5	Potential for Runoff:	None
Comments:

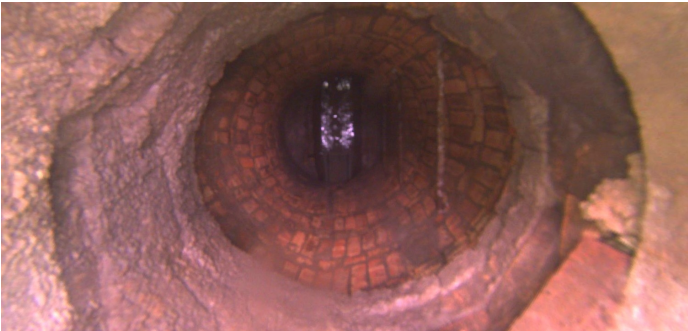
Code:	MGP
Description:	General Photo
Distance (ft):	.0
Structural Grade:	0
O&M Grade:	0
Clock Start/From:	
Clock To:	
1st Value:	
2nd Value:	
Value Percent:	
Step:	NO
Remarks:	ACCESS MH

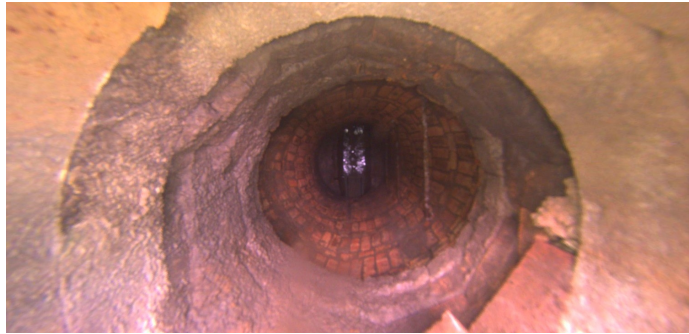
Code:	DAE
Description:	Deposits Attached Encrustation
Distance (ft):	.0
Structural Grade:	0
O&M Grade:	2
Clock Start/From:	8
Clock To:	11
1st Value:	
2nd Value:	
Value Percent:	5.000
Step:	NO
Remarks:

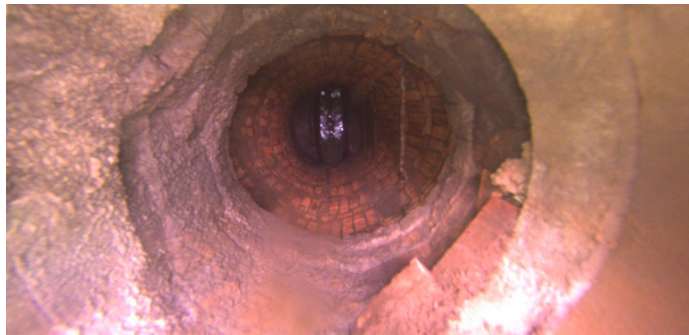
Code:	DB
Description:	Displaced Brick
Distance (ft):	.0
Structural Grade:	3
O&M Grade:	0
Clock Start/From:	4
Clock To:	6
1st Value:	
2nd Value:	
Value Percent:	
Step:	NO
Remarks:

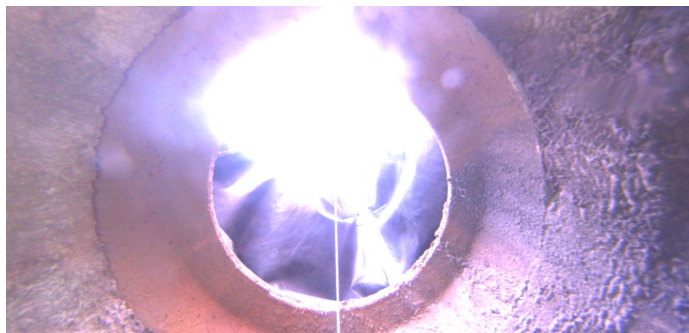
Code:	MGO
Description:	General Observation
Distance (ft):	1.5
Structural Grade:	0
O&M Grade:	0
Clock Start/From:	
Clock To:	
1st Value:	
2nd Value:	
Value Percent:	
Step:	NO
Remarks:	UNDERSIDE OF FRAME

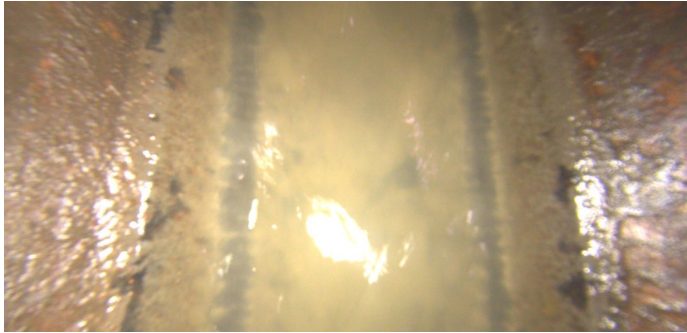
Code:	MGO
Description:	General Observation
Distance (ft):	9.3
Structural Grade:	0
O&M Grade:	0
Clock Start/From:	
Clock To:	
1st Value:	
2nd Value:	
Value Percent:	
Step:	NO
Remarks:	END SURVEY
