Manhole Inspection Report

Street:	Wisconsin St. 240' South of 2nd St.	Project:	Hobart, IN
City:	Hobart, IN	GPS Northing:	2901831.327
Location:		GPS Easting:	2901831.327
Drain Area:	West	GPS Accuracy:	Sub-Meter
Cover Shape:	Circular	Evidence of Surcharge:	No
Cover Size:	22.5	Potential for Runoff:	None
Comments:

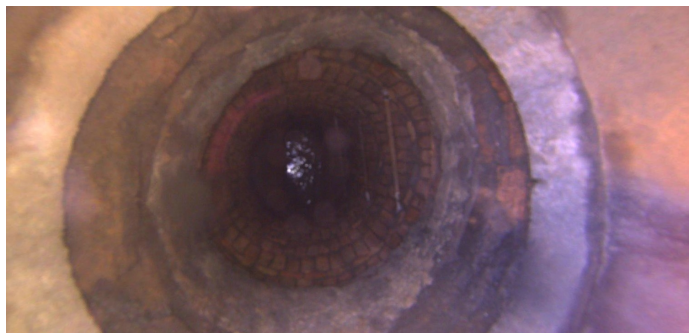
Code: **MGP**
Description: **General Photo**

Distance (ft): **.0**
Structural Grade: **0**
O&M Grade: **0**
Clock Start/From:
Clock To:
1st Value:
2nd Value:
Value Percent:
Step: **NO**
Remarks: **ACCESS MH**

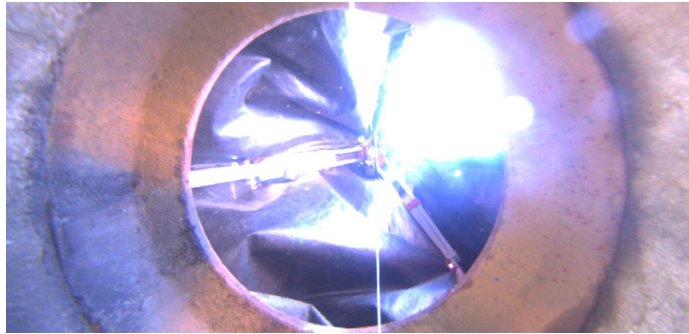
Code: **MGO**
Description: **General Observation**

Distance (ft): **2.0**
Structural Grade: **0**
O&M Grade: **0**
Clock Start/From:
Clock To:
1st Value:
2nd Value:
Value Percent:
Step: **NO**
Remarks: **UNDERSIDE OF FRAME**

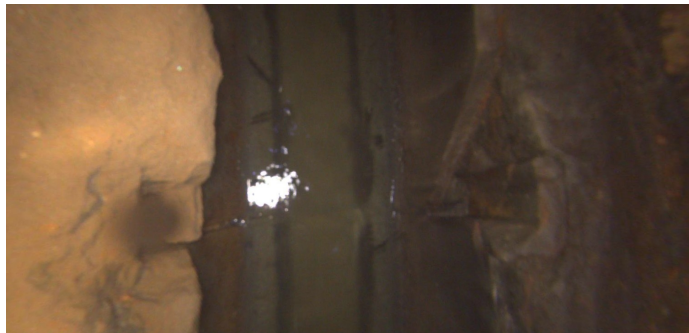
Code: **B**
Description: **Broken**

Distance (ft): **8.5**
Structural Grade: **5**
O&M Grade: **0**
Clock Start/From: **3**
Clock To: **9**
1st Value:
2nd Value:
Value Percent:
Step: **NO**
Remarks:

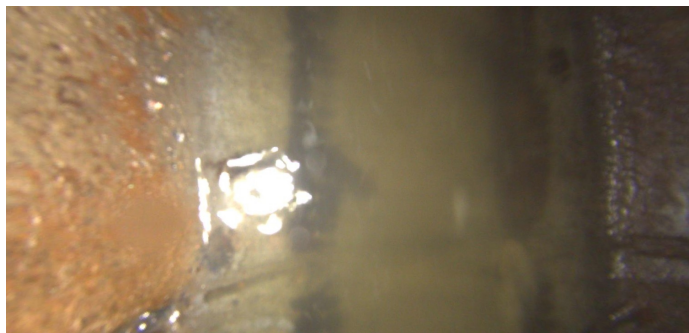
Code: **MGO**
Description: **General Observation**

Distance (ft): **10.1**
Structural Grade: **0**
O&M Grade: **0**
Clock Start/From:
Clock To:
1st Value:
2nd Value:
Value Percent:
Step: **NO**
Remarks: **END SURVEY**
