Manhole Inspection Report

Date:	04/30/2018	Weather:		Coding:	RZMACP
MH#:	M-605-050	Owner:	NA	Len. Surveyed:	11.1
P.O.#:		Surveyor:	Jen Costello	Rim to Invert:	11.6
Customer:		Cert. #:	U-907-5518	Wall Material:	Brick

Street:	Intersection of Wisconsin St. and 2n	Project:	Hobart, IN
City:	Hobart, IN	GPS Northing:	41.53458786
Location:		GPS Easting:	-87.26932526
Drain Area:	West	GPS Accuracy:	Nearest Meter
Cover Shape:	Circular	Evidence of Surcharge:	No
Cover Size:	22.5	Potential for Runoff:	None
Comments:

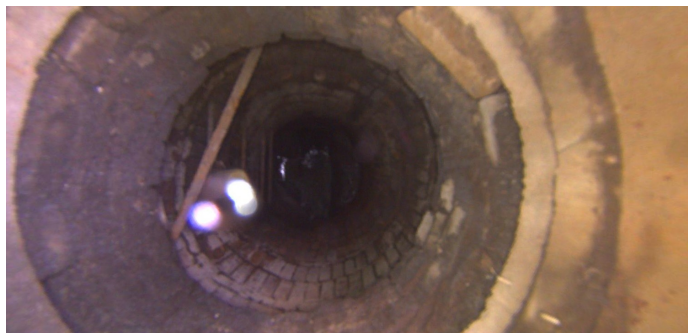
Code: **MGO**
Description: **General Observation**

Distance (ft): **.0**
Structural Grade: **0**
O&M Grade: **0**
Clock Start/From:
Clock To:
1st Value:
2nd Value:
Value Percent:
Step: **NO**
Remarks: **ACCESS MH**

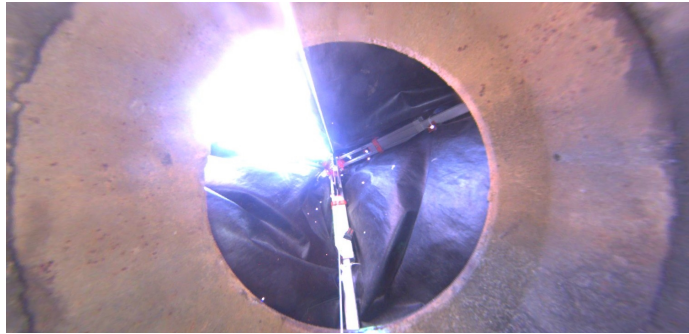
Code:	MGO
Description:	General Observation
Distance (ft):	1.4
Structural Grade:	0
O&M Grade:	0
Clock Start/From:	
Clock To:	
1st Value:	
2nd Value:	
Value Percent:	
Step:	NO
Remarks:	UNDERSIDE OF FRAME

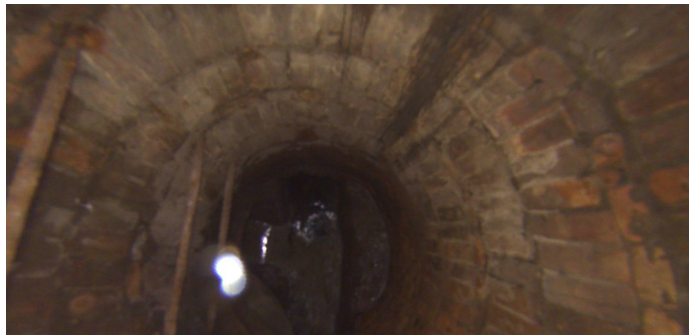
Code:	IW
Description:	Infil Weeper
Distance (ft):	4.4
Structural Grade:	0
O&M Grade:	2
Clock Start/From:	12
Clock To:	1
1st Value:	
2nd Value:	
Value Percent:	
Step:	NO
Remarks:

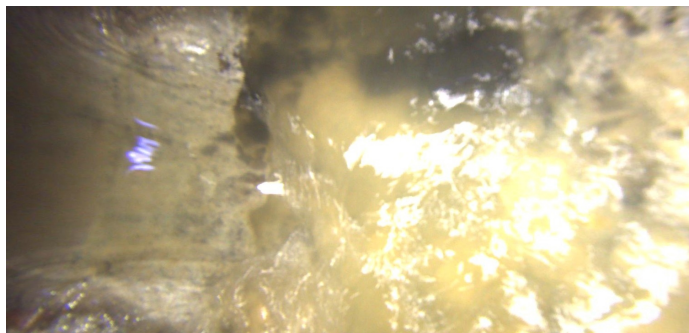
Code:	MGO
Description:	General Observation
Distance (ft):	11.1
Structural Grade:	0
O&M Grade:	0
Clock Start/From:	
Clock To:	
1st Value:	
2nd Value:	
Value Percent:	
Step:	NO
Remarks:	END SURVEY
