Manhole Inspection Report

Date:	04/30/2018	Weather:		Coding:	RZMACP
MH#:	M-605-052	Owner:	NA	Len. Surveyed:	9.8
P.O.#:		Surveyor:	Jen Costello	Rim to Invert:	11.0
Customer:		Cert. #:	U-907-5518	Wall Material:	Brick

Street:	Wisconsin St. 226' South of 1st St.	Project:	Hobart, IN
City:	Hobart, IN	GPS Northing:	2901823.29
Location:		GPS Easting:	2901823.29
Drain Area:	West	GPS Accuracy:	Sub-Meter
Cover Shape:	Circular	Evidence of Surcharge:	No
Cover Size:	22.5	Potential for Runoff:	None
Comments:

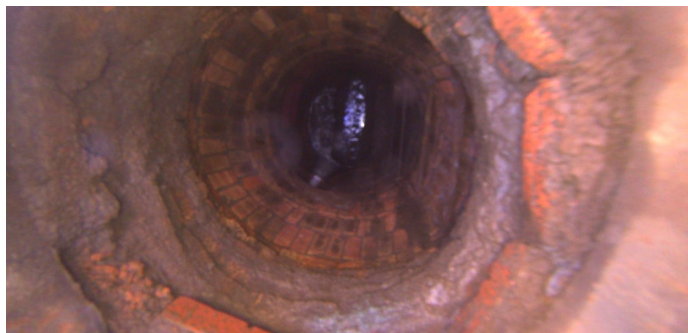
Code: **DB**
Description: **Displaced Brick**

Distance (ft): **.0**
Structural Grade: **3**
O&M Grade: **0**
Clock Start/From: **1**
Clock To: **7**
1st Value:
2nd Value:
Value Percent:
Step: **NO**
Remarks:

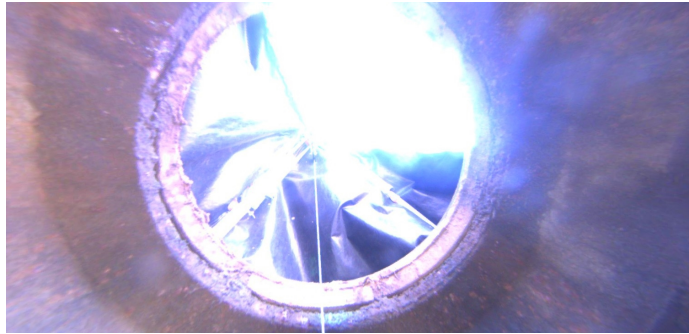
Code:	MGO
Description:	General Observation
Distance (ft):	1.5
Structural Grade:	0
O&M Grade:	0
Clock Start/From:	
Clock To:	
1st Value:	
2nd Value:	
Value Percent:	
Step:	NO
Remarks:	underside of frame

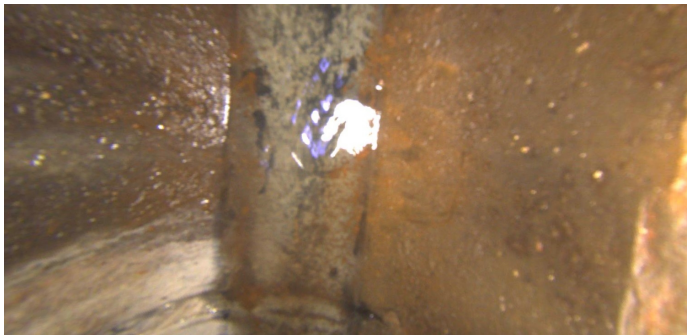
Code:	MGO
Description:	General Observation
Distance (ft):	9.8
Structural Grade:	0
O&M Grade:	0
Clock Start/From:	
Clock To:	
1st Value:	
2nd Value:	
Value Percent:	
Step:	NO
Remarks:	end survey
