# Manhole Inspection Report

Date:	<b>05/01/2018</b>	Weather:		Coding:	<b>RZMACP</b>
MH#:	<b>M-605-054</b>	Owner:	<b>NA</b>	Len. Surveyed:	<b>11.3</b>
P.O.#:		Surveyor:	<b>Jen Costello</b>	Rim to Invert:	<b>11.7</b>
Customer:		Cert. #:	<b>U-907-5518</b>	Wall Material:	<b>Brick</b>

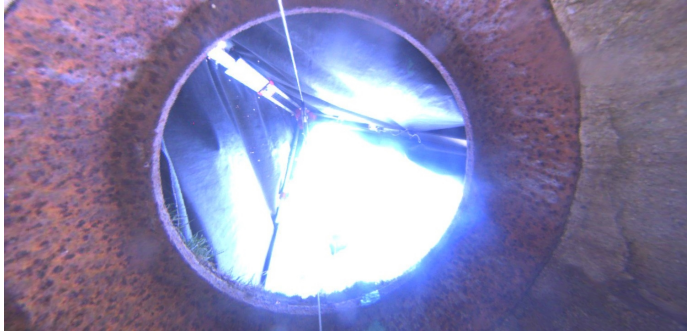
Code: **MGO**  
Description: **General Observation**

Distance (ft): **1.3**  
Structural Grade: **0**  
O&M Grade: **0**  
Clock Start/From:  
Clock To:  
1st Value:  
2nd Value:  
Value Percent:  
Step: **NO**  
Remarks: **UNDERSIDE OF FRAME**

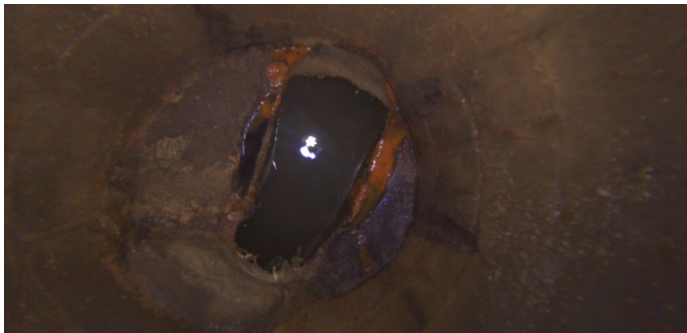
Code: **IW**  
Description: **Infil Weeper**

Distance (ft): **8.4**  
Structural Grade: **0**  
O&M Grade: **2**  
Clock Start/From: **12**  
Clock To: **12**  
1st Value:  
2nd Value:  
Value Percent:  
Step: **NO**  
Remarks:

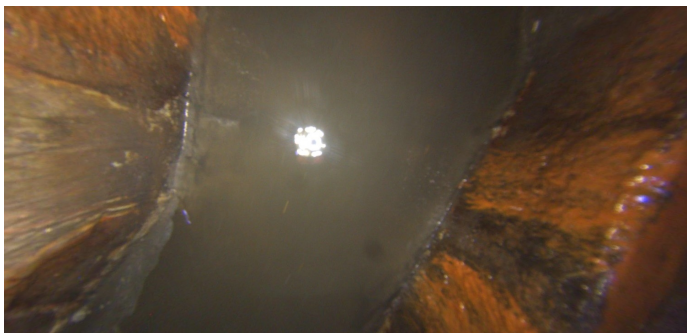
Code: **MGO**  
Description: **General Observation**

Distance (ft): **11.3**  
Structural Grade: **0**  
O&M Grade: **0**  
Clock Start/From:  
Clock To:  
1st Value:  
2nd Value:  
Value Percent:  
Step: **NO**  
Remarks: **END SURVEY**
