Manhole Inspection Report

Date:	05/01/2018	Weather:		Coding:	RZMACP
MH#:	M-605-055	Owner:	NA	Len. Surveyed:	13.5
P.O.#:		Surveyor:	Jen Costello	Rim to Invert:	15.3
Customer:		Cert. #:	U-907-5518	Wall Material:	Concrete (reinforced)

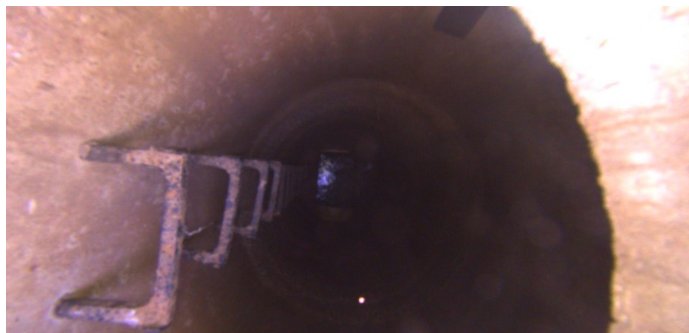
Code: **MGP**
Description: **General Photo**

Distance (ft): **.0**
Structural Grade: **0**
O&M Grade: **0**
Clock Start/From:
Clock To:
1st Value:
2nd Value:
Value Percent:
Step: **NO**
Remarks: **ACCESS MH**

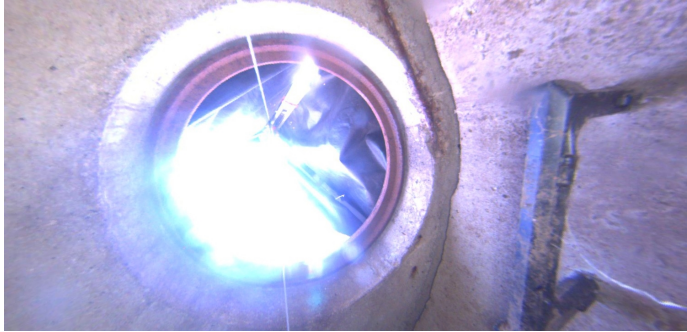
Code: **MGO**
Description: **General Observation**

Distance (ft): **2.0**
Structural Grade: **0**
O&M Grade: **0**
Clock Start/From:
Clock To:
1st Value:
2nd Value:
Value Percent:
Step: **NO**
Remarks: **UNDERSIDE OF FRAME**

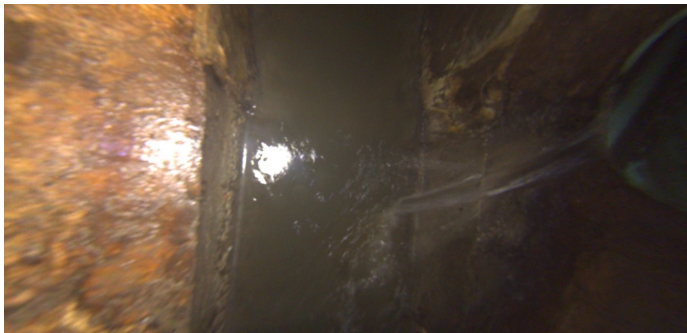
Code: **MGO**
Description: **General Observation**

Distance (ft): **13.5**
Structural Grade: **0**
O&M Grade: **0**
Clock Start/From:
Clock To:
1st Value:
2nd Value:
Value Percent:
Step: **NO**
Remarks: **END SURVEY**
