Manhole Inspection Report

Date:	05/01/2018	Weather:		Coding:	RZMACP
MH#:	M-605-057	Owner:	NA	Len. Surveyed:	9.6
P.O.#:		Surveyor:	Jen Costello	Rim to Invert:	10.7
Customer:		Cert. #:	U-907-5518	Wall Material:	Concrete (reinforced)

Street:	Beverly Blvd. 298' East of Beverly Ln.	Project:	Hobart, IN
City:	Hobart, IN	GPS Northing:	41.5347023
Location:		GPS Easting:	-87.26067352
Drain Area:	West	GPS Accuracy:	Nearest Meter
Cover Shape:	Circular	Evidence of Surcharge:	No
Cover Size:	22.5	Potential for Runoff:	None
Comments:

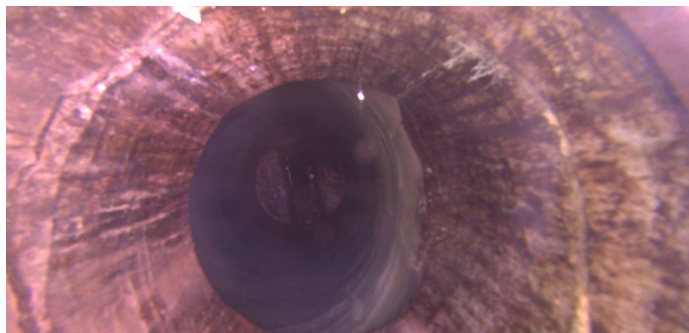
Code: **MGP**
Description: **General Photo**

Distance (ft): **.0**
Structural Grade: **0**
O&M Grade: **0**
Clock Start/From:
Clock To:
1st Value:
2nd Value:
Value Percent:
Step: **NO**
Remarks: **access MH**

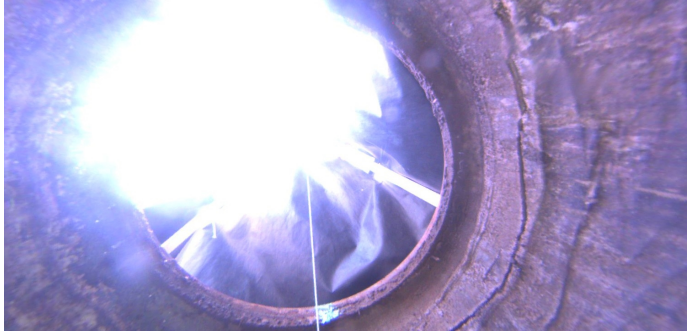
Code:	MGO
Description:	General Observation
Distance (ft):	1.6
Structural Grade:	0
O&M Grade:	0
Clock Start/From:	
Clock To:	
1st Value:	
2nd Value:	
Value Percent:	
Step:	NO
Remarks:	UNDERSIDE OF FRAME

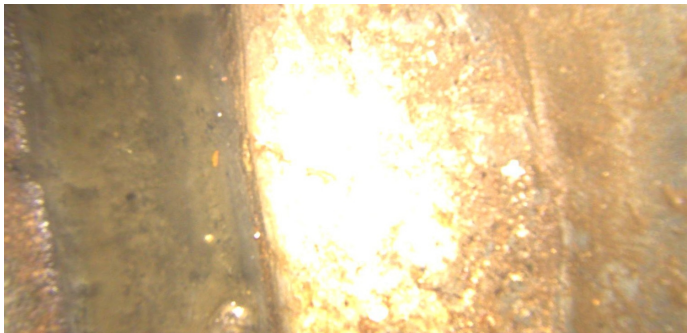
Code:	MGO
Description:	General Observation
Distance (ft):	9.6
Structural Grade:	0
O&M Grade:	0
Clock Start/From:	
Clock To:	
1st Value:	
2nd Value:	
Value Percent:	
Step:	NO
Remarks:	END SURVEY
