Manhole Inspection Report

Date:	05/01/2018	Weather:		Coding:	RZMACP
MH#:	M-605-058	Owner:	NA	Len. Surveyed:	12.5
P.O.#:		Surveyor:	Jen Costello	Rim to Invert:	13.0
Customer:		Cert. #:	U-907-5518	Wall Material:	Concrete (reinforced)

Street:	South of Cleveland Ave. 60' East of L	Project:	Hobart, IN
City:	Hobart, IN	GPS Northing:	41.53510284
Location:		GPS Easting:	-87.25944519
Drain Area:	West	GPS Accuracy:	Nearest Meter
Cover Shape:	Circular	Evidence of Surcharge:	No
Cover Size:	22.5	Potential for Runoff:	None
Comments:

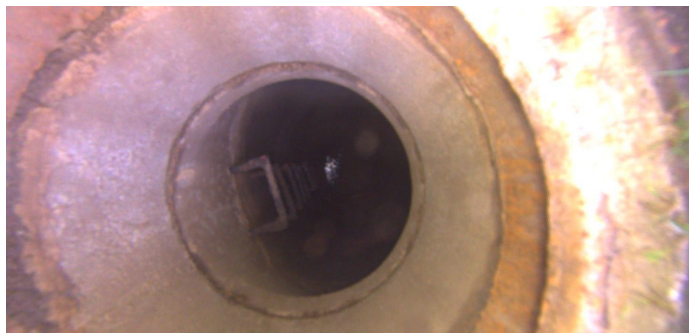
Code: **MGO**
Description: **General Observation**

Distance (ft): **.0**
Structural Grade: **0**
O&M Grade: **0**
Clock Start/From:
Clock To:
1st Value:
2nd Value:
Value Percent:
Step: **NO**
Remarks: **access MH**

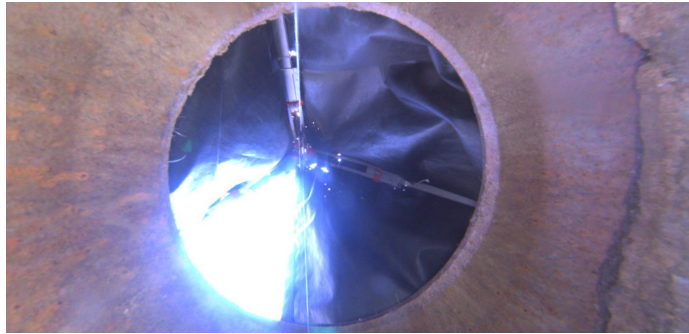
Code: **MGO**
Description: **General Observation**

Distance (ft): **1.9**
Structural Grade: **0**
O&M Grade: **0**
Clock Start/From:
Clock To:
1st Value:
2nd Value:
Value Percent:
Step: **NO**
Remarks: **UNDERSIDE OF FRAME**

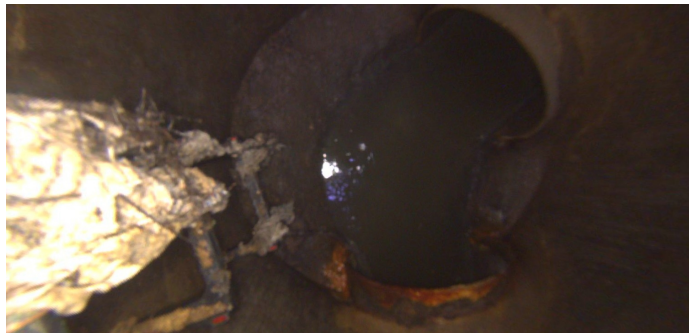
Code: **DAR**
Description: **Deposits Attached Ragging**

Distance (ft): **9.6**
Structural Grade: **0**
O&M Grade: **2**
Clock Start/From: **9**
Clock To:
1st Value:
2nd Value:
Value Percent: **10.000**
Step: **YES**
Remarks:
