Manhole Inspection Report

Date:	05/01/2018	Weather:		Coding:	RZMACP
MH#:	M-605-061	Owner:	NA	Len. Surveyed:	7.3
P.O.#:		Surveyor:	Jen Costello	Rim to Invert:	8.2
Customer:		Cert. #:	U-907-5518	Wall Material:	Concrete (reinforced)

Street:	Lake Park Ave. 335' South of Clevela	Project:	Hobart, IN
City:	Hobart, IN	GPS Northing:	41.53536987
Location:		GPS Easting:	-87.25974274
Drain Area:	West	GPS Accuracy:	Nearest Meter
Cover Shape:	Circular	Evidence of Surcharge:	No
Cover Size:	22.5	Potential for Runoff:	None
Comments:

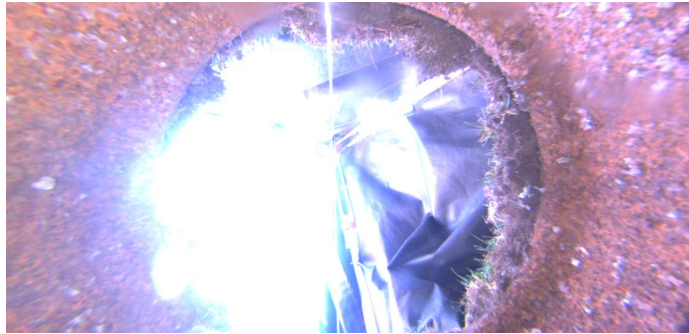
Code: **MGO**
Description: **General Observation**

Distance (ft): **1.4**
Structural Grade: **0**
O&M Grade: **0**
Clock Start/From:
Clock To:
1st Value:
2nd Value:
Value Percent:
Step: **NO**
Remarks: **UNDERSIDE OF FRAME**

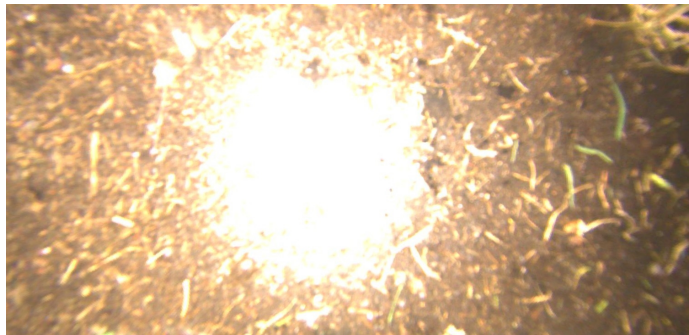
Code: **MGO**
Description: **General Observation**

Distance (ft): **7.3**
Structural Grade: **0**
O&M Grade: **0**
Clock Start/From:
Clock To:
1st Value:
2nd Value:
Value Percent:
Step: **NO**
Remarks: **END SURVEY**
