# Manhole Inspection Report

Date:	<b>04/29/2018</b>	Weather:		Coding:	<b>RZMACP</b>
MH#:	<b>M-605-066</b>	Owner:	<b>NA</b>	Len. Surveyed:	<b>10.3</b>
P.O.#:		Surveyor:	<b>Jen Costello</b>	Rim to Invert:	<b>10.8</b>
Customer:		Cert. #:	<b>U-907-5518</b>	Wall Material:	<b>Concrete (reinforced)</b>

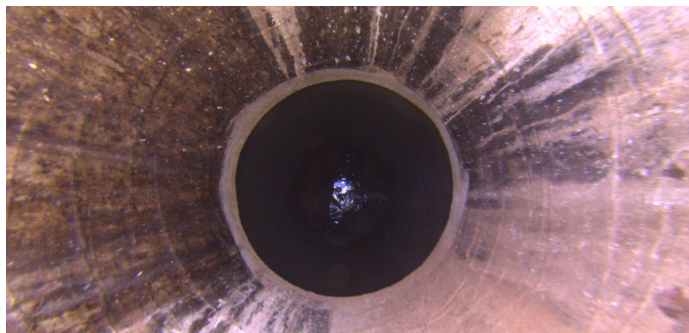
Code: **MGO**  
Description: **General Observation**

Distance (ft): **.0**  
Structural Grade: **0**  
O&M Grade: **0**  
Clock Start/From:  
Clock To:  
1st Value:  
2nd Value:  
Value Percent:  
Step: **NO**  
Remarks: **ACCESS MH**

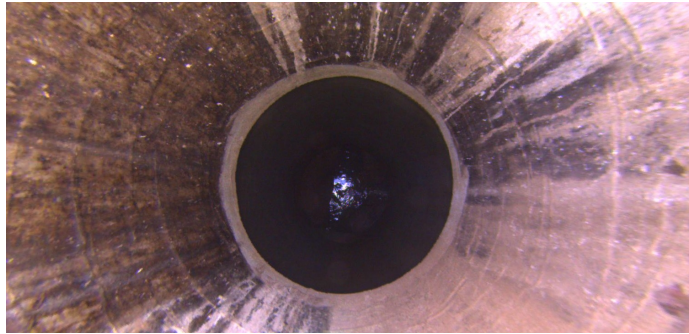
Code: **IS**  
Description: **Infil Stain**

Distance (ft): **.0**  
Structural Grade: **0**  
O&M Grade: **0**  
Clock Start/From: **12**  
Clock To: **12**  
1st Value:  
2nd Value:  
Value Percent:  
Step: **NO**  
Remarks:

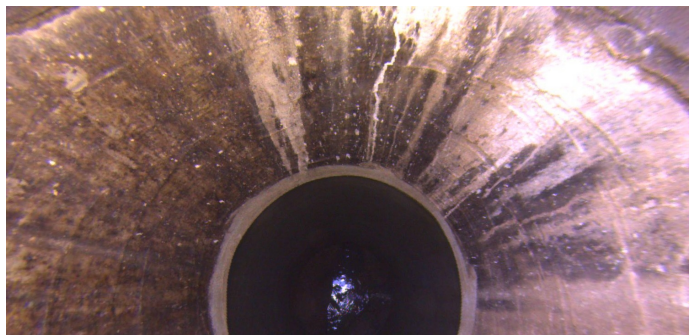
Code: **CL**  
Description: **Crack Longitudinal**

Distance (ft): **.0**  
Structural Grade: **2**  
O&M Grade: **0**  
Clock Start/From: **12**  
Clock To:  
1st Value:  
2nd Value:  
Value Percent:  
Step: **NO**  
Remarks:

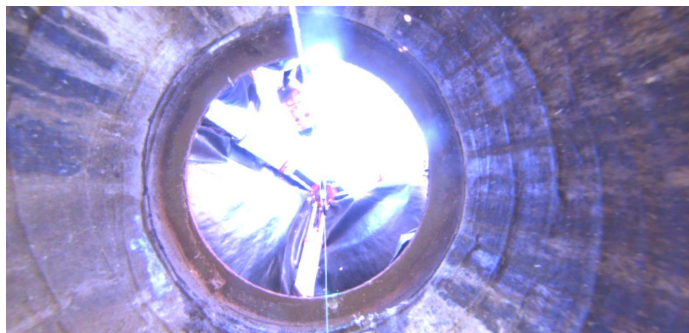
Code: **MGP**  
Description: **General Photo**

Distance (ft): **2.4**  
Structural Grade: **0**  
O&M Grade: **0**  
Clock Start/From:  
Clock To:  
1st Value:  
2nd Value:  
Value Percent:  
Step: **NO**  
Remarks: **UNDERSIDE OF FRAME**

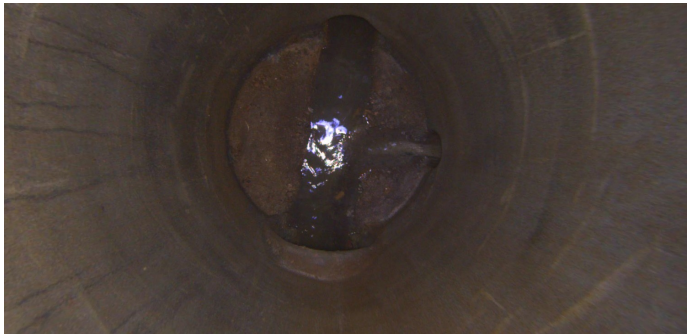
Code: **CM**  
Description: **Crack Multiple**

Distance (ft): **6.7**  
Structural Grade: **3**  
O&M Grade: **0**  
Clock Start/From: **12**  
Clock To: **12**  
1st Value:  
2nd Value:  
Value Percent:  
Step: **NO**  
Remarks:

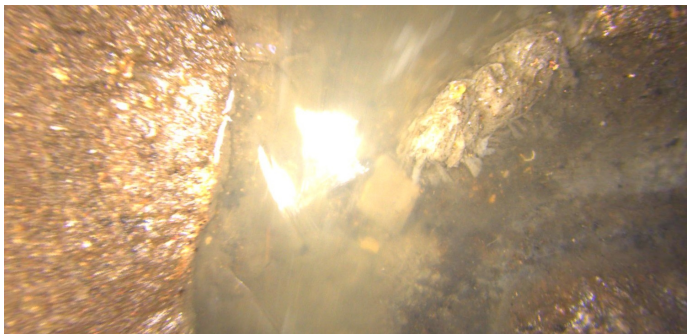
Code: **MGO**  
Description: **General Observation**

Distance (ft): **10.3**  
Structural Grade: **0**  
O&M Grade: **0**  
Clock Start/From:  
Clock To:  
1st Value:  
2nd Value:  
Value Percent:  
Step: **NO**  
Remarks: **END SURVEY**
