Manhole Inspection Report

Date:	05/01/2018	Weather:		Coding:	RZMACP
MH#:	M-605-071	Owner:	NA	Len. Surveyed:	11.5
P.O.#:		Surveyor:	Jen Costello	Rim to Invert:	13.0
Customer:		Cert. #:	U-907-5518	Wall Material:	Concrete (reinforced)

Street:	South of Cleveland Ave. 49' East of L	Project:	Hobart, IN
City:	Hobart, IN	GPS Northing:	41.53512192
Location:		GPS Easting:	-87.2594986
Drain Area:	West	GPS Accuracy:	Nearest Meter
Cover Shape:	Circular	Evidence of Surcharge:	No
Cover Size:	22.5	Potential for Runoff:	None
Comments:

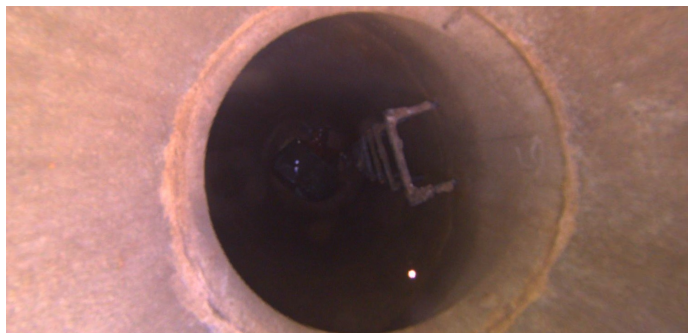
Code: **MGP**
Description: **General Photo**

Distance (ft): **.0**
Structural Grade: **0**
O&M Grade: **0**
Clock Start/From:
Clock To:
1st Value:
2nd Value:
Value Percent:
Step: **NO**
Remarks: **ACCESS MH**

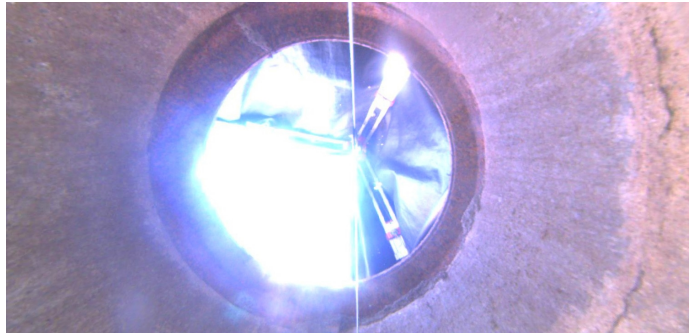
Code: **MGO**
Description: **General Observation**

Distance (ft): **2.2**
Structural Grade: **0**
O&M Grade: **0**
Clock Start/From:
Clock To:
1st Value:
2nd Value:
Value Percent:
Step: **NO**
Remarks: **UNDERSIDE OF FRAME**

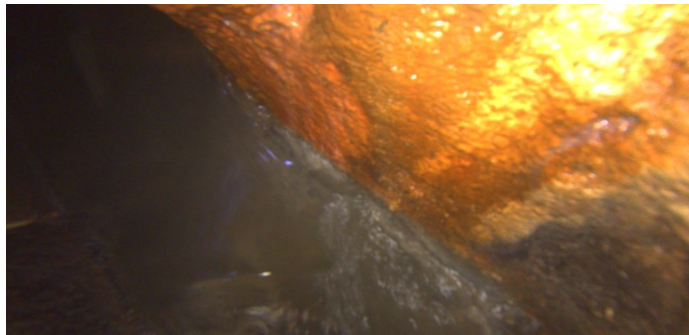
Code: **MGO**
Description: **General Observation**

Distance (ft): **11.5**
Structural Grade: **0**
O&M Grade: **0**
Clock Start/From:
Clock To:
1st Value:
2nd Value:
Value Percent:
Step: **NO**
Remarks: **end survey**
