Manhole Inspection Report

Date:	05/02/2018	Weather:		Coding:	RZMACP
MH#:	M-605-073	Owner:	NA	Len. Surveyed:	7.2
P.O.#:		Surveyor:	Jen Costello	Rim to Invert:	8.6
Customer:		Cert. #:	U-907-5518	Wall Material:	Brick

Street:	3rd St. and Ash St. 3 Manholes to th	Project:	Hobart, IN
City:	Hobart, IN	GPS Northing:	41.53110123
Location:		GPS Easting:	-87.26444244
Drain Area:	West	GPS Accuracy:	Nearest Meter
Cover Shape:	Circular	Evidence of Surcharge:	No
Cover Size:	22.5	Potential for Runoff:	None
Comments:

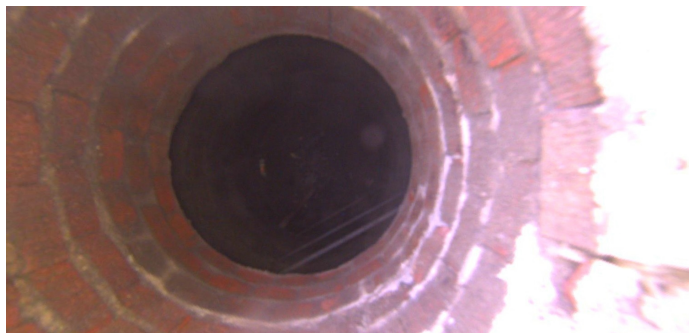
Code: **MGP**
Description: **General Photo**

Distance (ft): **.0**
Structural Grade: **0**
O&M Grade: **0**
Clock Start/From:
Clock To:
1st Value:
2nd Value:
Value Percent:
Step: **NO**
Remarks: **ACCESS MH**

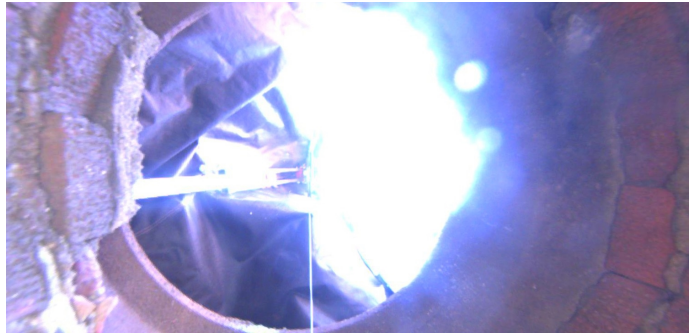
Code: **MGO**
Description: **General Observation**

Distance (ft): **1.8**
Structural Grade: **0**
O&M Grade: **0**
Clock Start/From:
Clock To:
1st Value:
2nd Value:
Value Percent:
Step: **NO**
Remarks: **UNDERSIDE OF FRAME**

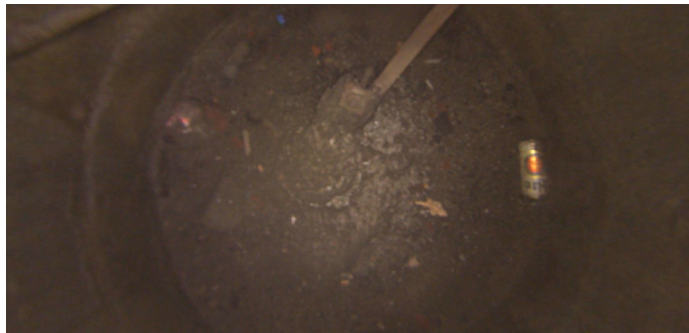
Code: **OBZ**
Description: **Obstacle Other**

Distance (ft): **5.9**
Structural Grade: **0**
O&M Grade: **2**
Clock Start/From: **12**
Clock To: **3**
1st Value:
2nd Value:
Value Percent: **5.000**
Step: **NO**
Remarks: **GARBAGE**

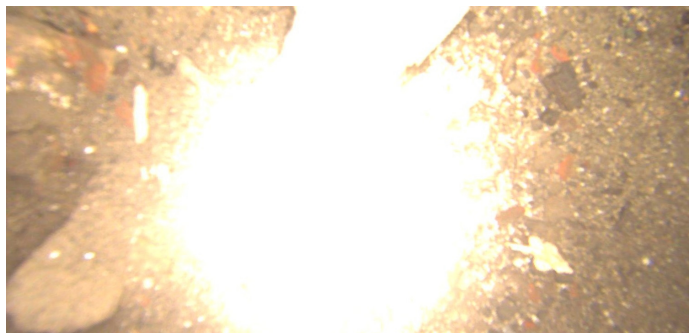
Code: **MGO**
Description: **General Observation**

Distance (ft): **7.2**
Structural Grade: **0**
O&M Grade: **0**
Clock Start/From:
Clock To:
1st Value:
2nd Value:
Value Percent:
Step: **NO**
Remarks: **END SURVEY**
