Manhole Inspection Report

Date:	05/02/2018	Weather:		Coding:	RZMACP
MH#:	M-605-075	Owner:	NA	Len. Surveyed:	8.4
P.O.#:		Surveyor:	Jen Costello	Rim to Invert:	8.4
Customer:		Cert. #:	U-907-5518	Wall Material:	Brick

Street:	3rd St. and Ash St. 1 Manhole to the	Project:	Hobart, IN
City:	Hobart, IN	GPS Northing:	41.53205872
Location:		GPS Easting:	-87.26445007
Drain Area:	West	GPS Accuracy:	Nearest Meter
Cover Shape:	Circular	Evidence of Surcharge:	No
Cover Size:	22.5	Potential for Runoff:	None
Comments:

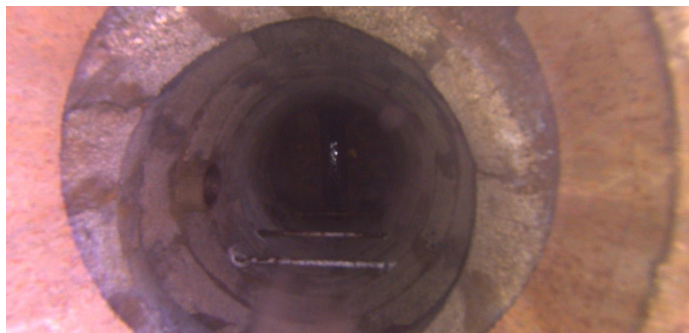
Code: **MGO**
Description: **General Observation**

Distance (ft): **.0**
Structural Grade: **0**
O&M Grade: **0**
Clock Start/From:
Clock To:
1st Value:
2nd Value:
Value Percent:
Step: **NO**
Remarks: **ACCESS MH**

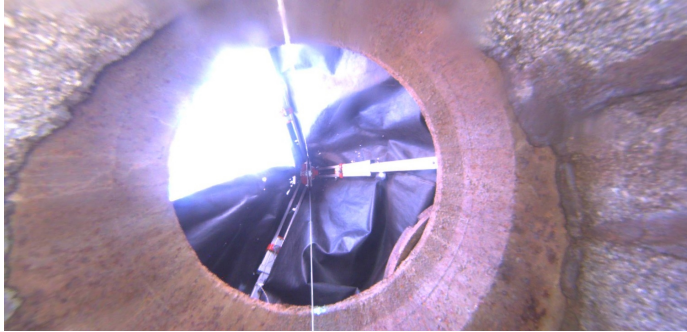
Code:	MGO
Description:	General Observation
Distance (ft):	1.9
Structural Grade:	0
O&M Grade:	0
Clock Start/From:	
Clock To:	
1st Value:	
2nd Value:	
Value Percent:	
Step:	NO
Remarks:	UNDERSIDE OF FRAME

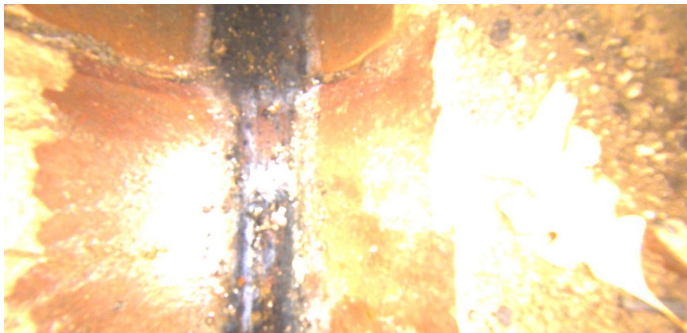
Code:	MGO
Description:	General Observation
Distance (ft):	8.4
Structural Grade:	0
O&M Grade:	0
Clock Start/From:	
Clock To:	
1st Value:	
2nd Value:	
Value Percent:	
Step:	NO
Remarks:	END SURVEY
