Manhole Inspection Report

Date:	05/02/2018	Weather:		Coding:	RZMACP
MH#:	M-605-076	Owner:	NA	Len. Surveyed:	6.5
P.O.#:		Surveyor:	Jen Costello	Rim to Invert:	7.7
Customer:		Cert. #:	U-907-5518	Wall Material:	Concrete (reinforced)

Street:	North of Wisconsin St. and 3rd St.	Project:	Hobart, IN
City:	Hobart, IN	GPS Northing:	41.53324127
Location:		GPS Easting:	-87.26911926
Drain Area:	West	GPS Accuracy:	Nearest Meter
Cover Shape:	Circular	Evidence of Surcharge:	No
Cover Size:	22.5	Potential for Runoff:	None
Comments:

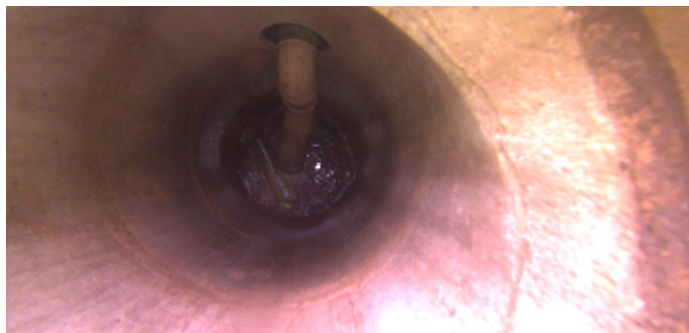
Code: **MGP**
Description: **General Photo**

Distance (ft): **.0**
Structural Grade: **0**
O&M Grade: **0**
Clock Start/From:
Clock To:
1st Value:
2nd Value:
Value Percent:
Step: **NO**
Remarks: **ACCESS MH**

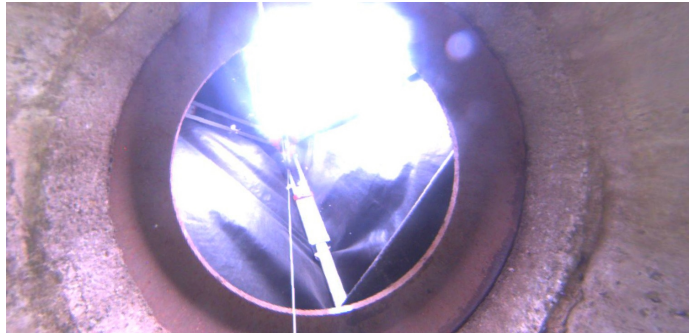
Code: **MGO**
Description: **General Observation**

Distance (ft): **2.0**
Structural Grade: **0**
O&M Grade: **0**
Clock Start/From:
Clock To:
1st Value:
2nd Value:
Value Percent:
Step: **NO**
Remarks: **UNDERSIDE OF FRAME**

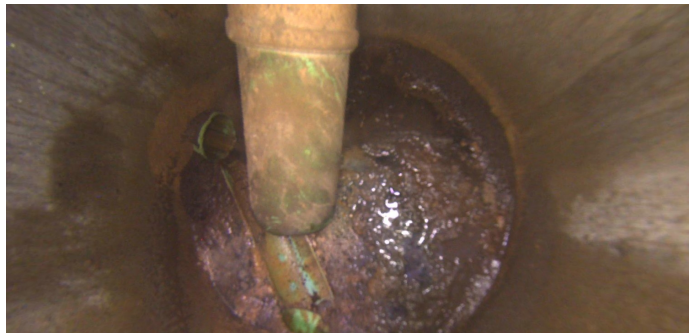
Code: **OBP**
Description: **Obstacle External Pipe or Cable**

Distance (ft): **4.6**
Structural Grade: **0**
O&M Grade: **2**
Clock Start/From: **12**
Clock To:
1st Value:
2nd Value:
Value Percent: **10.000**
Step: **NO**
Remarks:

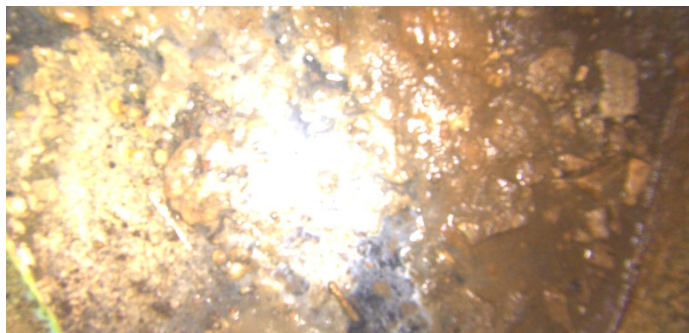
Code: **MGO**
Description: **General Observation**

Distance (ft): **6.5**
Structural Grade: **0**
O&M Grade: **0**
Clock Start/From:
Clock To:
1st Value:
2nd Value:
Value Percent:
Step: **NO**
Remarks: **END SURVEY**
