Manhole Inspection Report

Date:	04/25/2018	Weather:		Coding:	RZMACP
MH#:	M-606-001	Owner:	NA	Len. Surveyed:	13.6
P.O.#:		Surveyor:	John Kuglmaier	Rim to Invert:	14.4
Customer:	8.7	Cert. #:	U-1215-07002349	Wall Material:	Concrete (reinforced)

Street:	10th St. and Lake Park Ave. Middle	Project:	Hobart, IN
City:	Hobart, IN	GPS Northing:	0.0
Location:		GPS Easting:	0.0
Drain Area:	Southwest	GPS Accuracy:	Nearest Meter
Cover Shape:	Circular	Evidence of Surcharge:	Yes
Cover Size:	22.5	Potential for Runoff:	None
Comments:

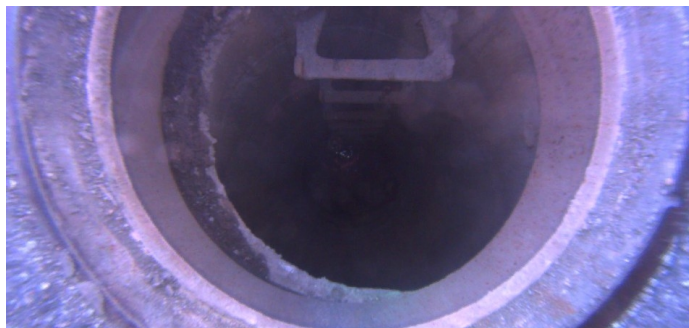
Code: **MGP**
Description: **General Photo**

Distance (ft): **.0**
Structural Grade: **0**
O&M Grade: **0**
Clock Start/From:
Clock To:
1st Value:
2nd Value:
Value Percent:
Step: **NO**
Remarks:

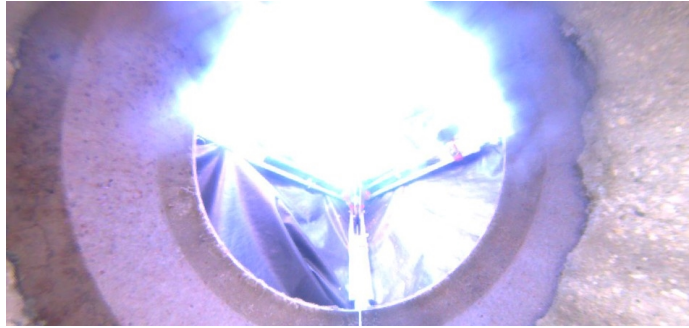
Code: **MGP**
Description: **General Photo**

Distance (ft): **2.8**
Structural Grade: **0**
O&M Grade: **0**
Clock Start/From:
Clock To:
1st Value:
2nd Value:
Value Percent:
Step: **NO**
Remarks:

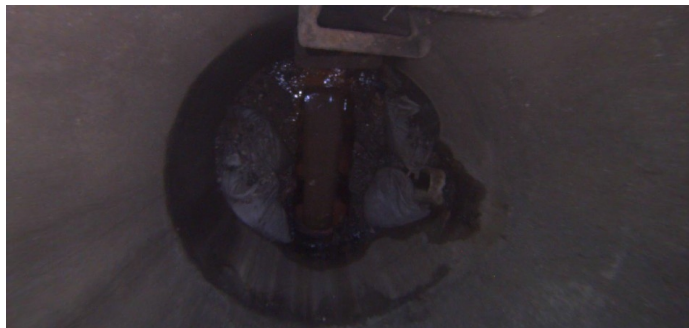
Code: **IS**
Description: **Infil Stain**

Distance (ft): **8.5**
Structural Grade: **0**
O&M Grade: **0**
Clock Start/From: **4**
Clock To: **1**
1st Value:
2nd Value:
Value Percent:
Step: **NO**
Remarks:

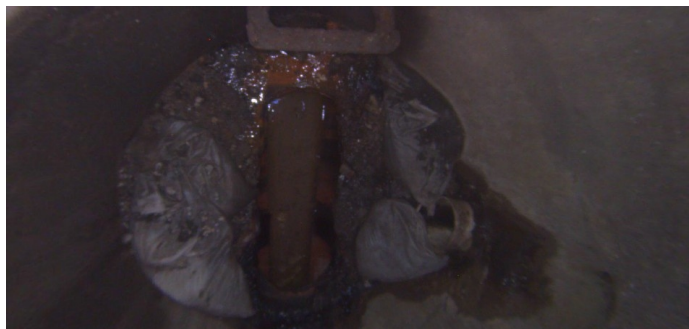
Code: **OBZ**
Description: **Obstacle Other**

Distance (ft): **10.4**
Structural Grade: **0**
O&M Grade: **3**
Clock Start/From: **1**
Clock To: **5**
1st Value:
2nd Value:
Value Percent: **15.000**
Step: **NO**
Remarks: **Sand bags**

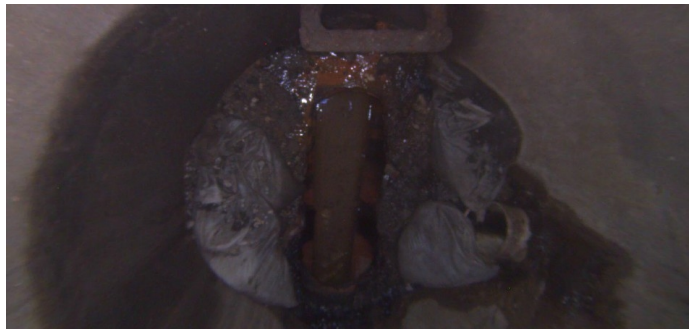
Code: **OBZ**
Description: **Obstacle Other**

Distance (ft): **10.4**
Structural Grade: **0**
O&M Grade: **3**
Clock Start/From: **7**
Clock To: **10**
1st Value:
2nd Value:
Value Percent: **15.000**
Step: **NO**
Remarks: **Sand bags**

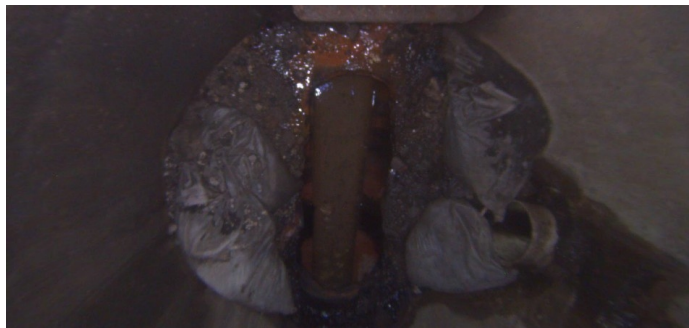
Code: **DAZ**
Description: **Deposits Attached Other**

Distance (ft): **10.9**
Structural Grade: **0**
O&M Grade: **2**
Clock Start/From: **12**
Clock To: **12**
1st Value:
2nd Value:
Value Percent: **10.000**
Step: **NO**
Remarks: **Mixed materials**

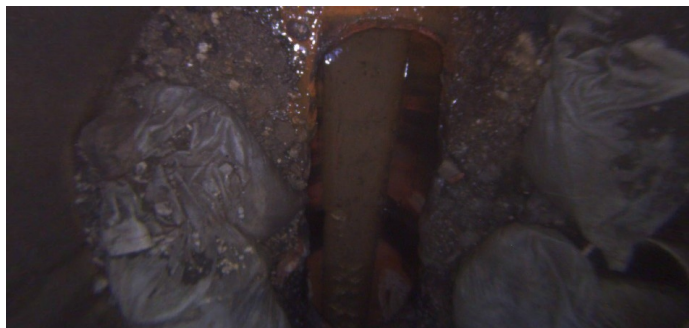
Code: **MGO**
Description: **General Observation**

Distance (ft): **12.1**
Structural Grade: **0**
O&M Grade: **0**
Clock Start/From:
Clock To:
1st Value:
2nd Value:
Value Percent:
Step: **NO**
Remarks: **Ins. Comp.**
