Manhole Inspection Report

Date:	09/25/2022	Weather:		Coding:	RZMACP
MH#:	M-606-002	Owner:	NA	Len. Surveyed:	11.5
P.O.#:		Surveyor:	Jen Costello	Rim to Invert:	13.0
Customer:		Cert. #:	U-907-5518	Wall Material:	Concrete (cast in place)

Street:	Lake Park Ave. 226' North of 10th St.	Project:	Hobart, IN
City:	Hobart, IN	GPS Northing:	2285407.023
Location:	Local Rural Streets	GPS Easting:	2904525.053
Drain Area:	Southeast	GPS Accuracy:	Sub-Meter
Cover Shape:	Circular	Evidence of Surcharge:	Yes
Cover Size:	24.0	Potential for Runoff:	None
Comments:

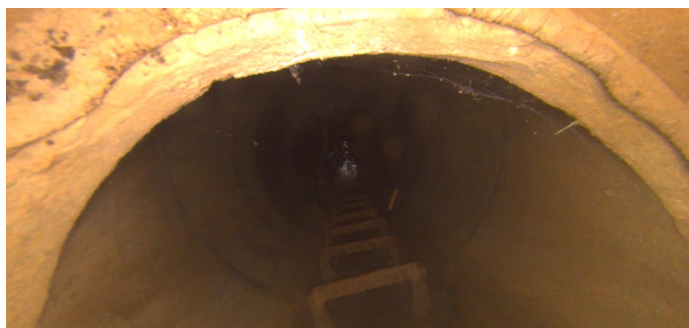
Code: **MGO**
Description: **General Observation**

Distance (ft): **.0**
Structural Grade: **0**
O&M Grade: **0**
Clock Start/From:
Clock To:
1st Value:
2nd Value:
Value Percent:
Step: **NO**
Remarks: **access mh**

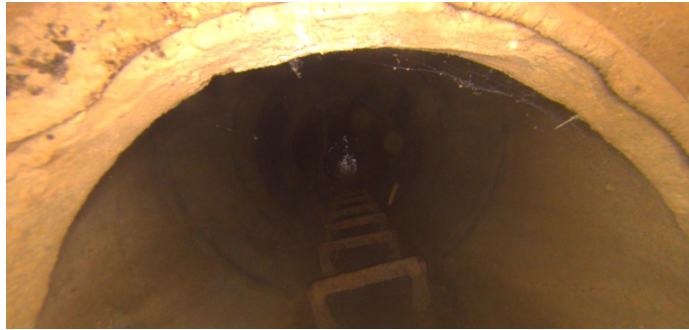
Code: **SRI**
Description: **Surface Roughness Increased**

Distance (ft): **.0**
Structural Grade: **1**
O&M Grade: **0**
Clock Start/From: **12**
Clock To: **12**
1st Value:
2nd Value:
Value Percent:
Step: **NO**
Remarks:

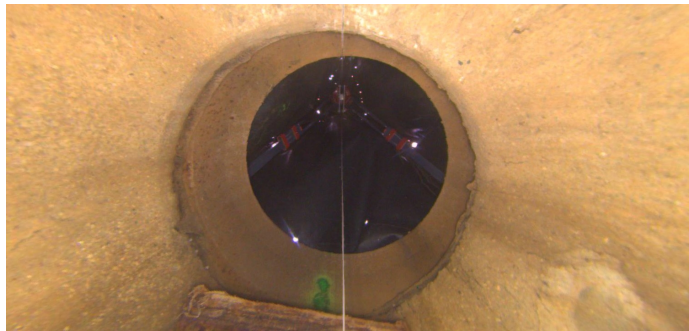
Code: **MGO**
Description: **General Observation**

Distance (ft): **2.4**
Structural Grade: **0**
O&M Grade: **0**
Clock Start/From:
Clock To:
1st Value:
2nd Value:
Value Percent:
Step: **NO**
Remarks: **underside of frame**

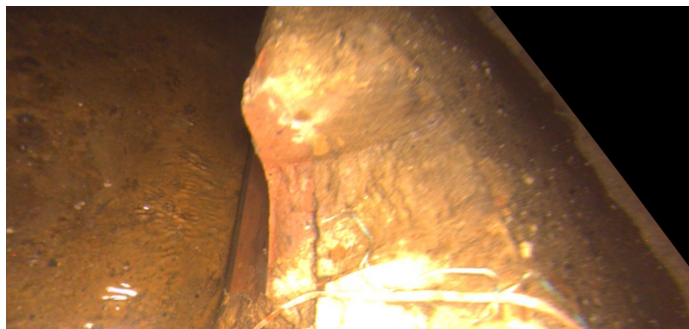
Code: **DSF**
Description: **Deposits Settled Fine**

Distance (ft): **11.3**
Structural Grade: **0**
O&M Grade: **2**
Clock Start/From: **12**
Clock To: **12**
1st Value:
2nd Value:
Value Percent: **5.000**
Step: **NO**
Remarks:

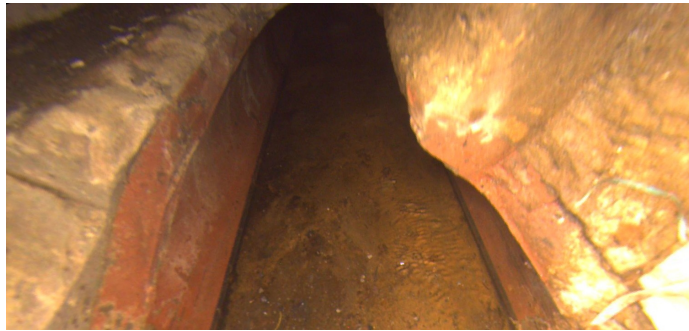
Code: **MGO**
Description: **General Observation**

Distance (ft): **11.3**
Structural Grade: **0**
O&M Grade: **0**
Clock Start/From:
Clock To:
1st Value:
2nd Value:
Value Percent:
Step: **NO**
Remarks: **end of survey**

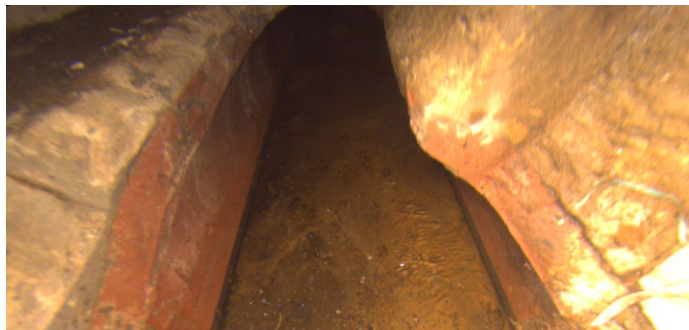
Code: **SRI**
Description: **Surface Roughness Increased**

Distance (ft): **11.3**
Structural Grade: **1**
O&M Grade: **0**
Clock Start/From: **12**
Clock To: **12**
1st Value:
2nd Value:
Value Percent:
Step: **NO**
Remarks:

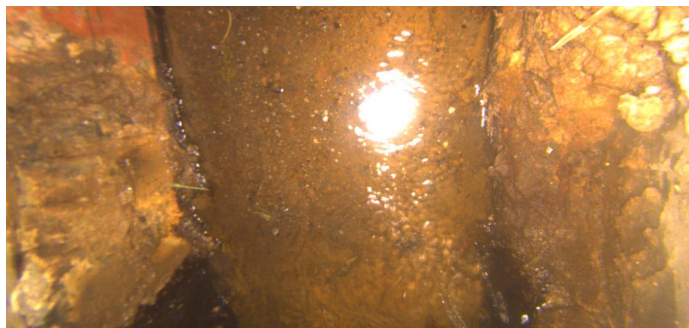
Code: **B**
Description: **Broken**

Distance (ft): **11.5**
Structural Grade: **5**
O&M Grade: **0**
Clock Start/From: **3**
Clock To: **9**
1st Value:
2nd Value:
Value Percent:
Step: **NO**
Remarks:
