Manhole Inspection Report

Date:	04/26/2018	Weather:		Coding:	RZMACP
MH#:	M-606-004	Owner:	NA	Len. Surveyed:	12.2
P.O.#:		Surveyor:	Jen Costello	Rim to Invert:	12.1
Customer:		Cert. #:	U-907-5518	Wall Material:	Concrete (reinforced)

Street:	Lake Park Ave. 631' South of 8th St.	Project:	Hobart, IN
City:	Hobart, IN	GPS Northing:	2904529.19
Location:		GPS Easting:	2904529.19
Drain Area:	Southeast	GPS Accuracy:	Sub-Meter
Cover Shape:	Circular	Evidence of Surcharge:	No
Cover Size:	22.5	Potential for Runoff:	None
Comments:

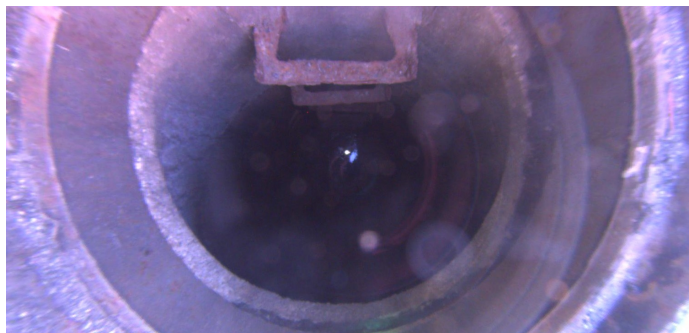
Code: **MGO**
Description: **General Observation**

Distance (ft): **.0**
Structural Grade: **0**
O&M Grade: **0**
Clock Start/From:
Clock To:
1st Value:
2nd Value:
Value Percent:
Step: **NO**
Remarks: **ACCESS MH**

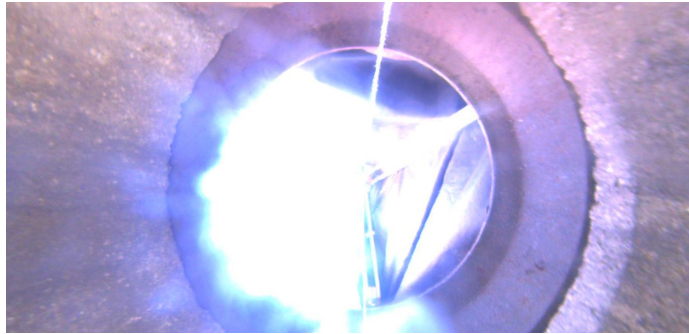
Code:	MGO
Description:	General Observation
Distance (ft):	2.9
Structural Grade:	0
O&M Grade:	0
Clock Start/From:	
Clock To:	
1st Value:	
2nd Value:	
Value Percent:	
Step:	NO
Remarks:	UNDERSIDE OF FRAME

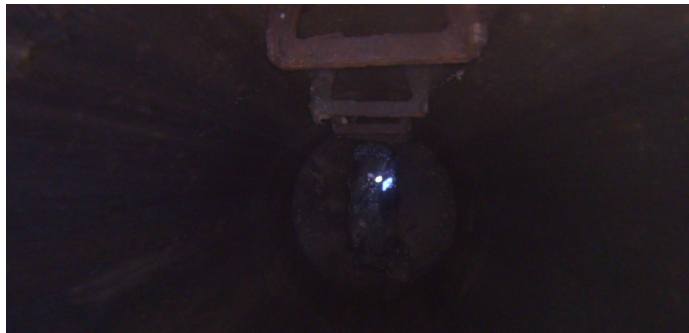
Code:	IS
Description:	Infil Stain
Distance (ft):	4.8
Structural Grade:	0
O&M Grade:	0
Clock Start/From:	12
Clock To:	12
1st Value:	
2nd Value:	
Value Percent:	
Step:	NO
Remarks:

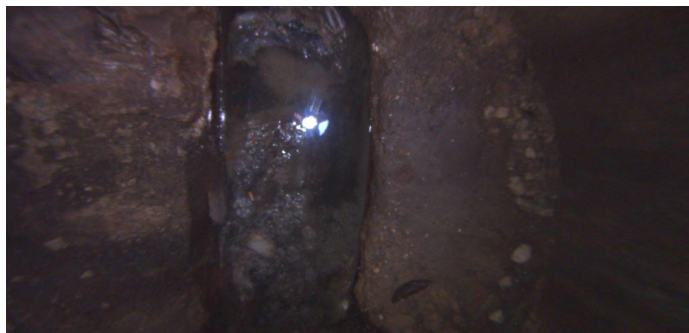
Code:	DSGV
Description:	Deposits Settled Gravel
Distance (ft):	10.3
Structural Grade:	0
O&M Grade:	2
Clock Start/From:	12
Clock To:	12
1st Value:	
2nd Value:	
Value Percent:	5.000
Step:	NO
Remarks:

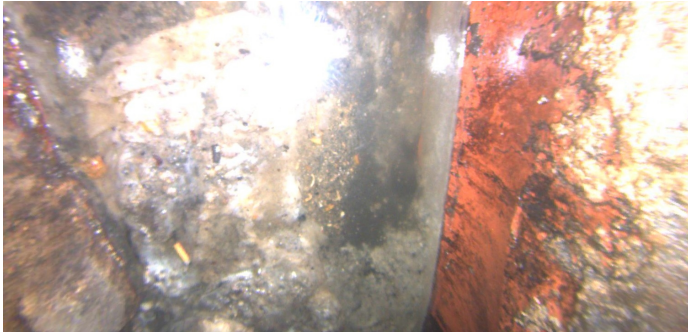
Code: **MGO**
Description: **General Observation**

Distance (ft): **12.2**
Structural Grade: **0**
O&M Grade: **0**
Clock Start/From:
Clock To:
1st Value:
2nd Value:
Value Percent:
Step: **NO**
Remarks: **END SURVEY**
