Manhole Inspection Report

Date:	04/27/2018	Weather:		Coding:	RZMACP
MH#:	M-606-006	Owner:	NA	Len. Surveyed:	10.7
P.O.#:		Surveyor:	Jen Costello	Rim to Invert:	11.6
Customer:		Cert. #:	U-907-5518	Wall Material:	Concrete (reinforced)

Street:	Lake Park Ave. 253' South of 8th St.	Project:	Hobart, IN
City:	Hobart, IN	GPS Northing:	2904523.569
Location:		GPS Easting:	2904523.569
Drain Area:	Southeast	GPS Accuracy:	Sub-Meter
Cover Shape:	Circular	Evidence of Surcharge:	No
Cover Size:	22.5	Potential for Runoff:	None
Comments:

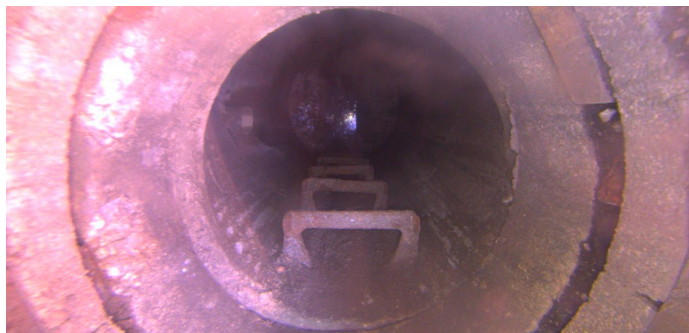
Code: **MGO**
Description: **General Observation**

Distance (ft): **.0**
Structural Grade: **0**
O&M Grade: **0**
Clock Start/From:
Clock To:
1st Value:
2nd Value:
Value Percent:
Step: **NO**
Remarks: **ACCESS MH**

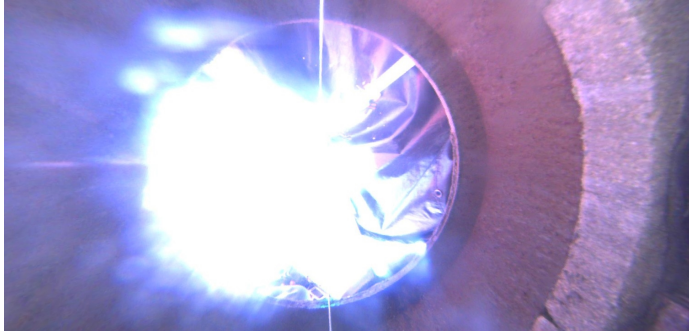
Code:	MGO
Description:	General Observation
Distance (ft):	1.4
Structural Grade:	0
O&M Grade:	0
Clock Start/From:	
Clock To:	
1st Value:	
2nd Value:	
Value Percent:	
Step:	NO
Remarks:	UNDERSIDE OF FRAME

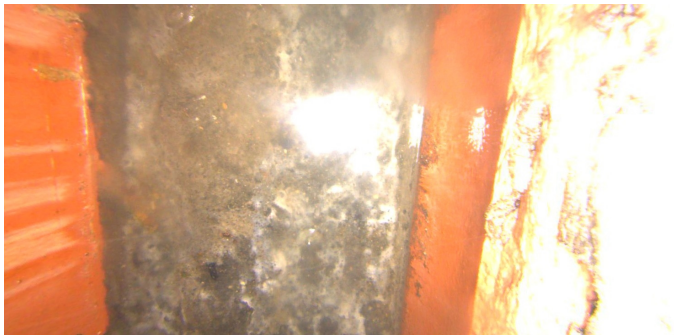
Code:	MGO
Description:	General Observation
Distance (ft):	10.7
Structural Grade:	0
O&M Grade:	0
Clock Start/From:	
Clock To:	
1st Value:	
2nd Value:	
Value Percent:	
Step:	NO
Remarks:	END SURVEY
